# Structural Report

New House Farm,  
Broadwater Lane,  
Copsale,  
Horsham,  
West Sussex RH13 6QW

David Wood & Peter Sennitt | 25<sup>th</sup> November 2025  
Studio 22, River Road, Arundel,  
West Sussex BN18 9DH  
01903 410408  
07889 646595

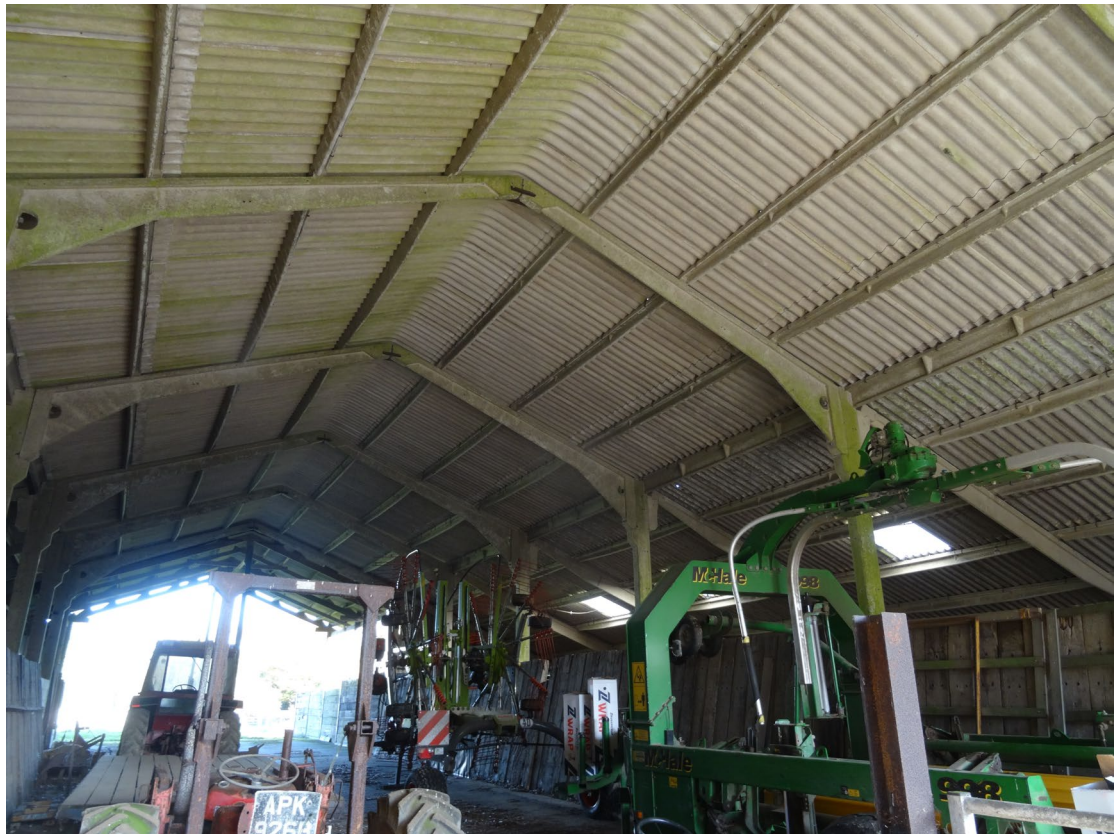
inside main span of Building No.1

This building which was erected in the mid 1960's is the largest structure and is central to the group. The “Tyler” refers to the manufacturer of precast concrete framed agricultural buildings who were active along with “Crenden” and “Atcost”. The main building is approximately 31 metres long with a span between the concrete columns of 8.6metres. The precast concrete columns are 250 x 250mm in shape and are 5.4 metres high to the underside of the bolted roof frames which are also precast concrete. There are 8 columns to each side giving approximately 4.550 metres between each upright. There appears to be no visual defects to either the concrete elements or the roof sheeting.

The roof has asbestos cement “big six” sheets covering bolted down to 6No. precast concrete purlins over this double pitched barn plus a deeper concrete edge beam. The main barn space has an extension of an additional width of 6metres to both long sides. With 8 smaller concrete columns of 200 x 150mm of approximately 3 metres height to the eaves.

The floor has a concrete slab with small block patten to the face. The outer face of the long side walls consists of 200mm thick blockwork of approximately 2 metres height and topped with vertical “big six” asbestos cement sheets up to underside of the eaves.

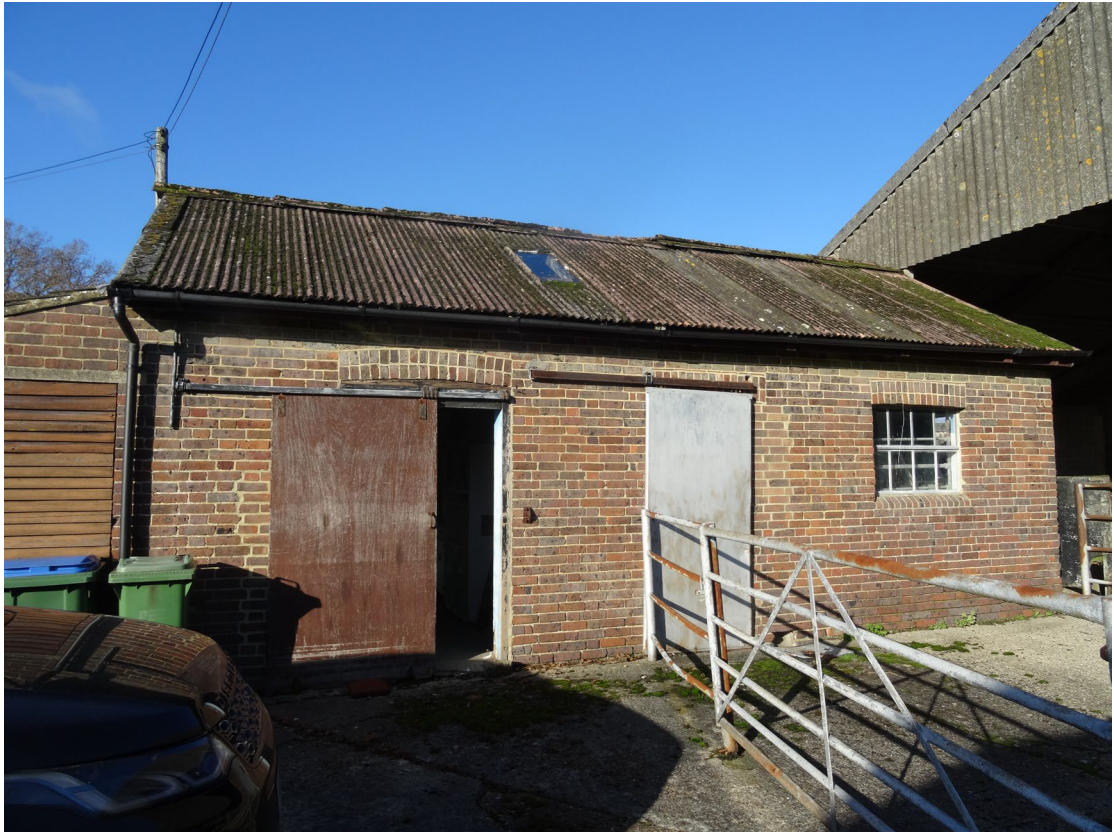
**Building No. 2**

The main parlour is approximately 6.400 x 5.000 metres on plan with a later extension opening from the end wall of 4.300 x 5.200 size. The main area has a ridge height of 4.8 metres and eaves of 2.8 with asbestos cement corrugated sheet roofing bolted down onto timber purlins supported by 2 timber trusses with a large steel RSJ (300 x 130mm) under. The walls to the front and part of the side walls are local "Warnham" facing bricks, but the rear has been extended in 200mm thick blockwork walls with rendered inner face. The main elevation facing onto the inner yard has two door openings and a steel window frame. The smaller extension is built in part horizontal timber cladding and part pebbledash blockwork walls and as this has been discounted in the outline scheme we have not reported on this area.

The main structure is in reasonable condition with no apparent major defects.

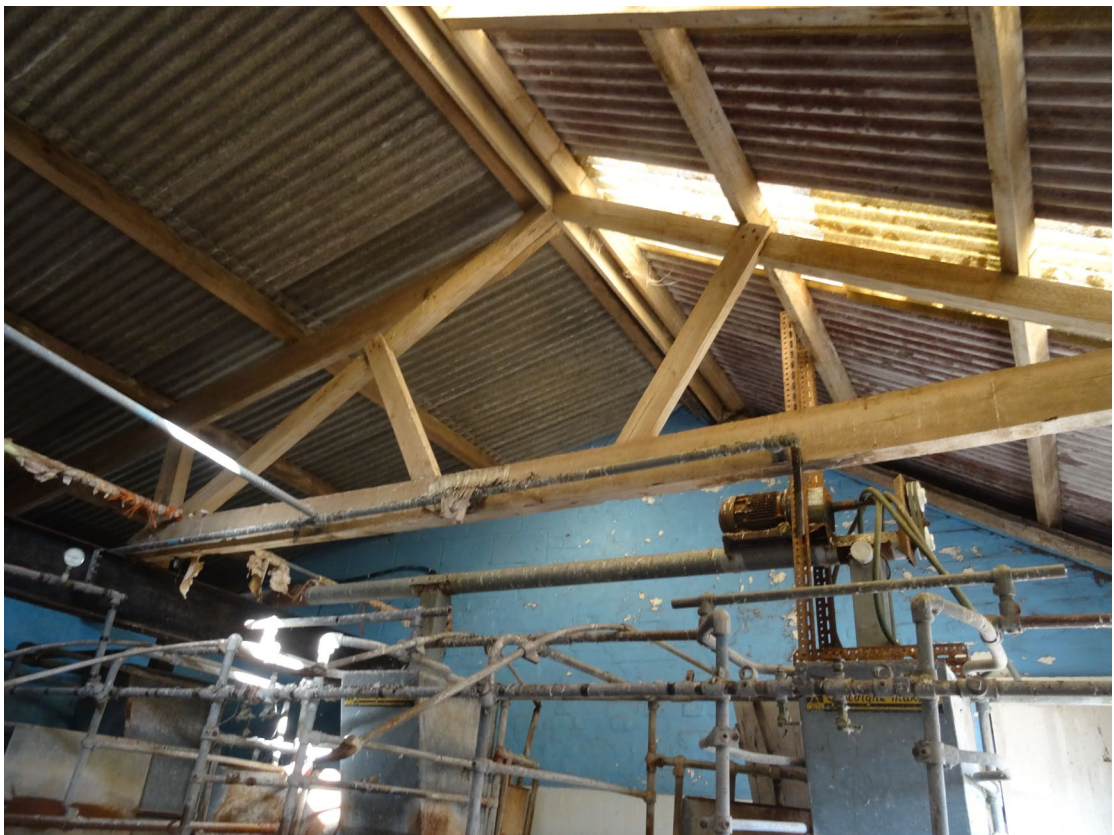
**Internal Building No.2**

The floor of the parlour is mass concrete with a step up to the milking/feeding stalls and all the metalwork for stalls and feeding troughs are still in place.
