**QUANTITATIVE GROUND  
CONTAMINATION RISK  
ASSESSMENT AND  
REMEDICATION STRATEGY  
REPORT**

**LAND TO THE REAR OF 1  
BROCKWELL COTTAGE  
FAYGATE LANE  
HORSHAM  
WEST SUSSEX**

**PROJECT REFERENCE: P17583**

**REPORT REFERENCE: R17054**

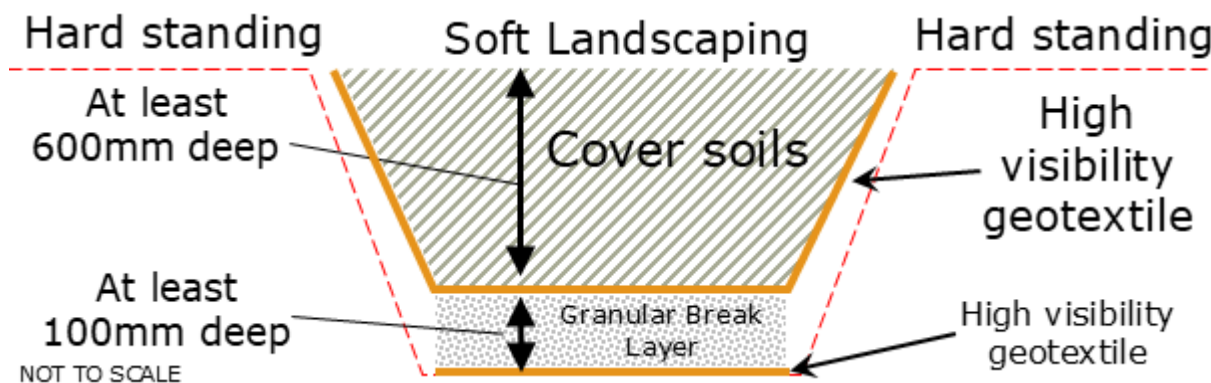
A schematic cross section of the cover system construction is shown below.

The depth of the cover system specified represents “two spade depths” to allow for planting of trees, shrubs etc. without residents coming into contact with the contaminated soils remaining at depth.

The top layer of geotextile must lap up the sides of the excavation to prevent future intermixing between the cover system soils and made ground that may remain beyond the site boundary or beneath adjacent areas of hard standing.

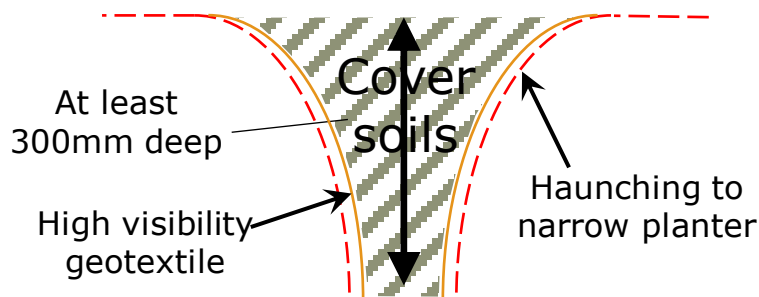
Where smaller planting beds are proposed it is recognised that it may be difficult to provide the full 600mm of cover due to the presence of concrete haunching or other adjacent fixtures. In such areas, the cover system should comprise 300mm of verified “clean” imported soils overlying the geotextile marker. A schematic cross section of the cover system construction is shown below.

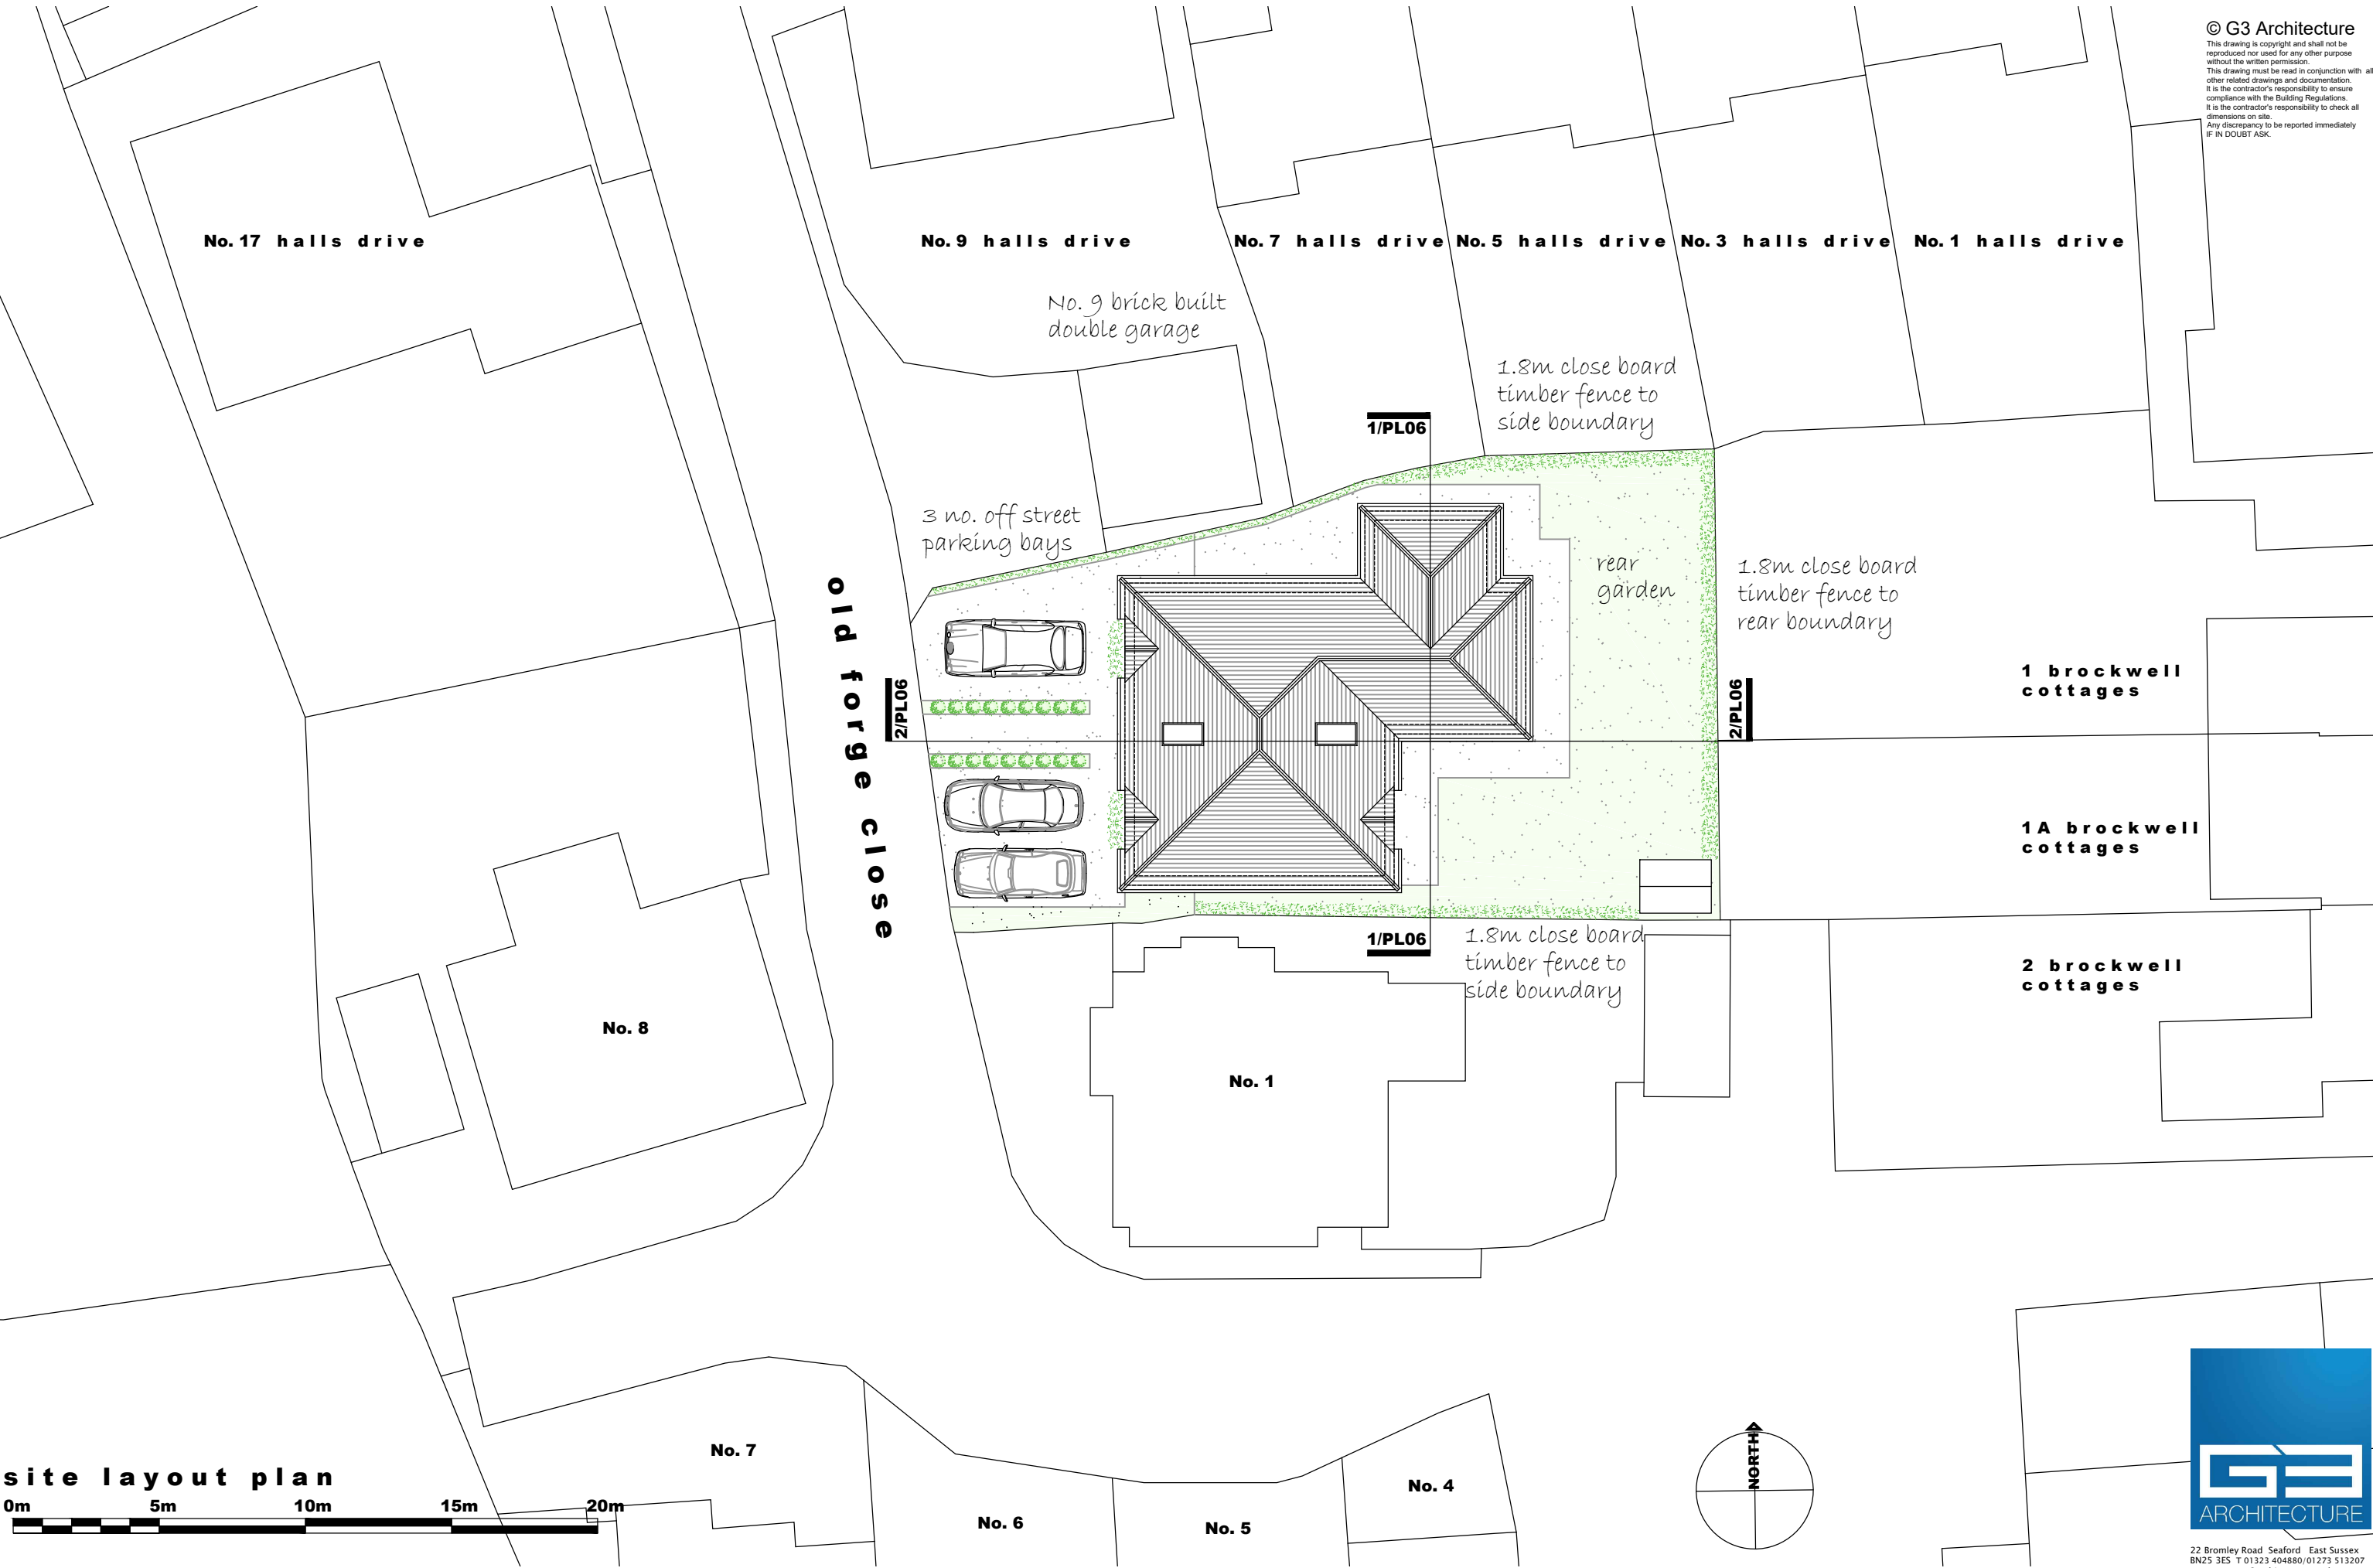
### Proposed Development Layout

site layout plan
