**Land South of Smugglers Lane,  
Barns Green, Horsham**

**Arboricultural Implications Assessment and  
Method Statement**

September 2025

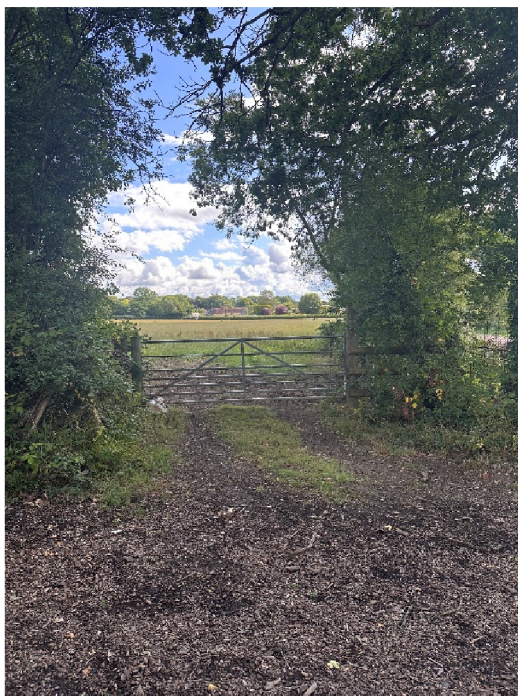
The proposed access path through the RPA of T26 and ASNW buffer zone utilises an existing access point, historically used for agricultural purposes.

Figure 1: Existing agricultural access viewed from bridleway

The proposed path ensures permeability of the layout in the interests of good planning and urban design. Using the proposed location negates the need to remove sections of hedgerow and provides the opportunity to install a semi-formalised path through an existing access point that is likely to be used by future residents in any case. The installation of a semi-formalised path focuses the footfall and therefore minimises the chances of further compaction of the ground. A fence will be installed on either side of the path, which will be reinforced with planting of thorny species.

Prior to the installation of the path, the former agricultural access will be de-compacted using a Turbo-Terra Air to inject compressed air at a depth of 300mm. Refer to Section 5.3 below for details.

The proposed footpath will be porous and will be constructed in accordance with the 'no dig' principles outlined in APN12 and utilise a cellular confinement system such as Cell Web as a subbase. Refer to Section 5.3 below for details.
