## Arboricultural Impact Assessment

**Location:** Clyst Hayes, Brook Lane Horsham, West Sussex, RH12 4SB

## **ARBORICULTURAL METHOD STATEMENT**

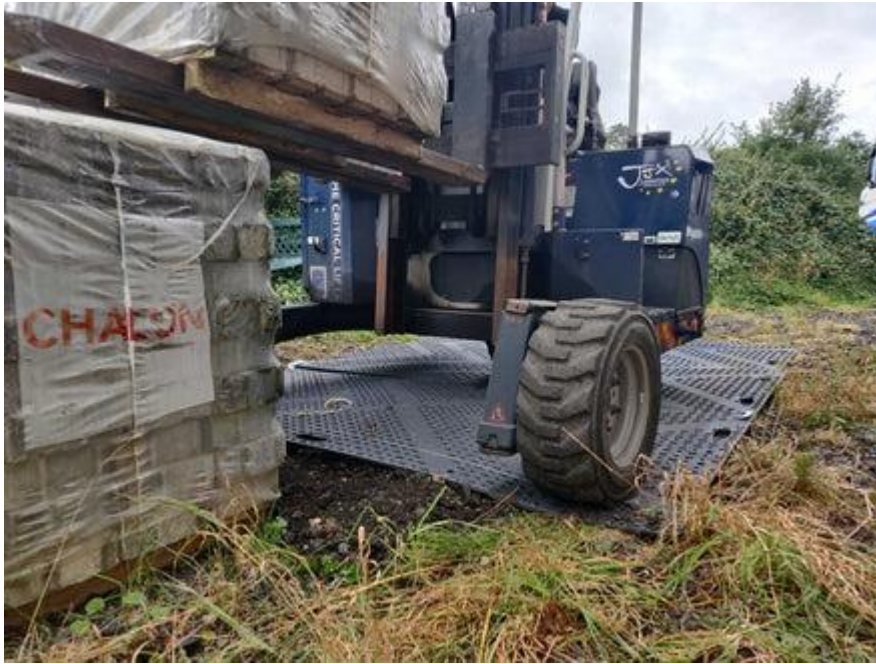
## **10. Working area / Access**

Ground boards such as 'EuroMat' or 'TuffTrak' (dependent upon loading), held together fixed with connection plates. Where access is for pedestrian or light machinery use only, scaffold boards or 18mm ply sheets may be used, these may need to be bolted together to add strength and to prevent movement. Existing ground for pedestrian access hollows should be filled with topsoil or woodchip. For vehicular / heavy machinery use or if prolonged access is required a 100- 150 mm bed of wood or bark chip should be laid underground boards Geotextile membrane such as Terram 1000 as a separating layer.

- 6.1 All demolition must take place from outside of any RPA's and where this is not possible, ground protection boards must be implemented. The positions of which are highlighted in the TPP. The positions of any current foundations should be used to stockpile debris where possible.
- 6.2 Any machinery used during the demolition must work backwards from the RPA and work with extreme care, so no debris fall into the RPA. The roof and walls of the building shall be 'folded' inwards, within the footprint of the structure.
- 6.3 No materials shall be stockpiled on any area within the RPA.
- 6.4 Under no circumstances shall any machinery or vehicles operate or traverse across exposed soils within RPAs.

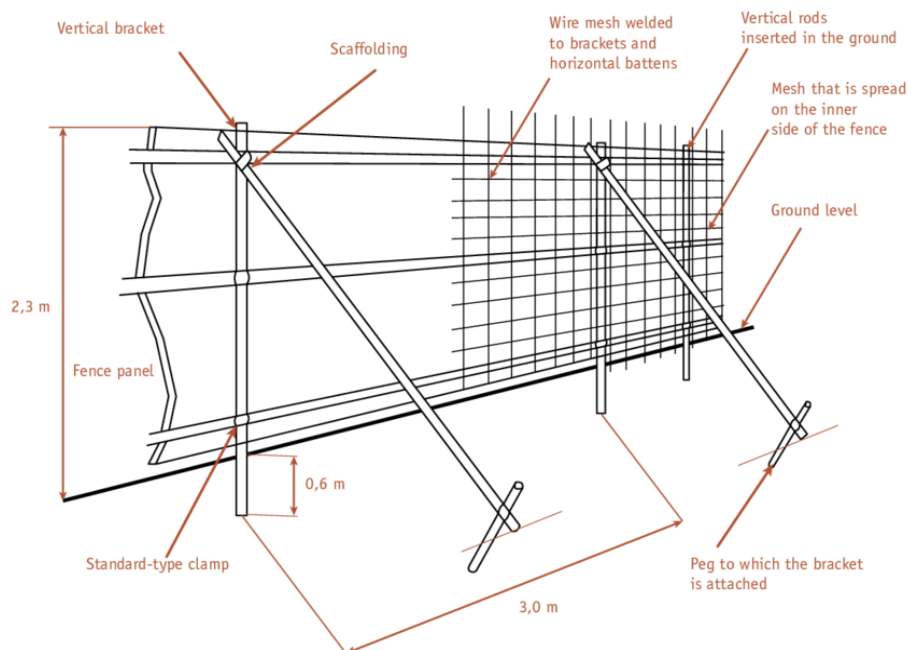
## 11. Example of protection fencing

'Heras' weldmesh panels securely attached to scaffold poles driven firmly into ground and braced with supporting scaffold poles. Where fencing is in or near RPA's, base supports are to be used to prevent damaging any roots underneath.

- 4.1 Tree protection barriers shall be installed prior to the commencement of any site clearance or construction works.
- 4.2 Vertical tree protection barriers shall be erected in the positions indicated on the Tree Protection Plan [TPP]. Barriers shall be formed from a system of 'heras' style weldmesh panels securely fixed to scaffold poles and stabilized

on either rubber or concrete feet and secured by ground pins driven firmly into the ground and braced as illustrated on the TPP. These barriers demarcate the 'Construction Exclusion Zone', the areas adjacent to trees that shall be safeguarded from all forms of construction activity.

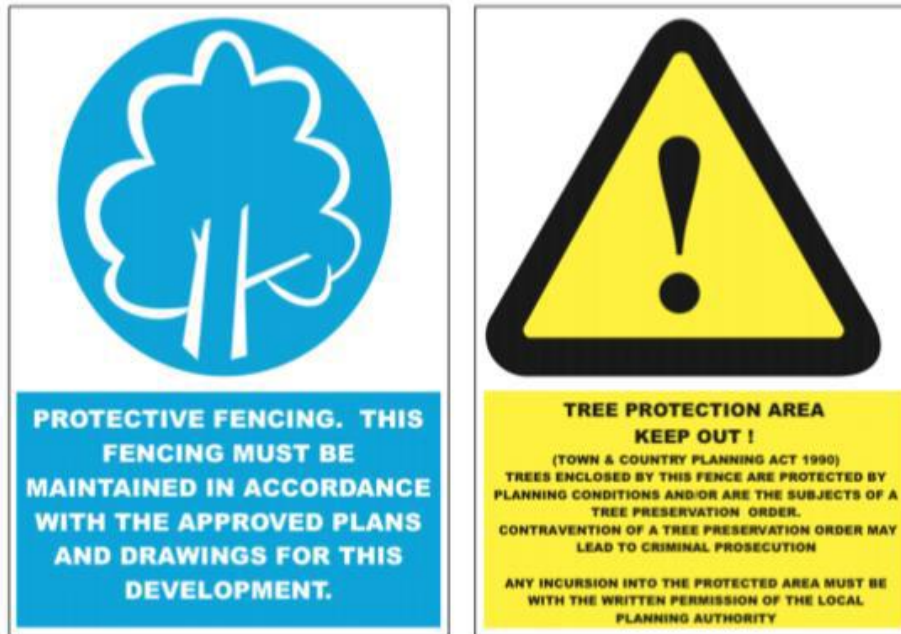
## 12. Example of protective fencing signs

Signs such as these must be firmly secured onto each fence panel.
