## Arboricultural Impact Assessment

**Location:** Lock House, Lock Lane, Partridge Green, West Sussex, RH13 8EG

**Reference:** AIA-LH-28/4/26

## ARBORICULTURAL METHOD STATEMENT

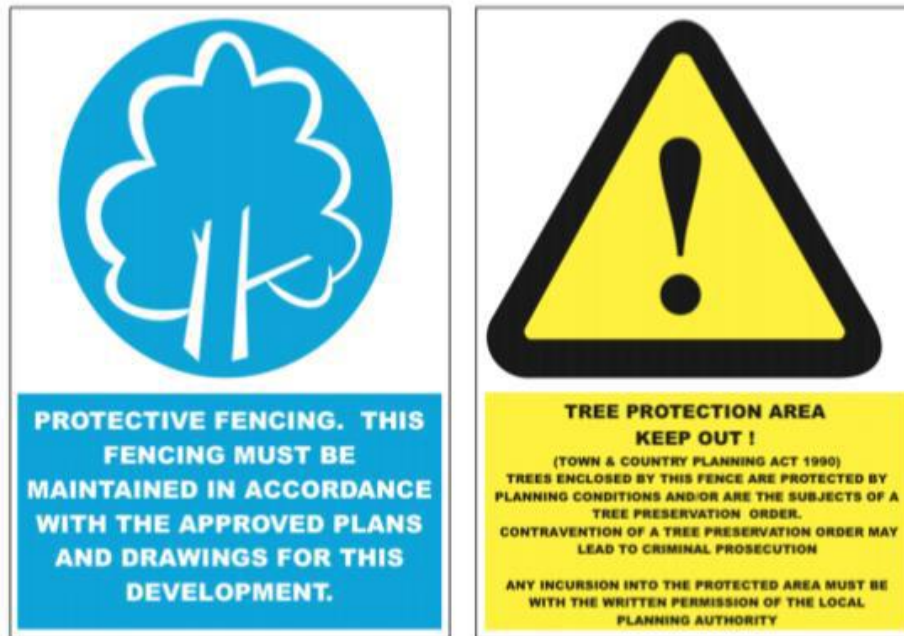
## 12.0 Example of protective fencing signs

Signs such as these must be firmly secured onto each fence panel.
