**Project Name:** Menzies Wood Farm  
**Project Description:** CCTV Survey, trace & plot  
**Project Status:** Complete  
**Project Date:** 08/07/2024  
**Inspection Standard:** MSCC5 Sewers & Drainage GB (SRM5 Scoring)

# **EYES ON DRAINAGE**

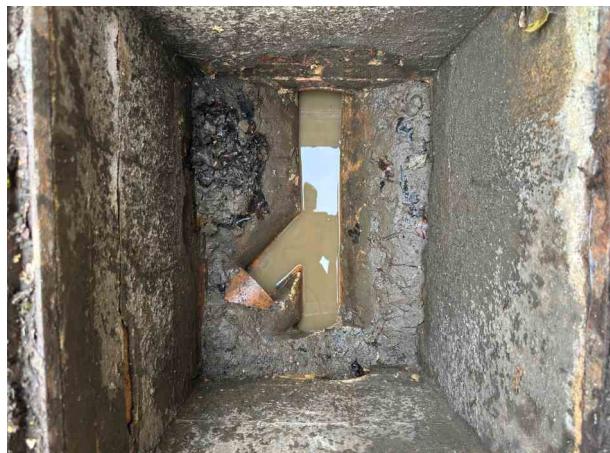
SW1 (after cleaning)

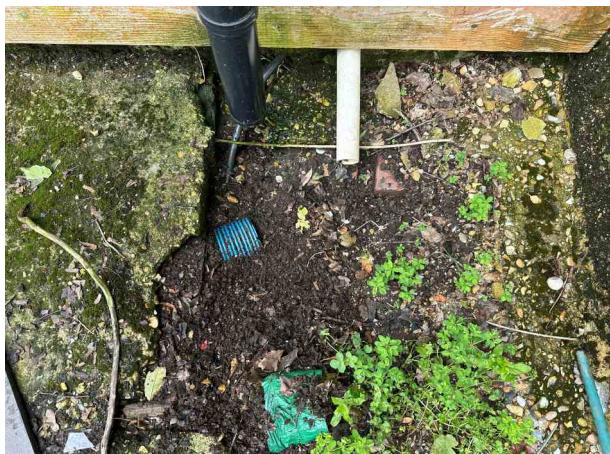
Grey water discharging to 'D'

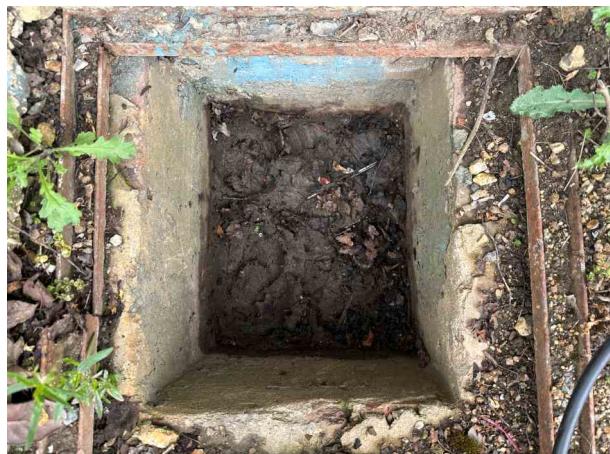
Unidentified chamber

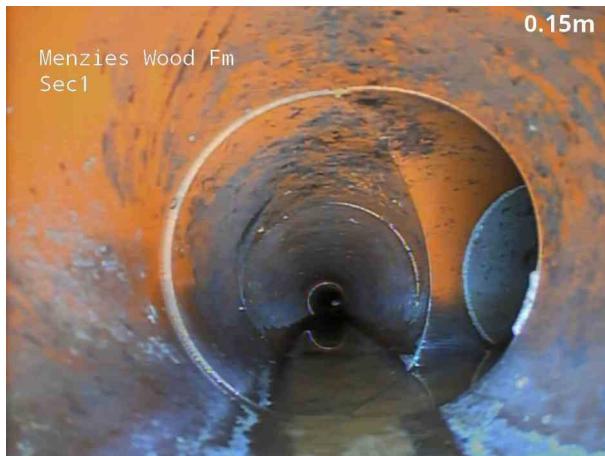
2, 00:00:15, 0.30 m  
Junction at 3 o'clock, 100mm dia

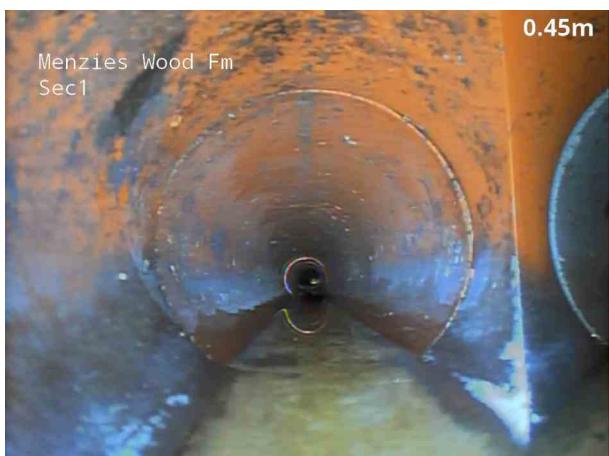
3, 00:00:22, 0.50 m  
Water level, 10% of the vertical dimension, Continuous

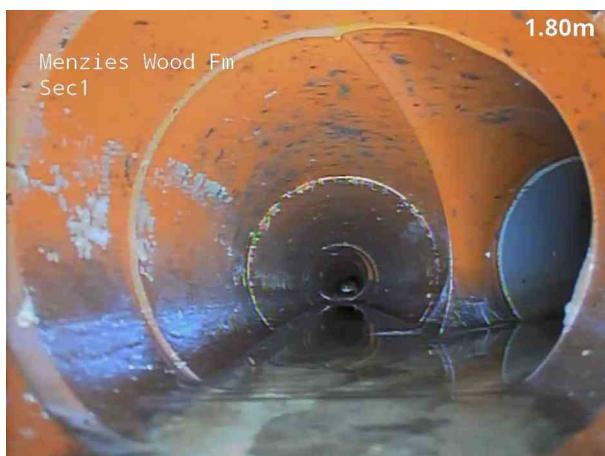
4, 00:00:36, 2.00 m  
Junction at 3 o'clock, 100mm dia

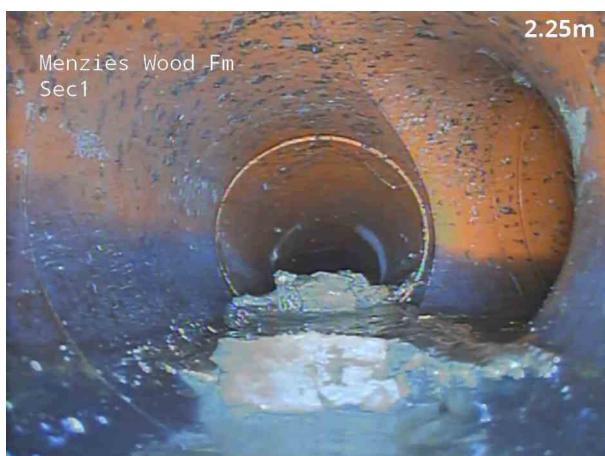
6, 00:00:48, 2.40 m  
Junction at 3 o'clock, 100mm dia

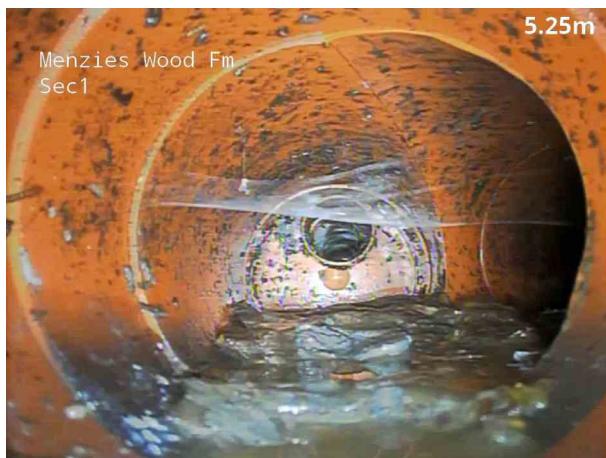
7, 00:01:18, 5.30 m  
Junction at 3 o'clock, 100mm dia

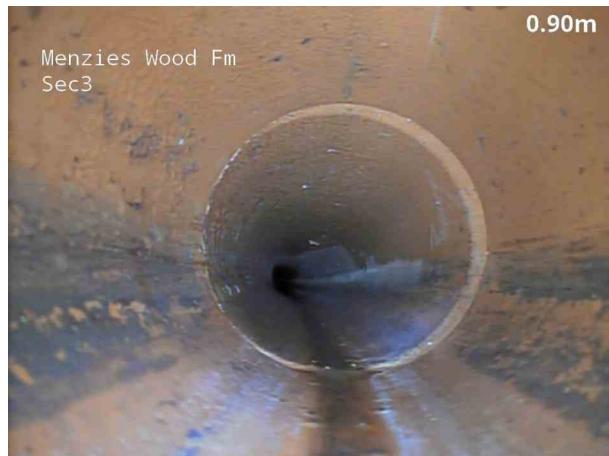
2, 00:00:10, 1.40 m  
Line deviates left, start

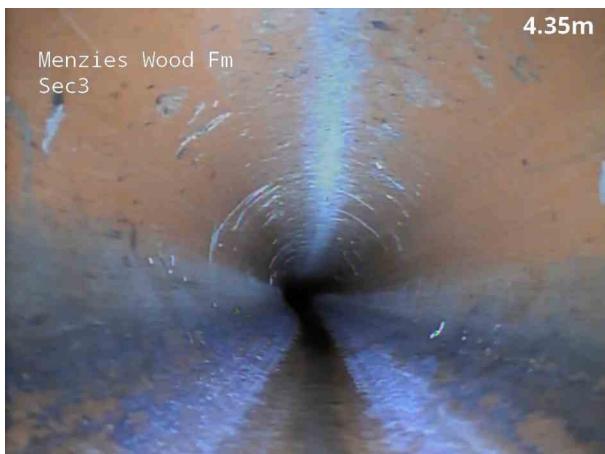
3, 00:00:23, 4.50 m  
Line deviates left, finish

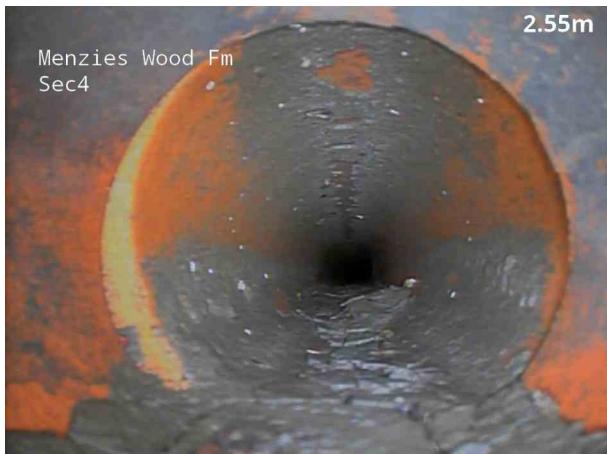
7, 00:01:02, 2.55 m  
Joint displaced, medium

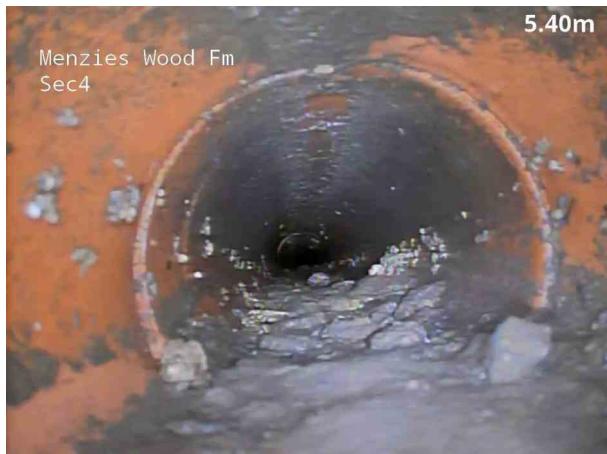
8, 00:01:30, 5.50 m  
Settled deposits, hard or compacted, 20% cross-sectional area loss, change

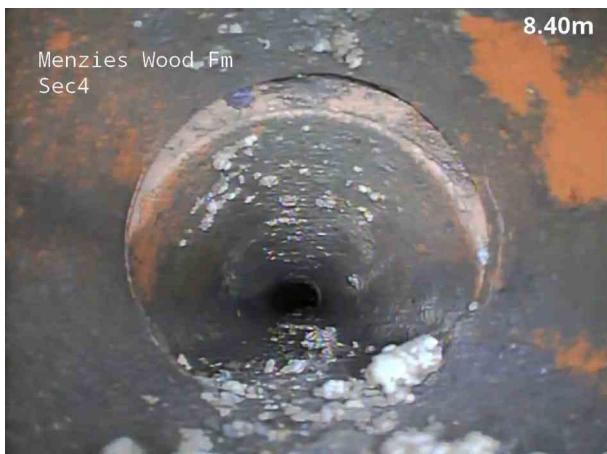
9, 00:01:56, 8.40 m  
Joint displaced, medium

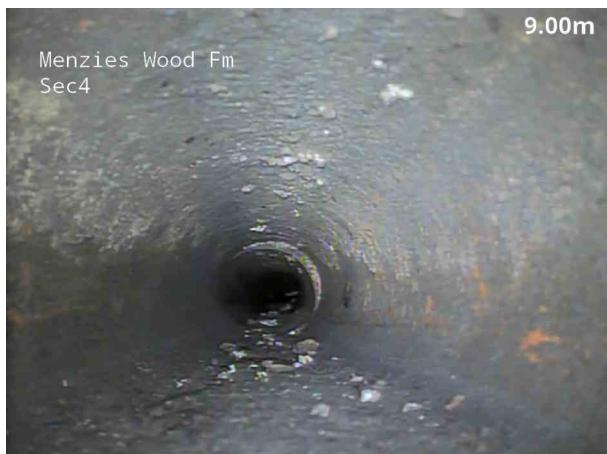
10, 00:02:03, 9.00 m  
Settled deposits, hard or compacted, 10% cross-sectional area loss, change

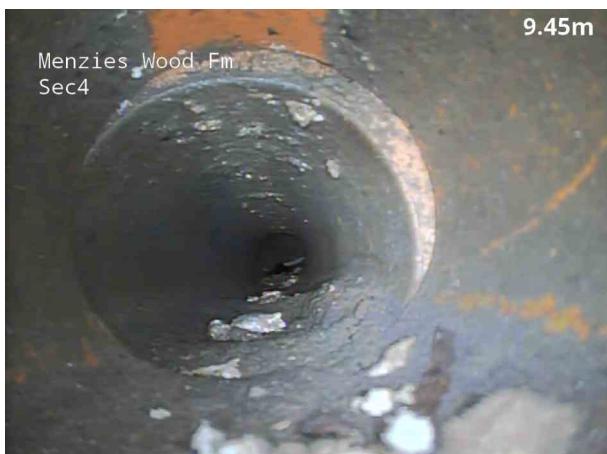
11, 00:02:07, 9.60 m  
Joint displaced, medium

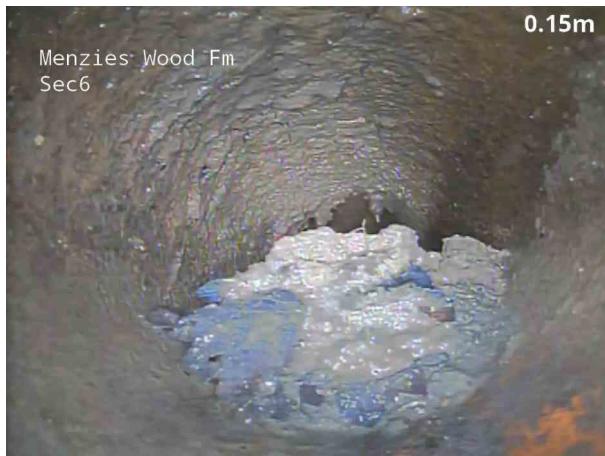
2, 00:00:06, 0.30 m  
Settled deposits, fine, 50% cross-sectional area loss

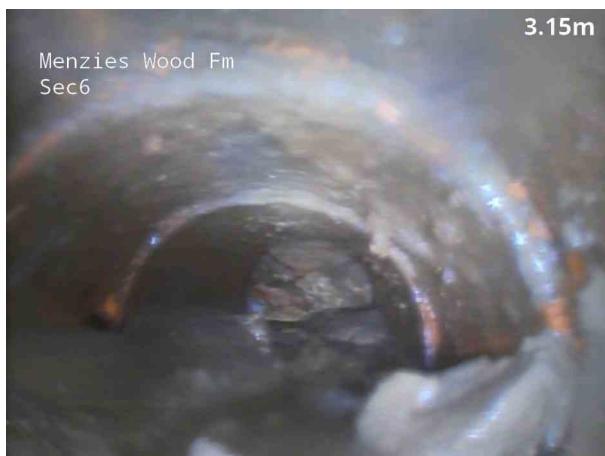
6, 00:00:51, 3.60 m  
Survey abandoned, Unable to continue, assumed redundant

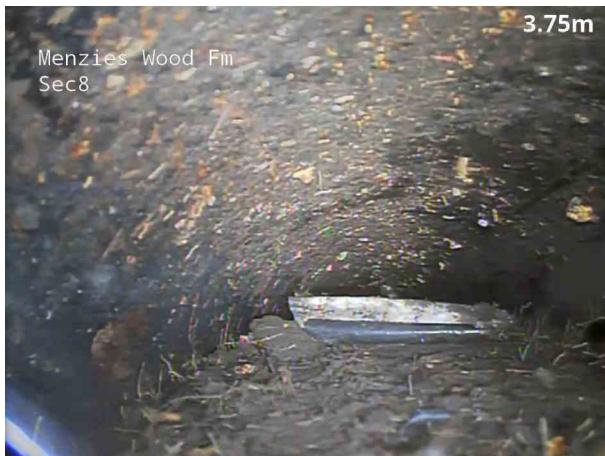
7, 00:01:21, 3.90 m  
Settled deposits, coarse, 80% cross-sectional area loss,  
change

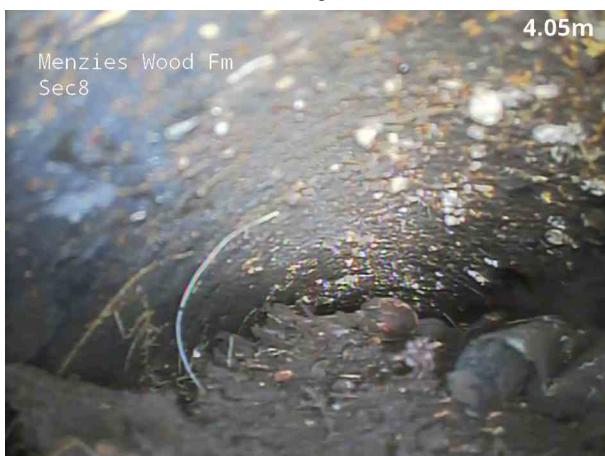
9, 00:01:29, 4.30 m  
Survey abandoned, Unable to continue

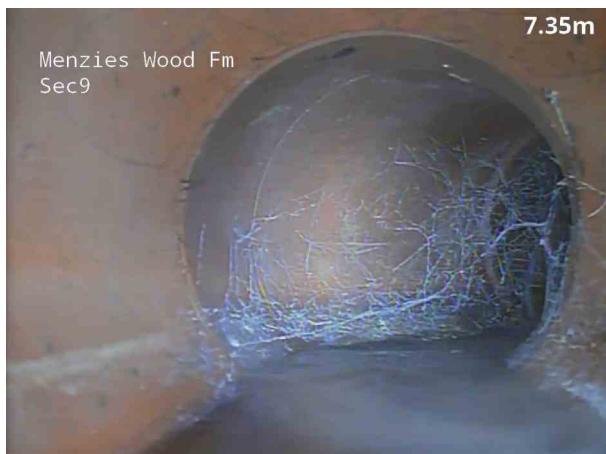
3, 00:00:45, 7.35 m  
Line deviates right

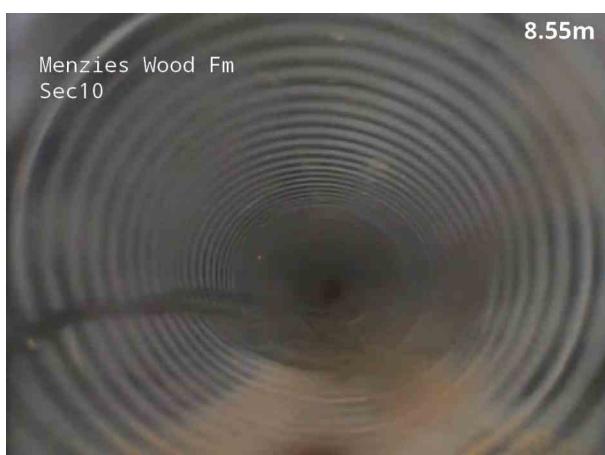
6, 00:01:19, 8.50 m  
Settled deposits, fine, 10% cross-sectional area loss, finish

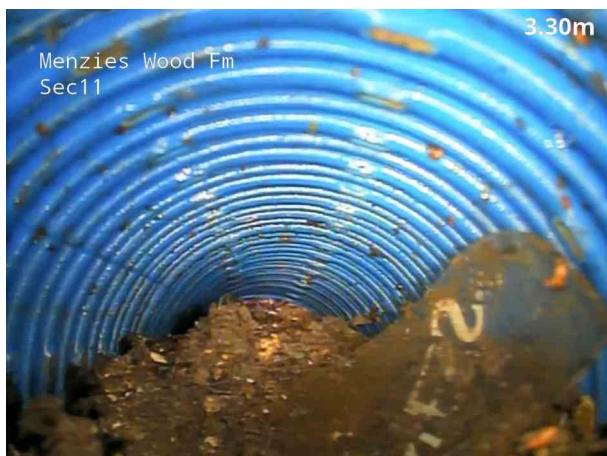
6, 00:01:25, 3.50 m  
Survey abandoned, Unable to continue

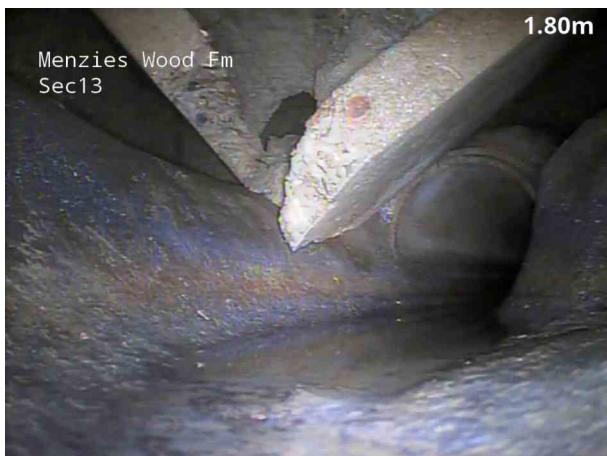
3, 00:00:21, 2.10 m  
Finish node, manhole, reference: SW7, Buried. Cover collapsed

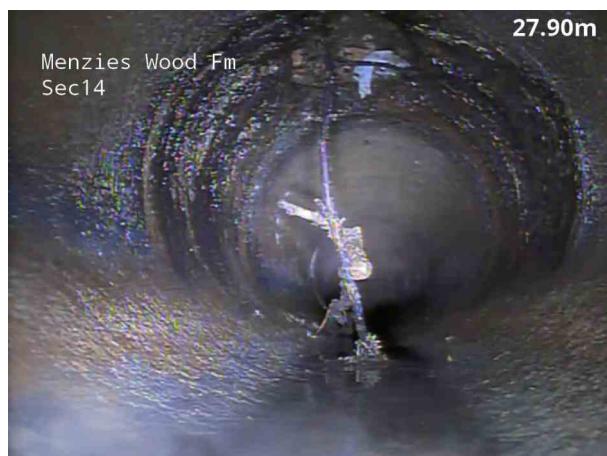
4, 00:02:02, 28.20 m  
Hole in drain or sewer at 12 o'clock

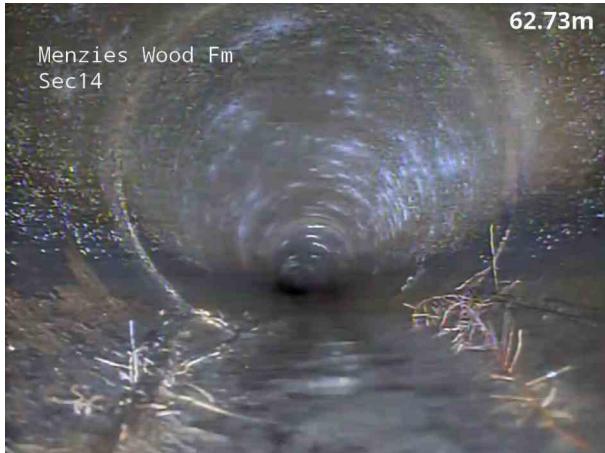
7, 00:03:28, 63.00 m  
Roots, fine at joint

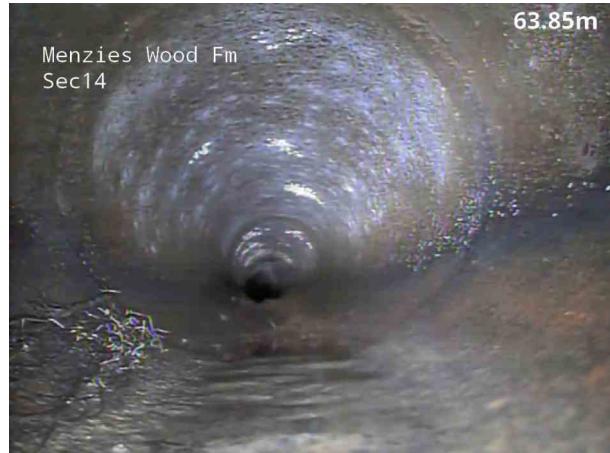
8, 00:03:39, 64.00 m  
Roots, fine at joint

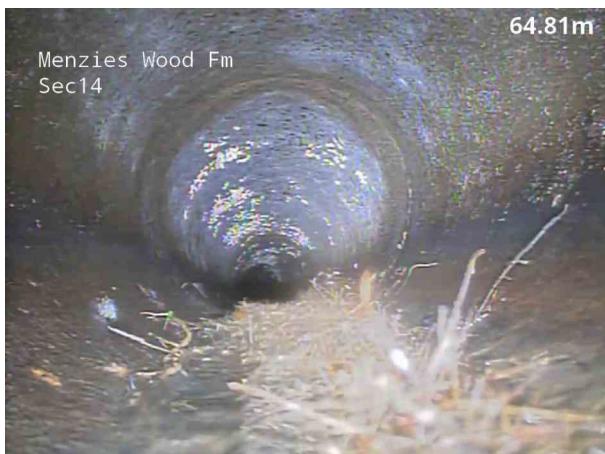
9, 00:03:55, 65.20 m  
Roots, mass at joint, 10% cross-sectional area loss

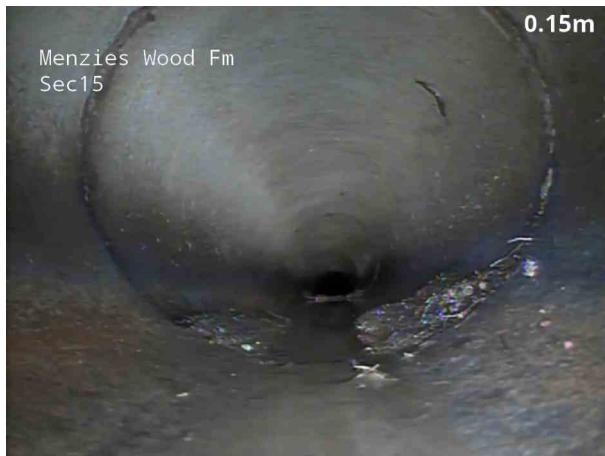
2, 00:00:07, 0.60 m  
Roots, fine at joint, start

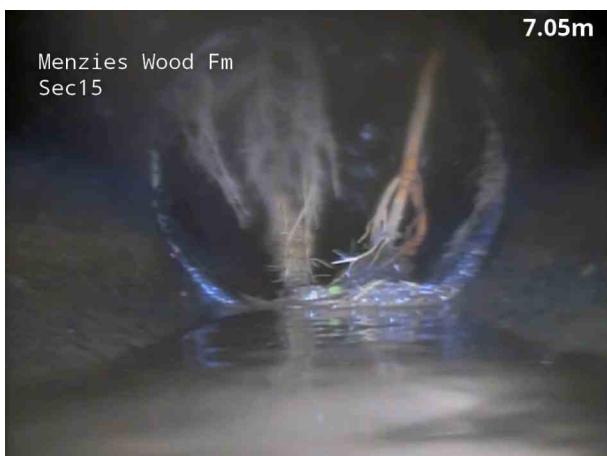
3, 00:00:56, 7.30 m  
Roots, tap at joint

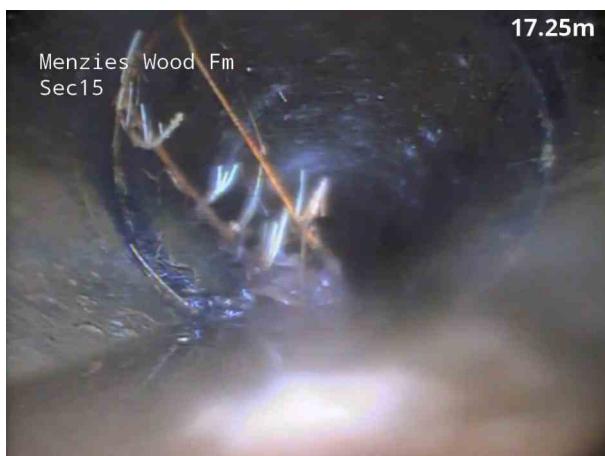
4, 00:02:20, 17.50 m  
Roots, tap at joint

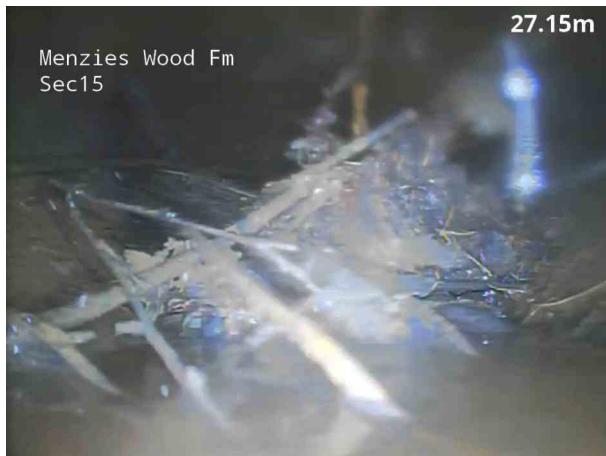
7, 00:04:00, 27.15 m  
Roots, mass, 25% cross-sectional area loss

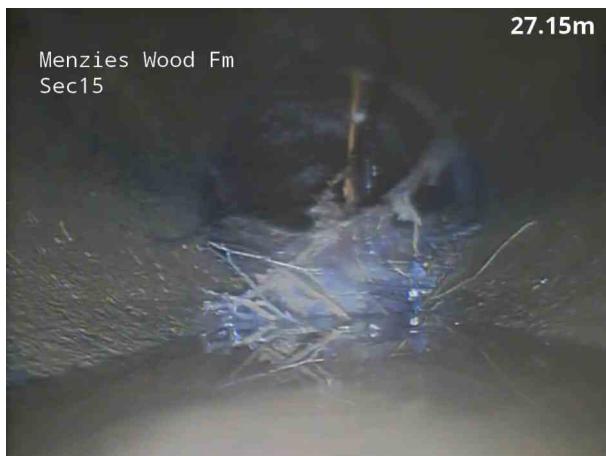
9, 00:04:08, 27.40 m  
Survey abandoned, Unable to continue

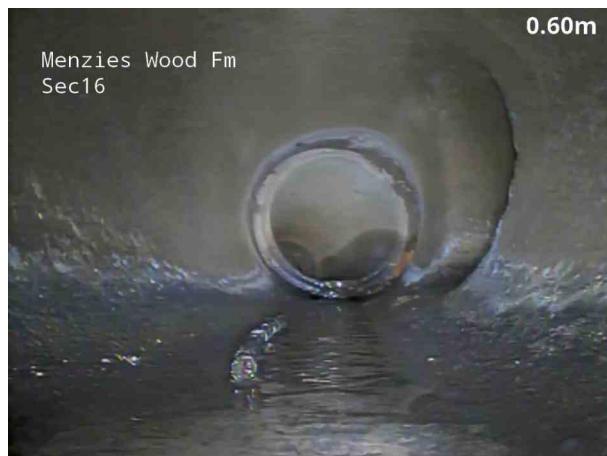
2, 00:00:13, 1.00 m  
Junction at 3 o'clock, 300mm dia

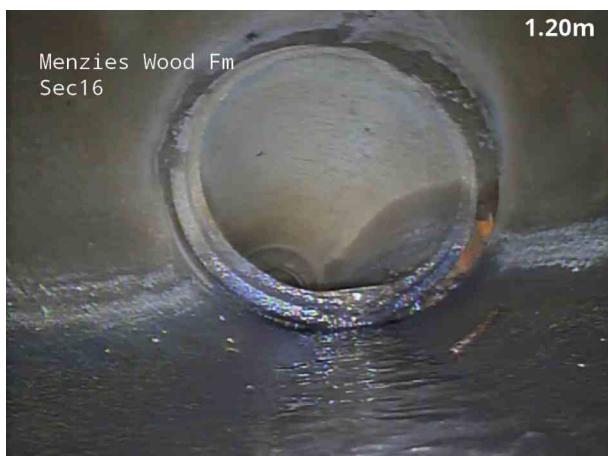
3, 00:00:18, 1.40 m  
Pipe size changes, new size(s), 225mm high, 225mm wide

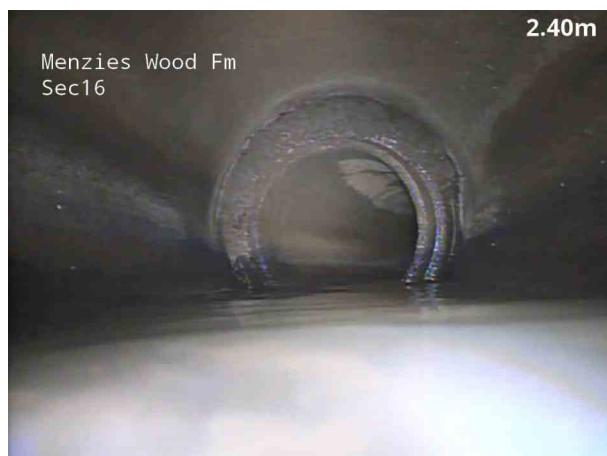
4, 00:00:35, 2.40 m  
Water level, 20% of the vertical dimension

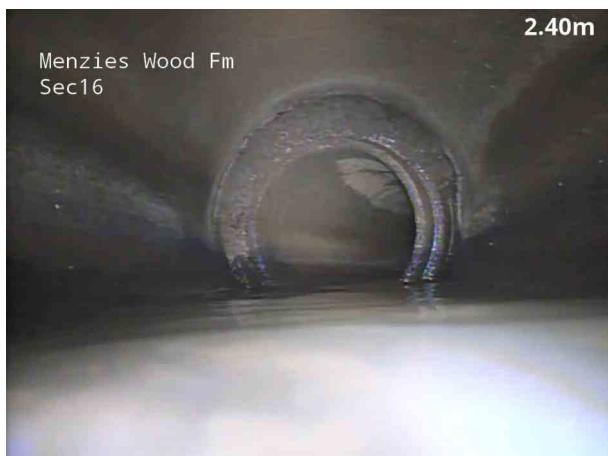
5, 00:00:35, 2.90 m  
Pipe size changes, new size(s), 150mm high

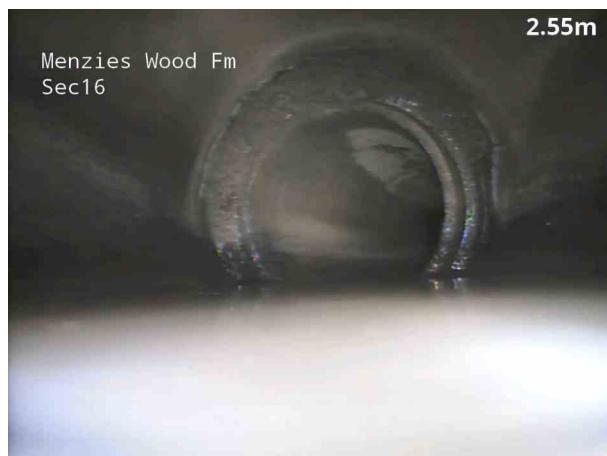
6, 00:00:49, 2.90 m  
Line deviates right

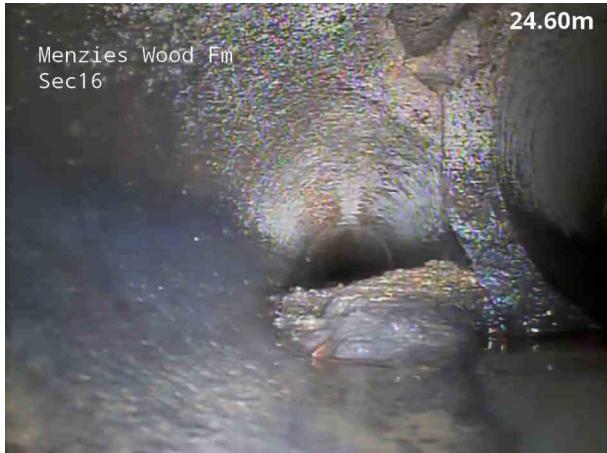
13, 00:02:26, 24.90 m  
Settled deposits, hard or compacted, 20% cross-sectional area loss, start

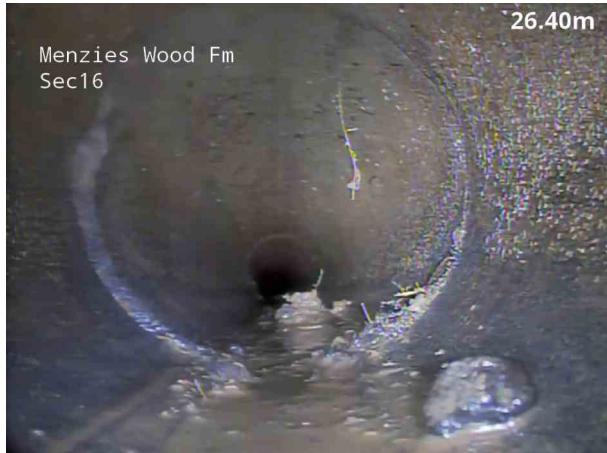
14, 00:02:42, 26.60 m  
Roots, fine at joint

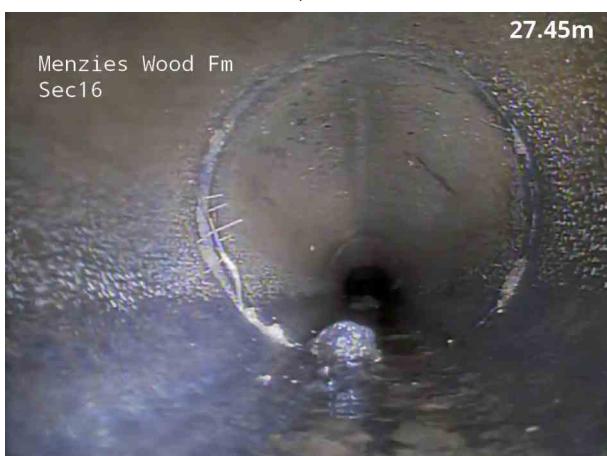
15, 00:02:48, 27.60 m  
Roots, fine at joint

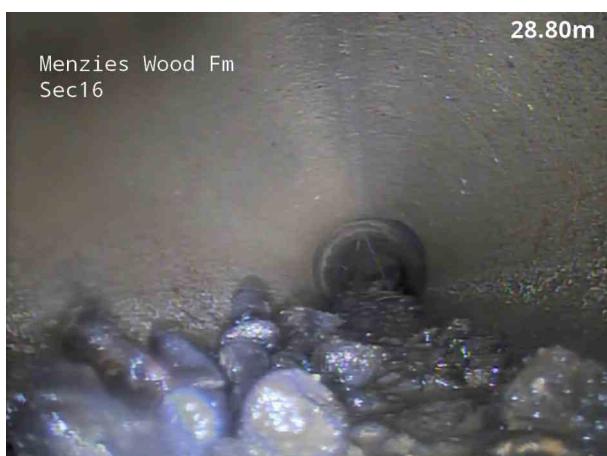
16, 00:02:55, 28.80 m  
Settled deposits, coarse, 15% cross-sectional area loss, start

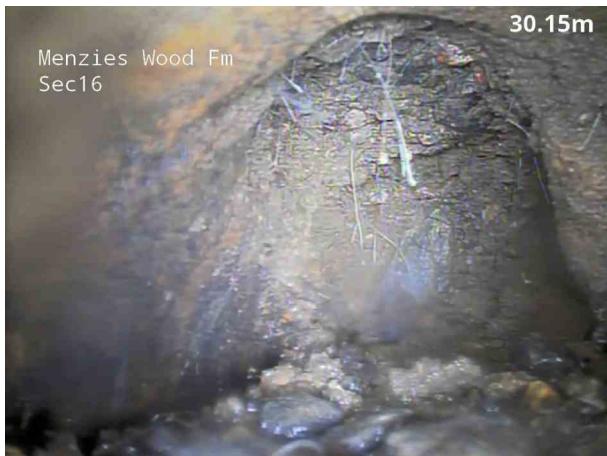
19, 00:03:26, 30.30 m  
Collapsed drain or sewer, 100% cross-sectional area loss

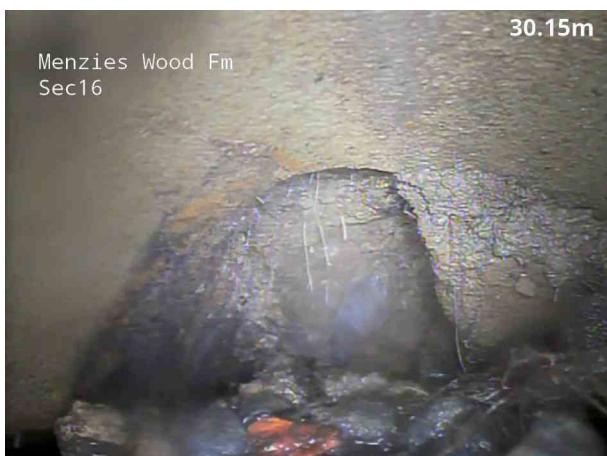
21, 00:03:30, 30.30 m  
Survey abandoned, Unable to continue

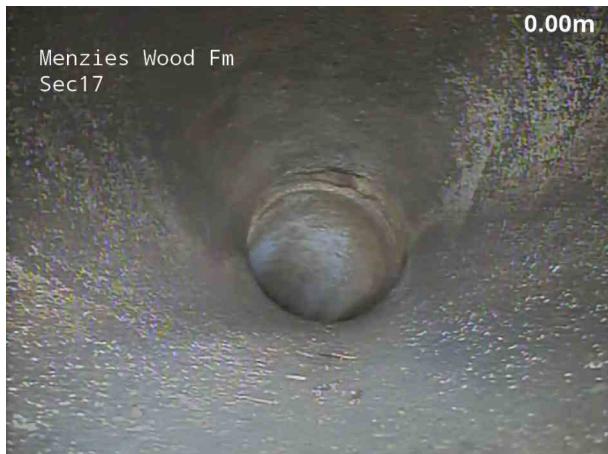
1, 00:00:01, 0.00 m  
Water level, 0% of the vertical dimension

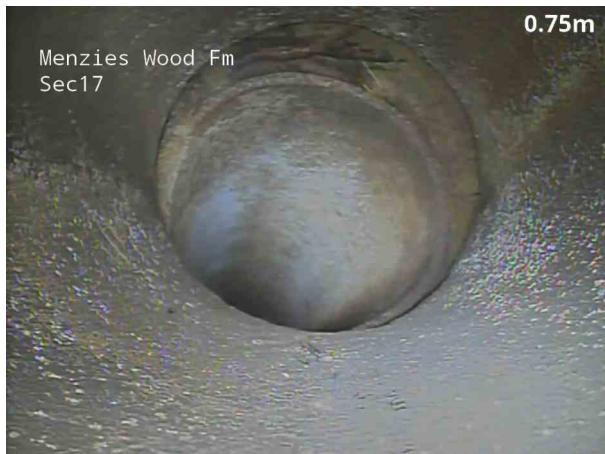
2, 00:00:09, 1.00 m  
Open joint, large

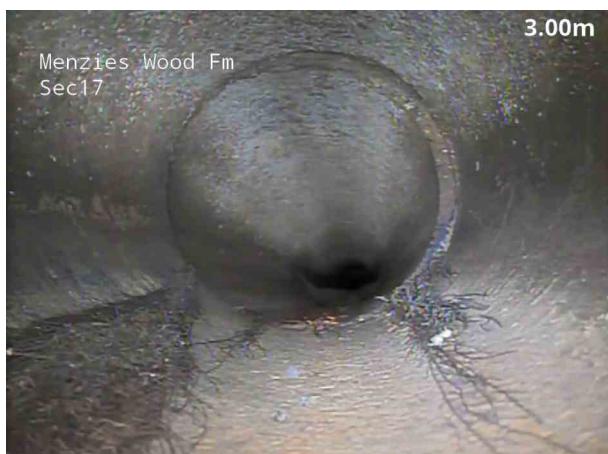
3, 00:00:20, 3.30 m  
Roots, fine at joint

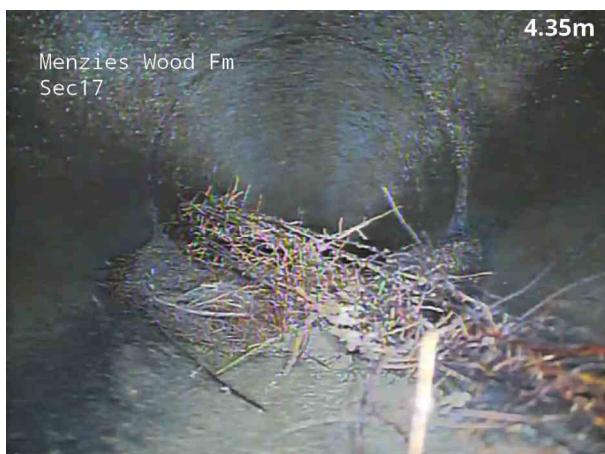
4, 00:00:31, 4.50 m  
Roots, mass at joint, 15% cross-sectional area loss

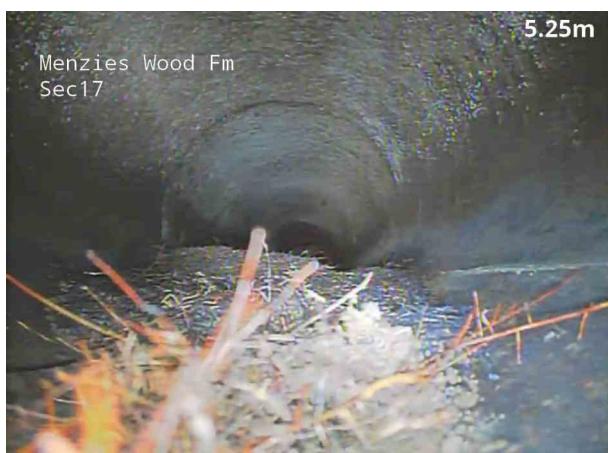
5, 00:00:44, 5.50 m  
Roots, mass at joint, 25% cross-sectional area loss

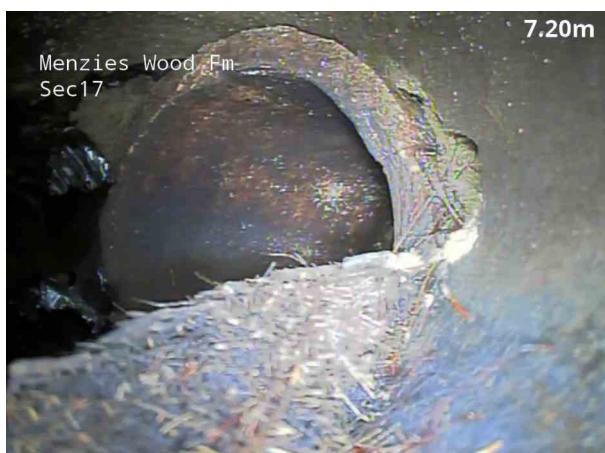
6, 00:00:56, 7.40 m  
Line deviates right

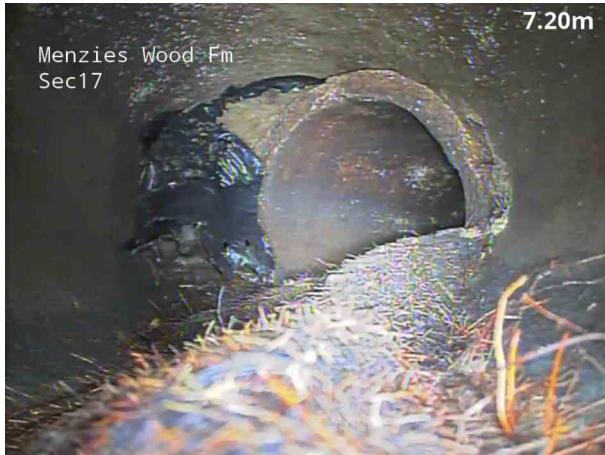
7, 00:00:56, 7.40 m  
Roots, mass at joint, 20% cross-sectional area loss

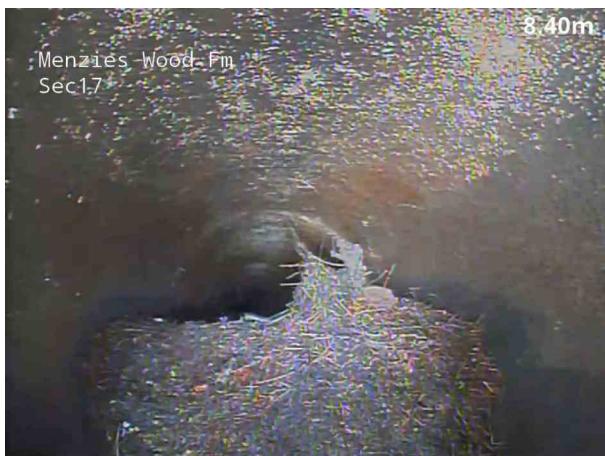
9, 00:01:15, 8.60 m  
Roots, mass, 55% cross-sectional area loss
