1.0 Introduction

- 1.1 This technical note has been prepared in response to West Sussex County Council's (WSCC's) comments on DC/25/0403 as the Lead Local Flood Authority (LLFA). Following WSCC's review of Motion's Flood Risk Assessment (FRA) and Drainage Strategy, WSCC have provided a holding objection until further information is provided.

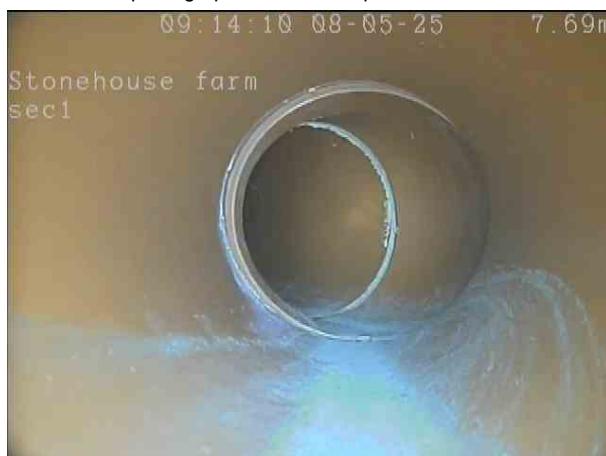
edb0e9d7-24cd-42c5-b9f3-e5be8a7f537c.png, 00:00:49, 7.80
m

Line deviates left, sharp bend

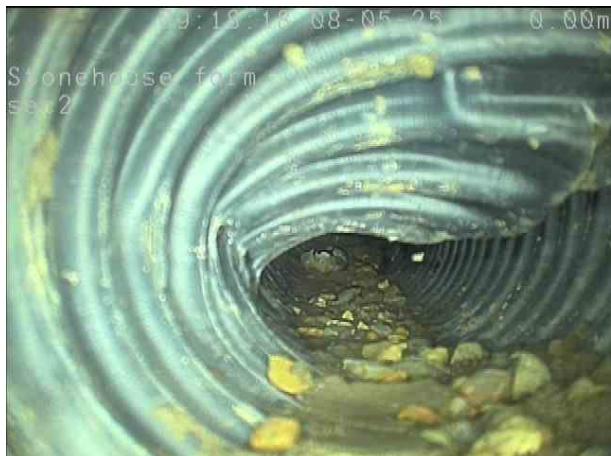
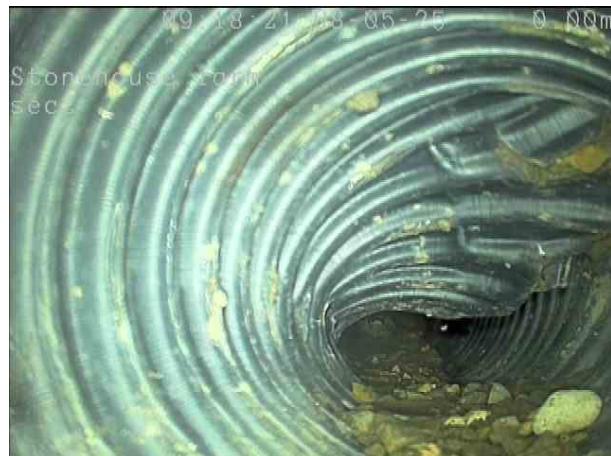
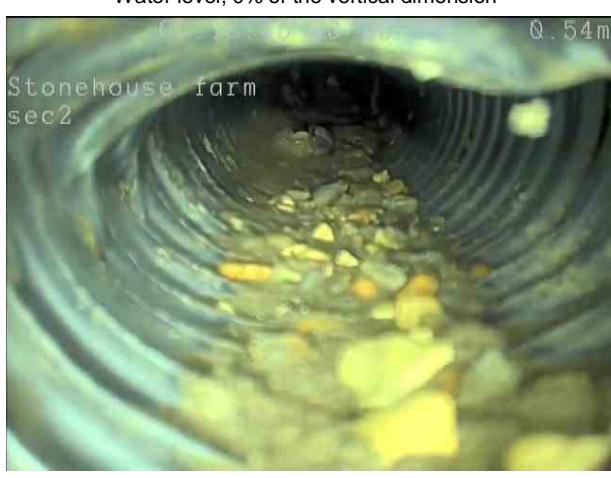
Item No.	Inspection Direction	PLR	Client's Job Ref	Contractor's Job Ref
2	Upstream	AX

Scale:	1:50	Position [m]	Code	Observation	MPEG	Photo	Grade
Depth: m							
SW3		0.00	MH	Start node, manhole, reference: SW3	00:00:02		
		0.00	WL	Water level, 0% of the vertical dimension	00:00:02		
		0.30	D	Deformed sewer or drain, 70%	00:00:05	5 / 4	
		0.50	SA	Survey abandoned: crushed pipe work	00:00:28

Abandoned section inspection

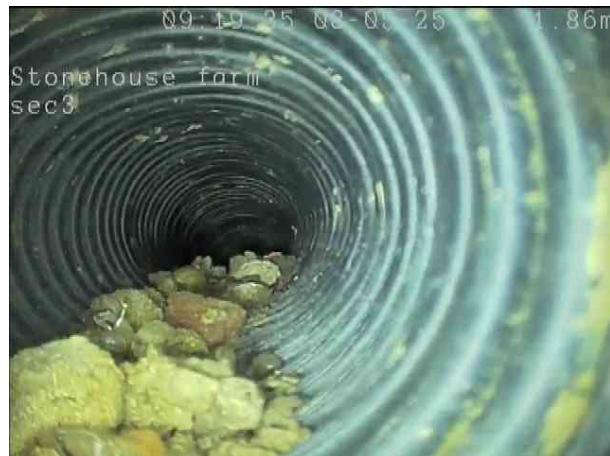
835b38c7-f6be-4f9a-bd41-927da3a1b33a.png, 00:00:13, 1.80
m

Settled deposits, hard or compacted, 25% cross-sectional area

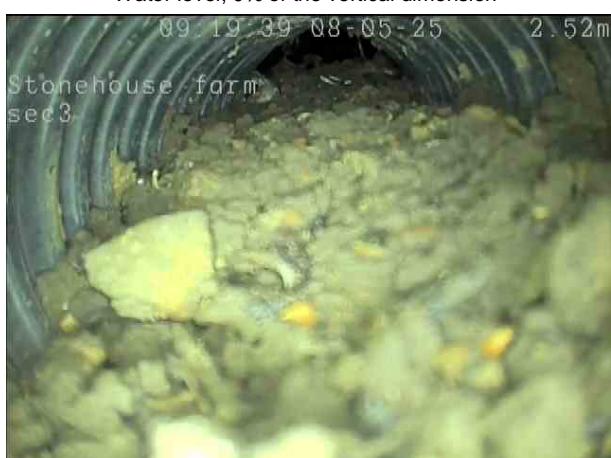
6d72067e-e336-47ff-b0fc-3b5edaefdc7d.png, 00:00:18, 2.50
m

Item No.	PLR	Grade	Description
2	AX	4	Deformed sewer or drain, 70%
3	BX	5	Settled deposits, hard or compacted, 85% cross-sectional area loss
4	CX	4	Multiple defects
6	DX	4	Settled deposits, hard or compacted, 35% cross-sectional area loss
8	RG1X	4	Multiple defects
11	CesspitX	5	Settled deposits, hard or compacted, 80% cross-sectional area loss
16	RG5X	4	Multiple defects
17	SW9X	3	Multiple defects
19	RE1X	4	Joint displaced, large
22	SW2X	4	Multiple defects
23	SW1X	4	Multiple defects
25	SW6X	5	Other obstacles, brick or masonry in invert from 5 o'clock to 7 o'clock, 25% cross-sectional area loss
26	SW7X	4	Multiple defects
27	SW8X	4	Multiple defects
28	EX	5	Settled deposits, hard or compacted, 95% cross-sectional area loss

Settled deposits, hard or compacted, 85% cross-sectional area

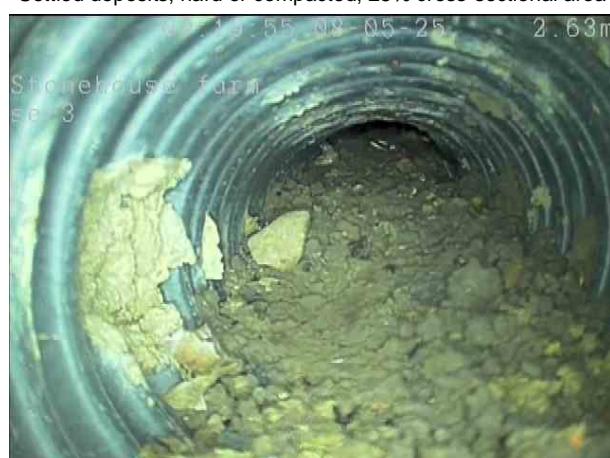
4a59a6f4-f902-4ad8-a4dc-1fd9c0eb0ec5.png, 00:00:34, 2.60
m

Survey abandoned, debris obstruction

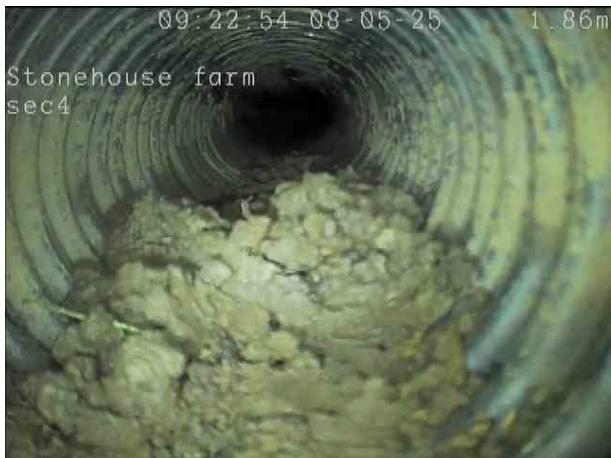
09:22:54 08-05-25 1.86m
Stonehouse farm sec4
dca98030-e1be-4a14-a5d0-54d0d1180ac0.png, 00:01:19, 2.00 m

Settled deposits, fine, 30% cross-sectional area loss

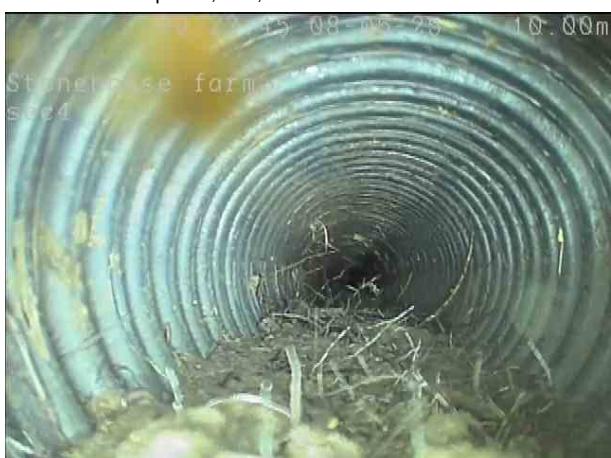
09:23:12 08-05-25 10.00m
Stonehouse farm sec4
c59c8a99-3d8d-47ac-a172-5cc1ea747f80.png, 00:02:10, 10.00 m

Settled deposits, fine, 35% cross-sectional area loss

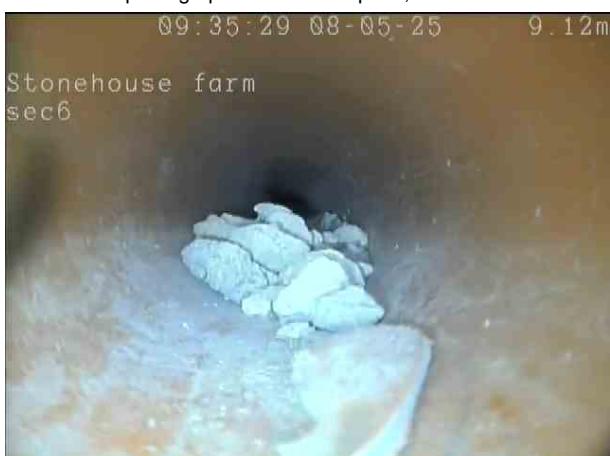
Settled deposits, hard or compacted, 35% cross-sectional area

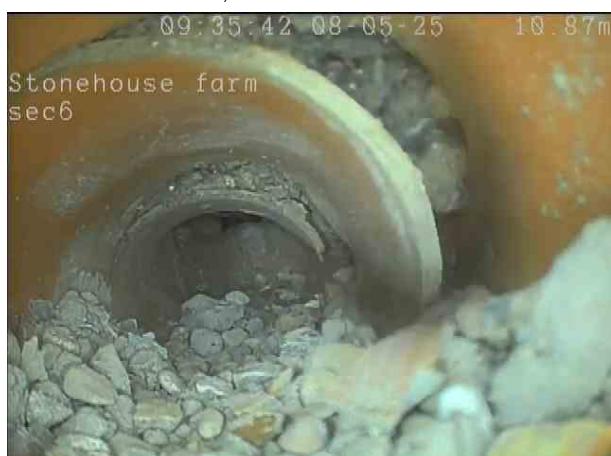
Item No.	PLR	Grade	Description
2	AX	5	Deformed sewer or drain, 70%
4	CX	4	Deformed sewer or drain, 25%
6	DX	5	Collapsed drain or sewer, 60% cross-sectional area loss
11	CesspitX	4	Deformed sewer or drain, 25%
22	SW2X	4	Deformed sewer or drain, 25%
23	SW1X	5	Deformed sewer or drain, 35%
24	SW6X	5	Hole in drain or sewer from 6 o'clock to 1 o'clock
25	SW6X	5	Multiple defects
26	SW7X	5	Multiple defects
27	SW8X	5	Multiple defects

Collapsed drain or sewer, 60% cross-sectional area loss

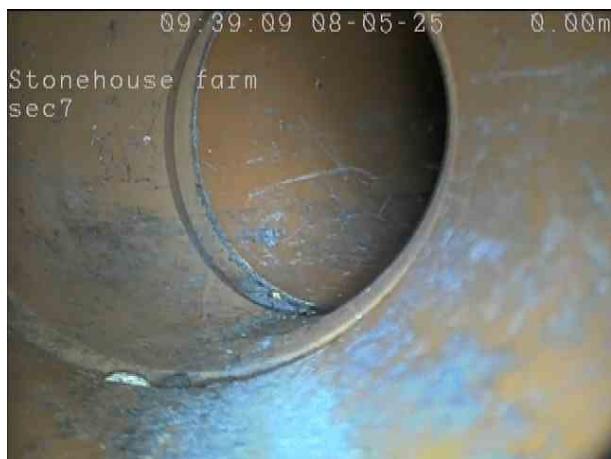
0dc15830-0d59-4899-b36b-c25cdf0edc50.png, 00:00:05, 0.10
m

Line deviates right, sharp bend

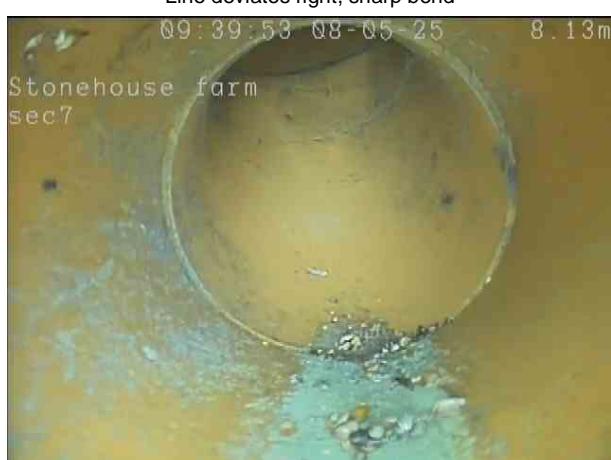
bb32d21f-86b6-45cb-a0d6-7ec9c6d4cc44.png, 00:00:49, 8.20
m

Line deviates up, sharp bend

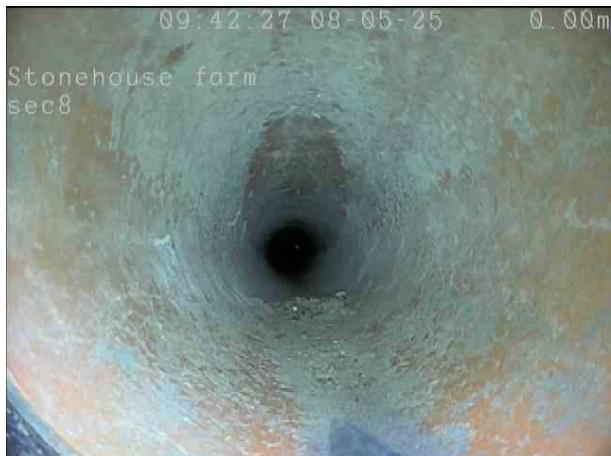
09:42:27 08-05-25 0.00m
Stonehouse farm sec8
b9172ff6-179b-416d-a0d9-0568803e8810.png, 00:00:01, 0.00m

Water level, 0% of the vertical dimension

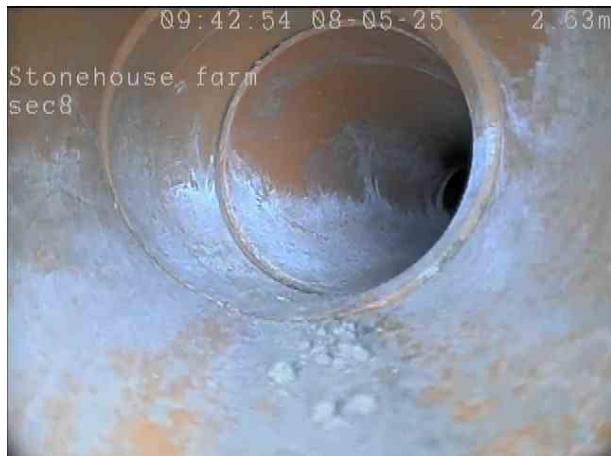
09:42:54 08-05-25 2.63m
Stonehouse farm sec8
c6df7ac7-7095-4b52-9d8e-33ebe6494b99.png, 00:00:27, 2.80m

Line deviates right, sharp bend

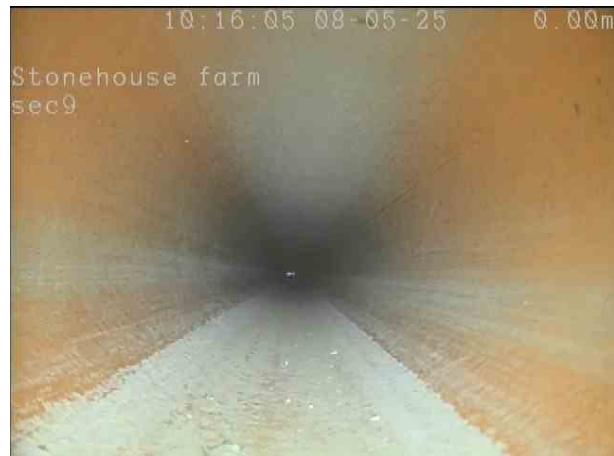
6574f32d-77a6-420a-b421-aff95c096112.png, 00:00:14, 0.00
m

Water level, 0% of the vertical dimension

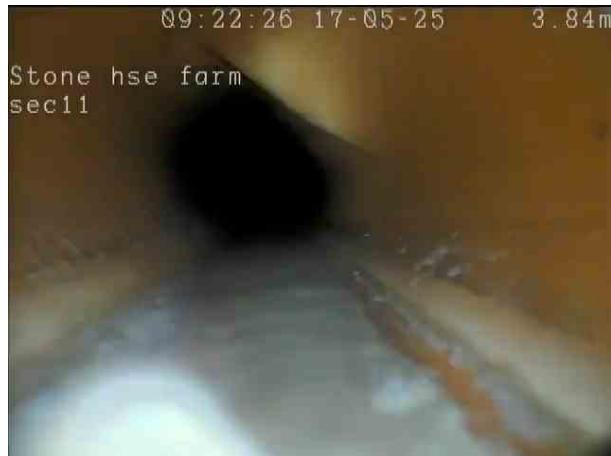
dbed75ed-dead-4e9e-ba63-33eb17ea6fe5.png, 00:00:24, 4.00 m

Deformed sewer or drain, 25%

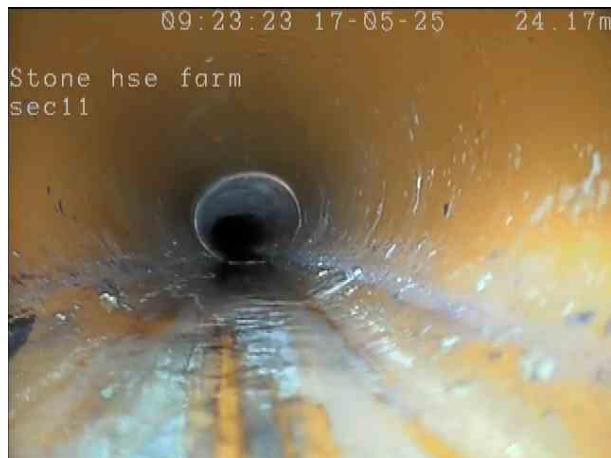
a80de13a-dc00-483e-9b67-3f425435d914.png, 00:01:21, 24.20 m

Deformed sewer or drain, 15%

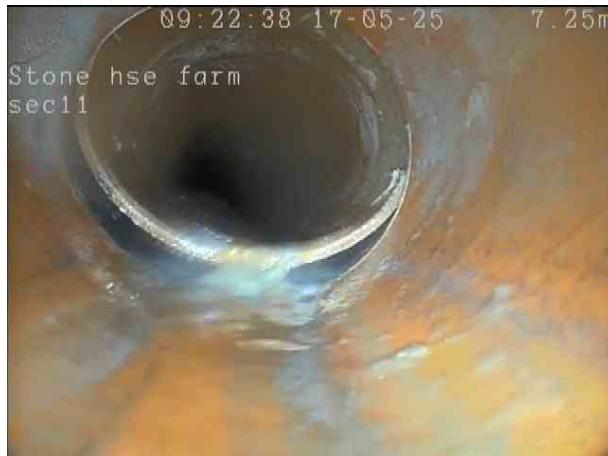
4f103868-4728-490e-867e-aaa01b8f68e8.png, 00:00:36, 7.40 m

Joint displaced, large, deformed joint

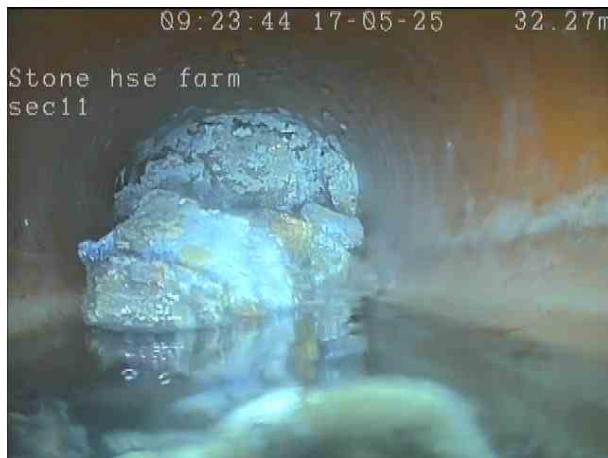
4bada9ca-88ca-462b-9a97-4f41cd643b6f.png, 00:01:42, 32.30 m

Settled deposits, hard or compacted, 80% cross-sectional area

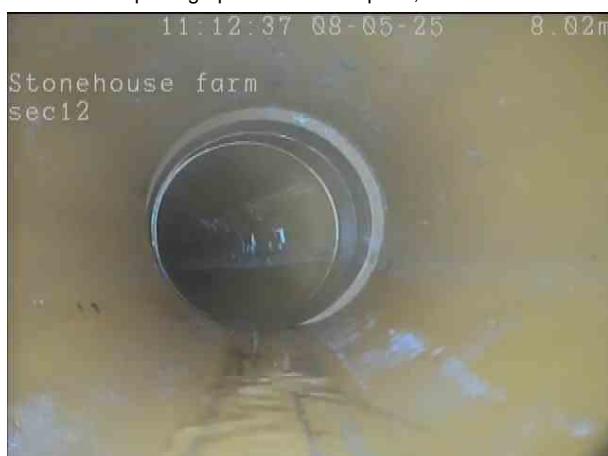
d35208cb-a27a-487c-9eb5-d7995d4ef68d.png, 00:00:48, 8.10 m

Line deviates left, slight bend

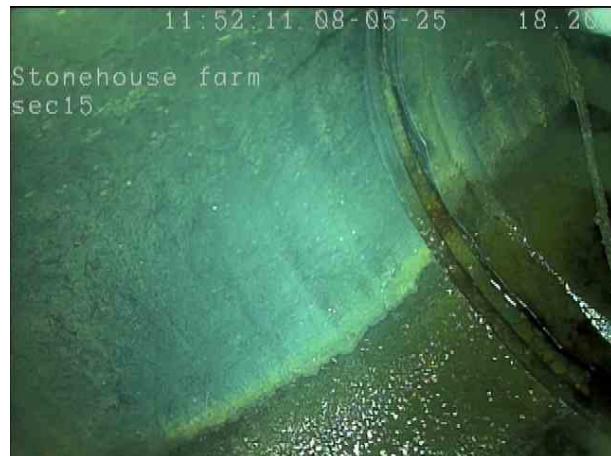
2d9e18f0-46e6-4087-95e8-16bd75b4f48d.png, 00:02:05,
18.30 m

General photograph taken at this point, view into 450mm main

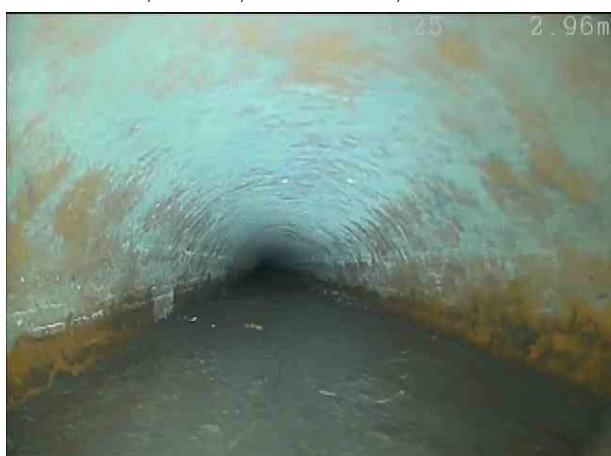
0b3d9dd8-d2ed-4c9e-a72d-c40293320292.png, 00:00:41, 3.00 m

Settled deposits, fine, 35% cross-sectional area loss

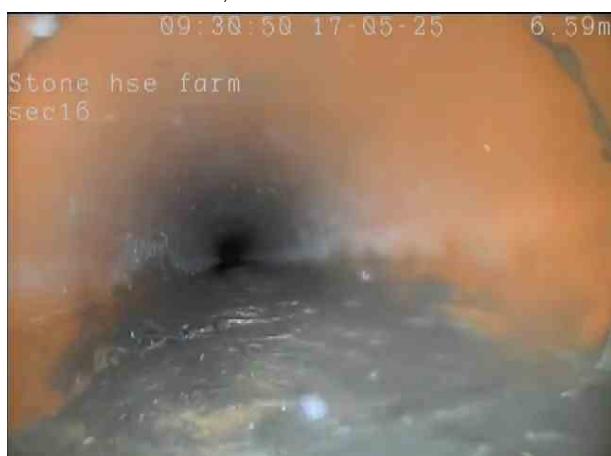
eeec6322-56c0-4d21-814f-9e3f627b9d08.png, 00:01:04, 6.60 m

Settled deposits, fine, 25% cross-sectional area loss

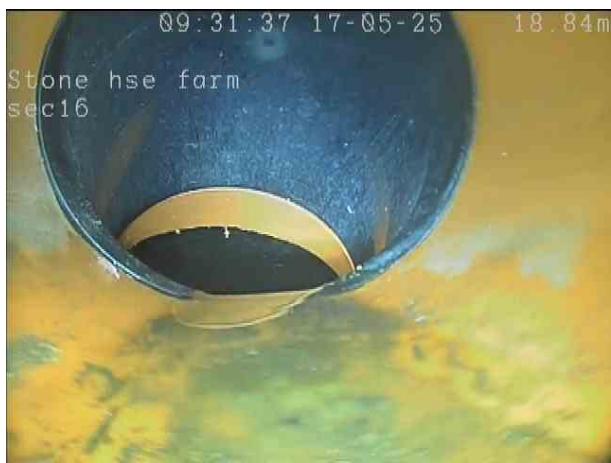
005e40c6-de5e-46f4-a521-8ccdd2042341.png, 00:01:51,
19.00 m

Line deviates down, sharp bend

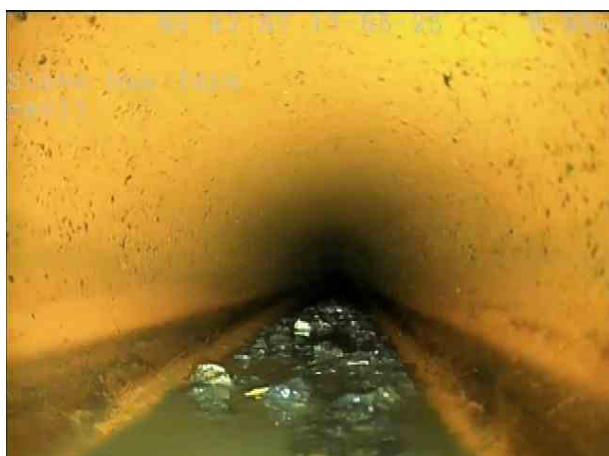
194d5477-f5dc-4782-9d51-e306c5f67ba7.png, 00:00:15, 0.50
m

Settled deposits, fine, 10% cross-sectional area loss

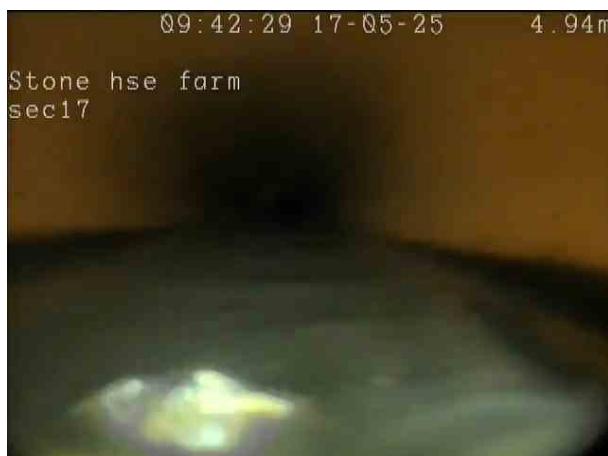
7d263758-03db-4952-8c16-604515ecc577.png, 00:00:37, 5.00
m

Water level, 25% of the vertical dimension

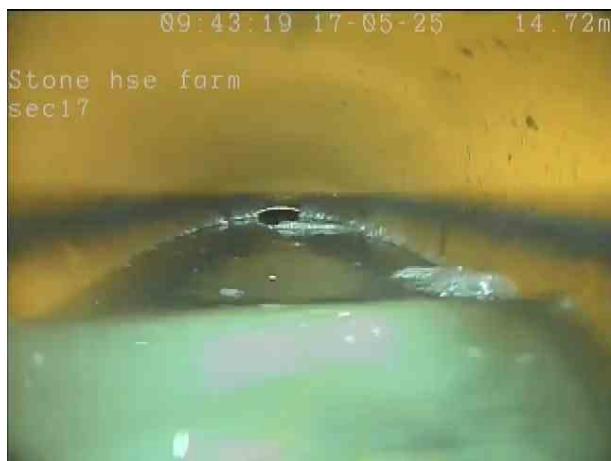
42115dcf-fabe-4b09-add5-df4ee6eef327.png, 00:01:27, 14.80 m

Water level, 85% of the vertical dimension, dropped section

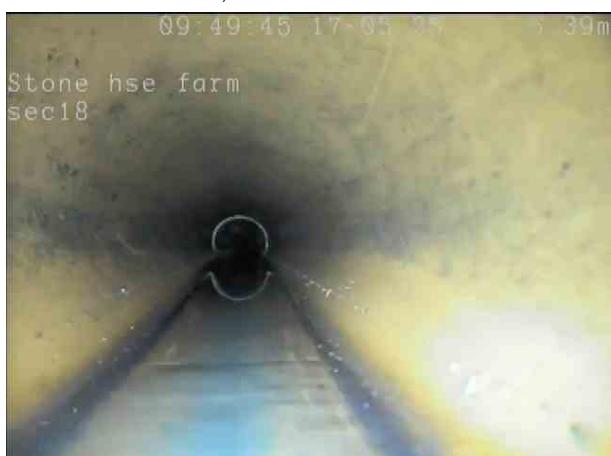
d7dce049-ad96-457a-ba5c-0277162808da.png, 00:00:23,
5.40 m

Water level, 20% of the vertical dimension

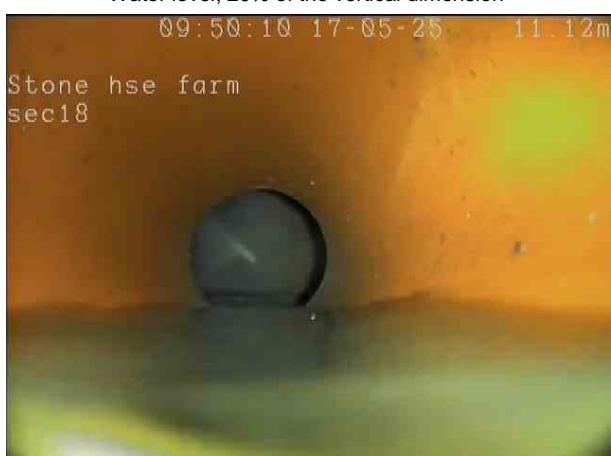
35f8b9ff-f2bf-48fa-9328-f4b07f82d5f1.png, 00:00:48, 11.00 m
Water level, 10% of the vertical dimension

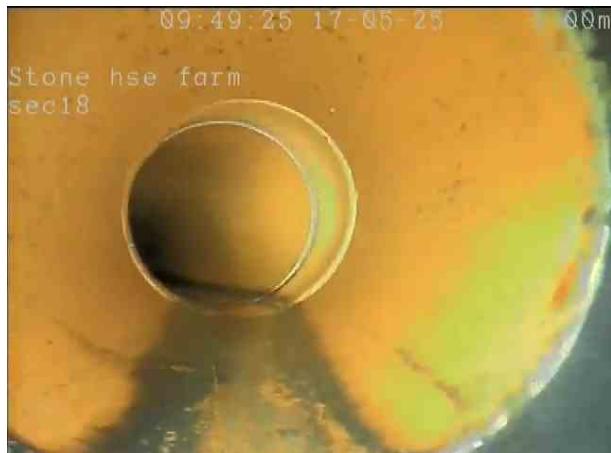
f5ad725d-6ffc-408f-8ee7-b5499479db9e.png, 00:00:03, 0.20

Line deviates left, slight bend

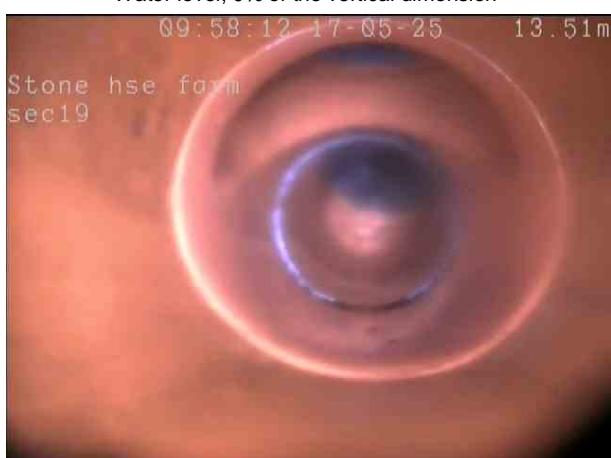
15c02a60-6b0a-4327-ba76-0f79e9b81eef.png, 00:00:49,
13.60 m

Junction at 12 o'clock, 100mm dia, serves rwp

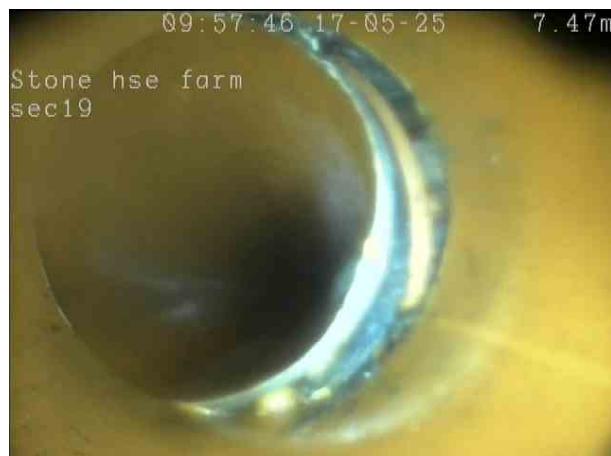
6a75b795-7754-47b7-8ad7-7f96e83b2660.png, 00:00:23, 7.50
m

Joint displaced, large

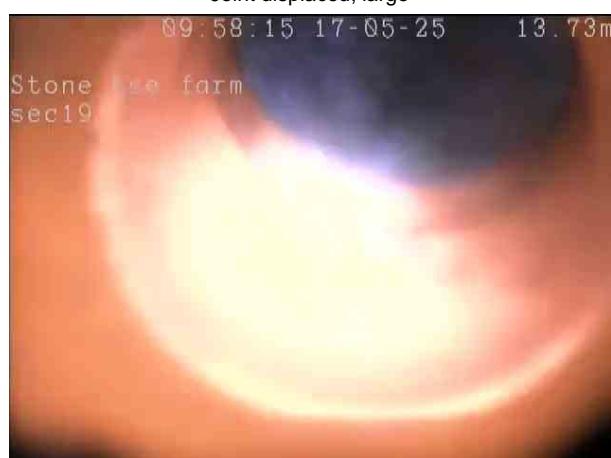
fbbaa57e-3b67-4633-8d7b-8fadf970fa5f.png, 00:00:52, 13.80
m

Line deviates up, sharp bend

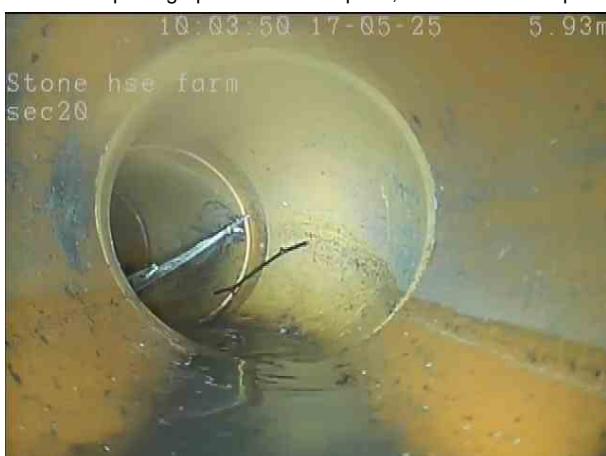
b3170df2-75ac-4185-99f0-097c56bcce87.png, 00:01:08, 6.00 m

Line deviates left, sharp bend

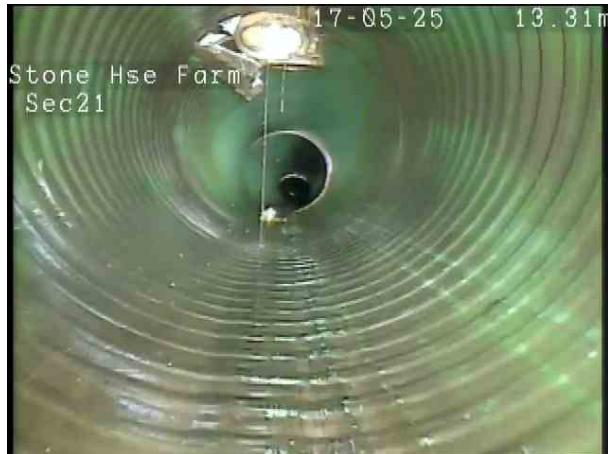
6b0f2f4d-4a35-4beb-a009-e2e8b347bd37.png, 00:01:56,
14.00 m

Connection other than junction at 12 o'clock, 100mm dia,

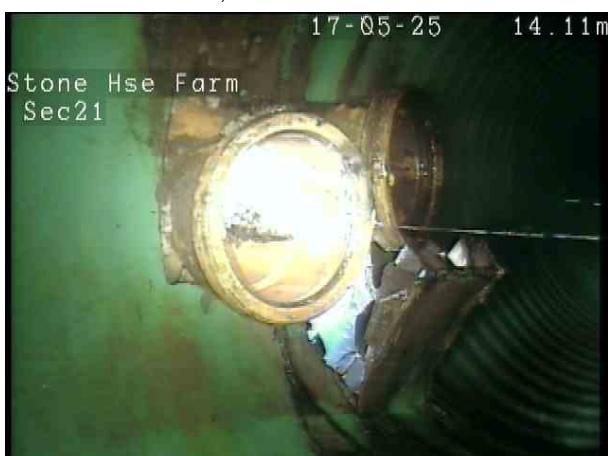
9b915c5f-7883-4957-8e8a-63928149a281.png, 00:02:10,
14.10 m

General photograph taken at this point, intruding connections

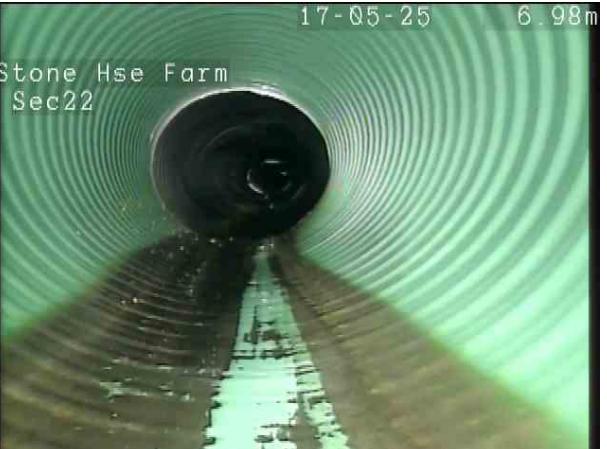
17-05-25	6.98m	Stone Hse Farm Sec22	
eea8d6d7-b02f-4892-9bdd-4832aadb6a0.png, 00:00:59, 7.00 m Deformed sewer or drain, 15%

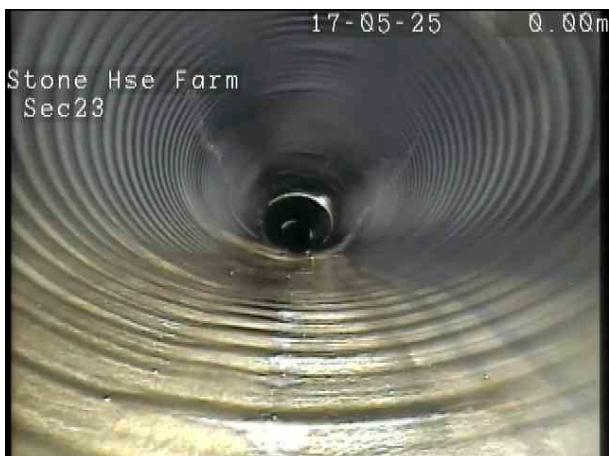
fbf7f5c5-b7f6-4617-a8c5-0d55d098f849.png, 00:00:02, 0.10 m
Deformed sewer or drain, 15%

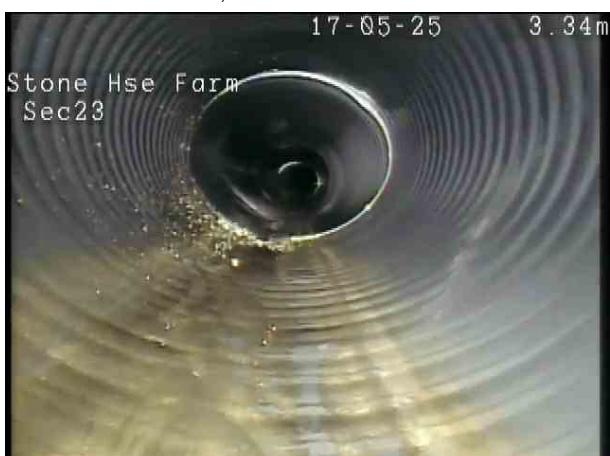
a291e06e-86b9-4d0a-8080-ff11faed5702.png, 00:00:26, 3.50
m

Deformed sewer or drain, 20%

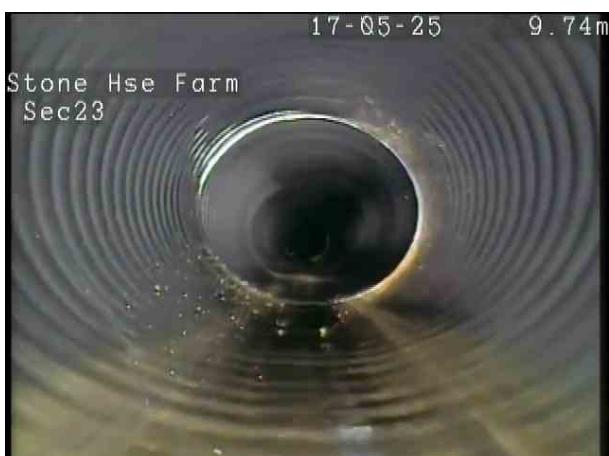
5b24db94-cdf2-4b12-ab19-d851edf7001b.png, 00:01:05,
10.00 m

Deformed sewer or drain, 20%

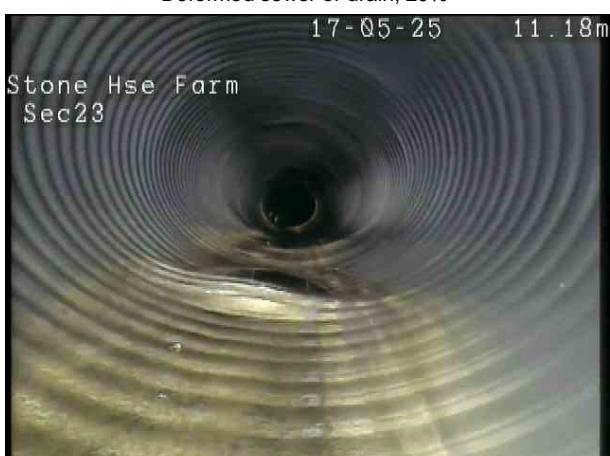
43ddd2e0-a573-4baf-a491-13f54fb589dd.png, 00:01:16, 11.30
m

Hole in drain or sewer from 6 o'clock to 7 o'clock

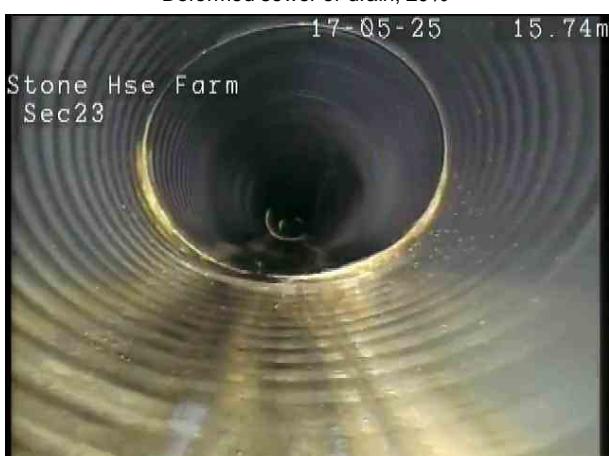
4973f8fa-a4dd-46b9-a7fa-4798b6d62da2.png, 00:01:42, 15.80 m

Deformed sewer or drain, 15%

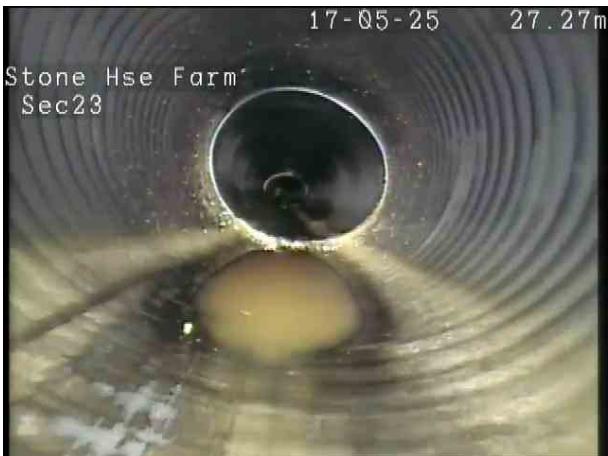
2cb4ab0b-8e54-4902-ab1d-175a7a75332b.png, 00:02:33,
27.50 m

Deformed sewer or drain, 15%

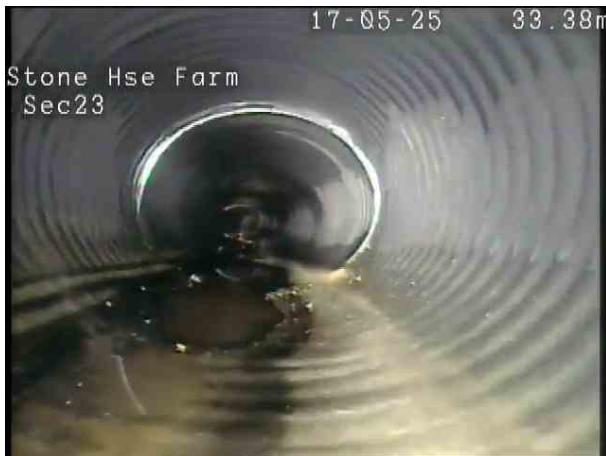
20de7bb8-8fe2-4148-8d71-5c2c8eef8bbf.png, 00:03:03, 33.50m

Deformed sewer or drain, 30%

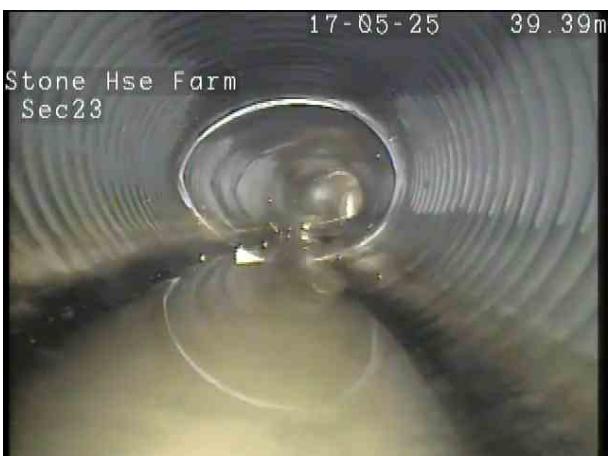
52e5663c-8b45-498f-8a3a-b57c8d704160.png, 00:03:56,
39.50 m

Deformed sewer or drain, 35%

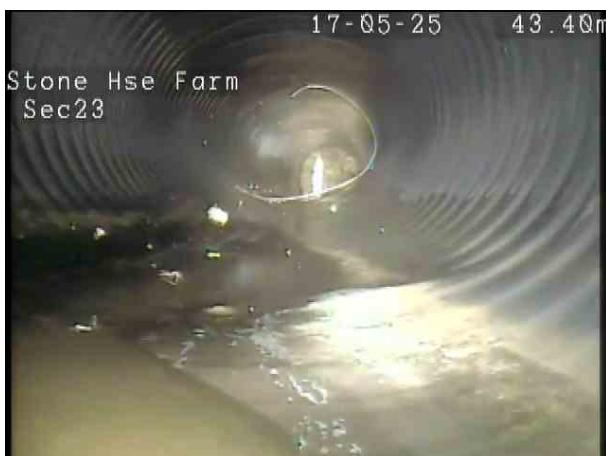
5297a643-8e92-4c66-ab70-4f1185e48459.png, 00:04:28,
43.50 m

Deformed sewer or drain, 20%

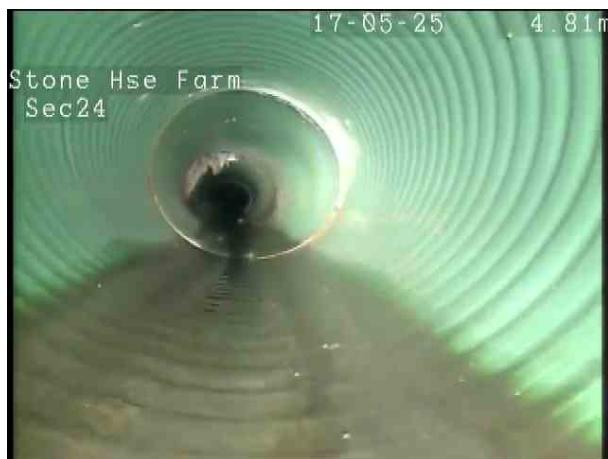
b11ae014-a296-4f4f-9917-cff9ea64299f.png, 00:00:40, 4.80 m
Deformed sewer or drain, 10%

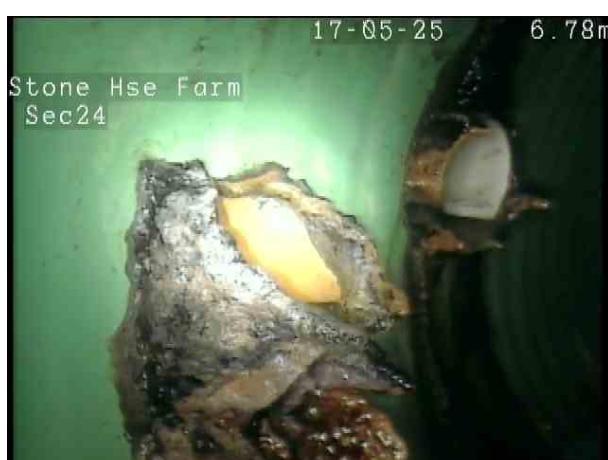
4b4f561f-f90c-4427-90e9-f38d68e4a95f.png, 00:01:16, 6.80 m
Connection other than junction at 11 o'clock, 100mm dia,
intruding

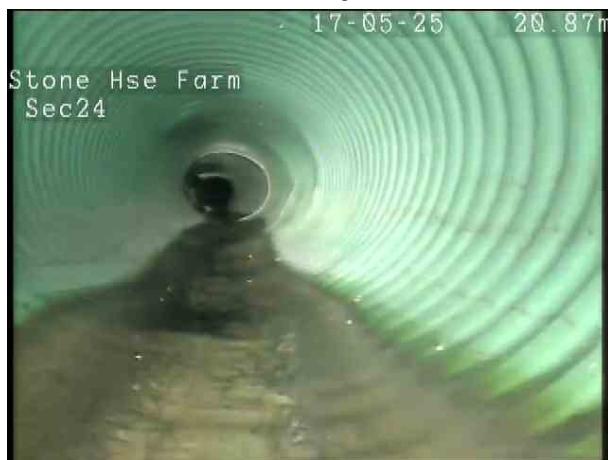
d2c521ea-1e7b-4fd8-8963-3a6d69cdd06d.png, 00:02:57,
21.00 m

Deformed sewer or drain, 20%

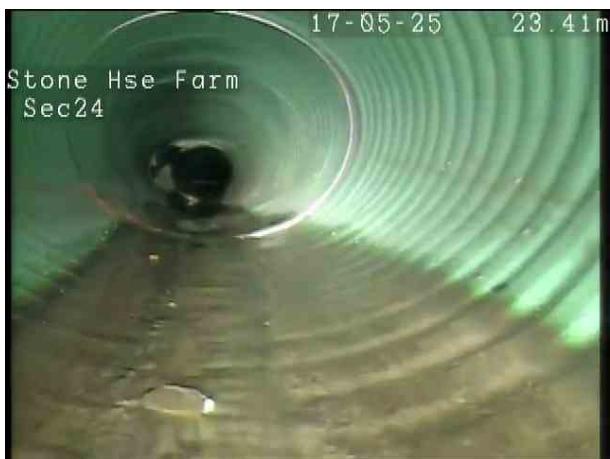
bcf0778e-dc5c-47ea-8fdd-651319b08627.png, 00:03:10,
23.50 m

Deformed sewer or drain, 20%

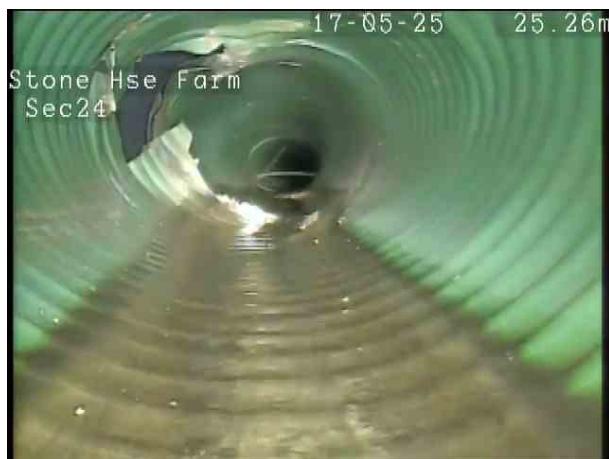
8723efe1-6fb0-46fb-851b-dca3ea5e6a30.png, 00:03:26, 25.50
m

Hole in drain or sewer from 6 o'clock to 1 o'clock

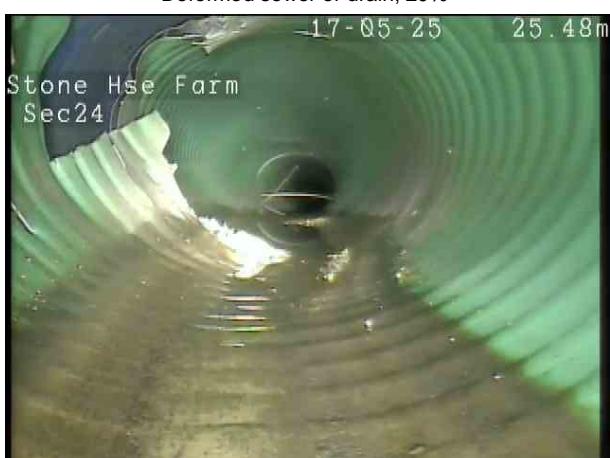
2a506dbd-b296-473b-aea1-4d9dfa2912e9.png, 00:03:32,
25.50 m

Deformed sewer or drain, 25%

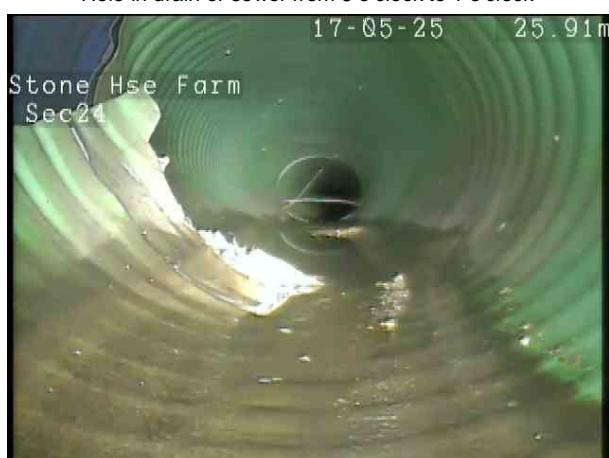
7b093a31-9dd1-40a1-bb2d-cf6af083e435.png, 00:03:55,
25.60 m

Survey abandoned, crawler will tilt over

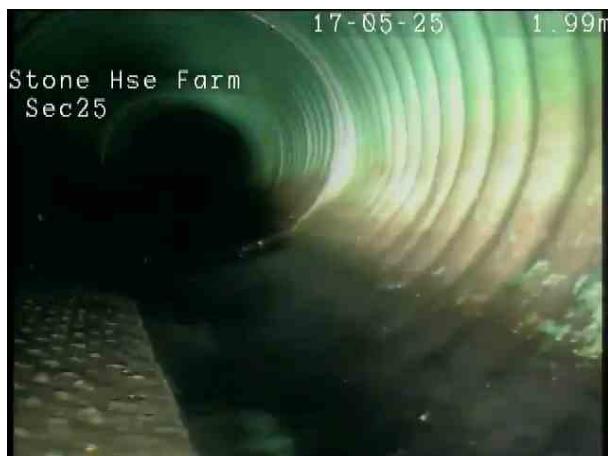
dd64660f-087f-4f2e-873d-646401071db6.png, 00:00:15, 2.00
m

Other obstacles, brick or masonry in invert from 5 o'clock to 7

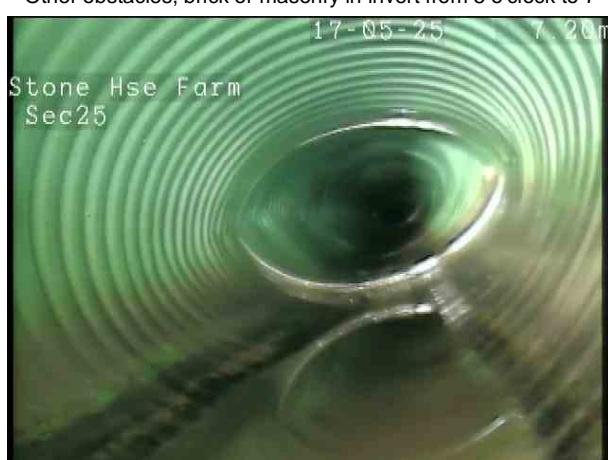
12366aeb-28a8-463f-82ee-57d31161a532.png, 00:00:52, 7.50
m

Deformed sewer or drain, 45%

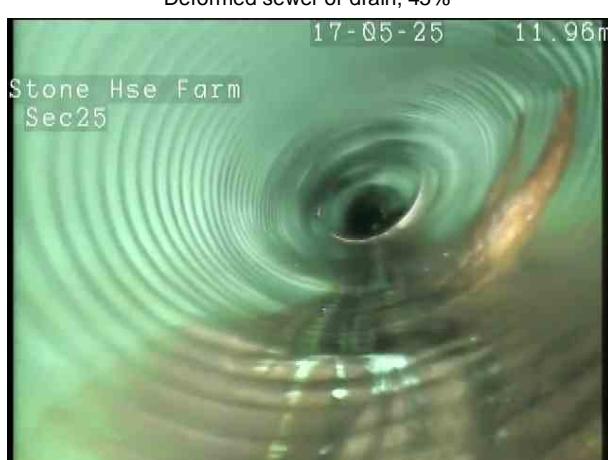
90b14cb1-66c2-43e0-a8da-f199a710dca0.png, 00:01:44,
12.00 m

Hole in drain or sewer from 2 o'clock to 4 o'clock

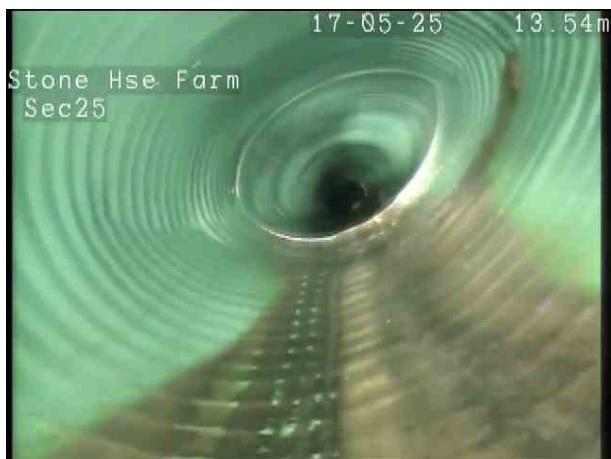
d60aa9fc-1468-4f79-8c78-2b986f9a0466.png, 00:01:56, 15.00 m

Deformed sewer or drain, 40%

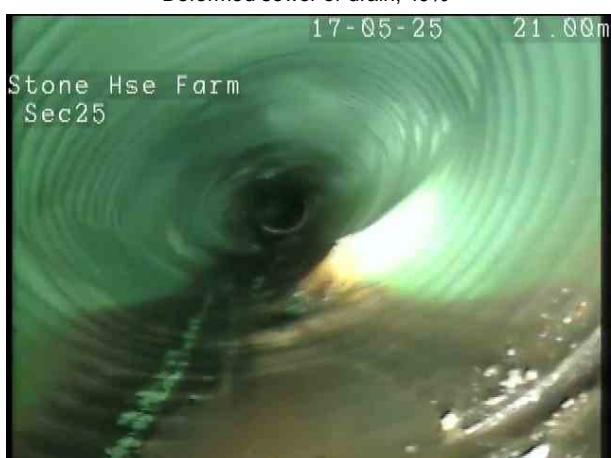
9acab896-a4f8-4573-9648-f059255cb092.png, 00:03:02, 21.00 m

Deformed sewer or drain, 45%

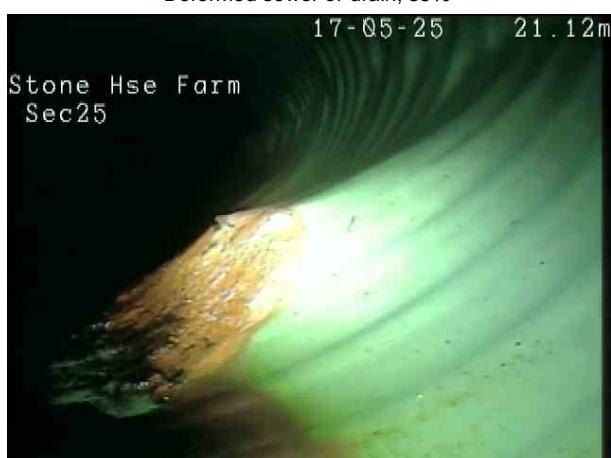
591e2157-abcd-4207-99b0-770ad446df99.png, 00:03:36, 21.20 m

Hole in drain or sewer from 4 o'clock to 6 o'clock

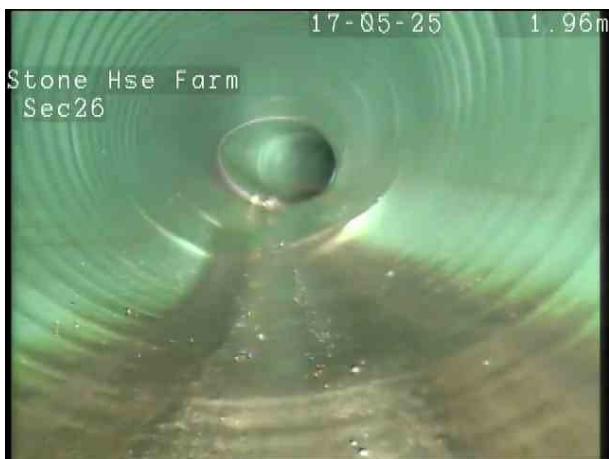
99be0dd0-8085-4999-af15-a050bc3b126f.png, 00:00:19, 2.00 m
Deformed sewer or drain, 15%

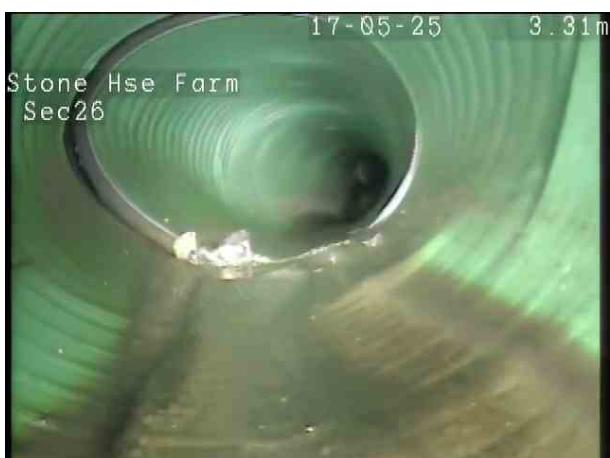
a231dc10-c2ea-4197-96e3-88745ee8fcb7.png, 00:00:41, 4.00 m
Deformed sewer or drain, 40%

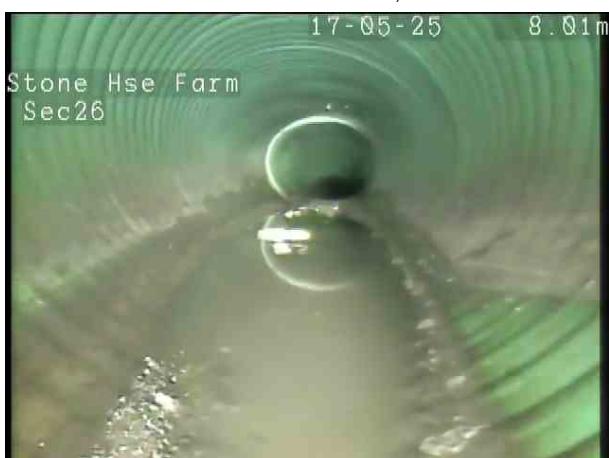
45458732-5374-4e38-8f9a-ae3b790c2857.png, 00:01:33, 8.20 m
Water level, 20% of the vertical dimension, deformed

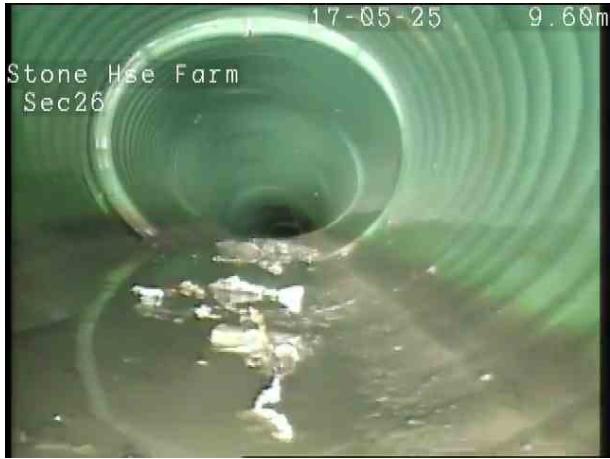
a028aed8-f8fb-4f4c-ab9a-052274501bab.png, 00:01:50, 10.00 m
Deformed sewer or drain, 25%

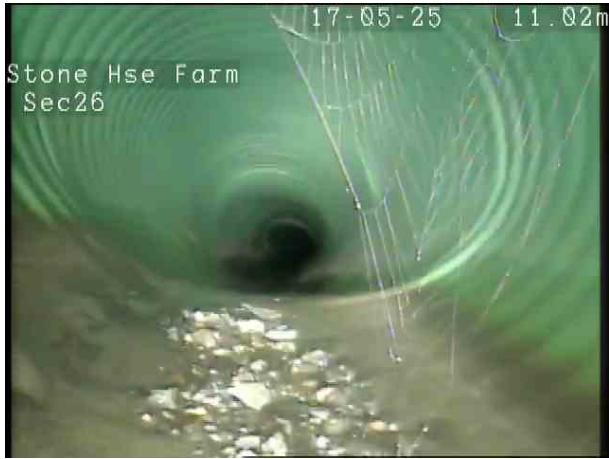
6cd98298-c634-44f6-974c-5e30a6a905c3.png, 00:01:58, 11.20 m
Deformed sewer or drain, 15%

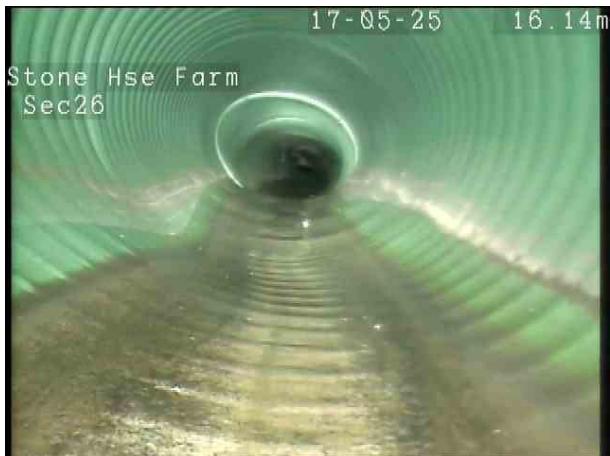
792d6174-c3f4-4969-93c2-6d52daa7b238.png, 00:03:31,
16.40 m

Deformed sewer or drain, 40%

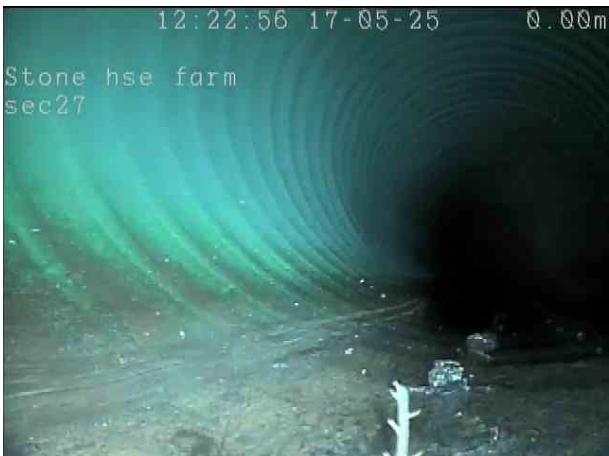
4b39655a-59b7-4328-b457-2be04f89f301.png, 00:00:16, 0.00
m

Water level, 0% of the vertical dimension

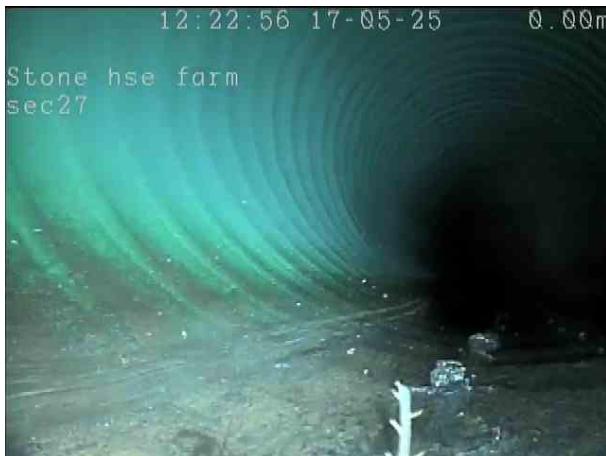
aa138485-1cbc-4c1f-a2b3-559bce67b31e.png, 00:00:16, 0.10
m

General photograph taken at this point, using push rod due to

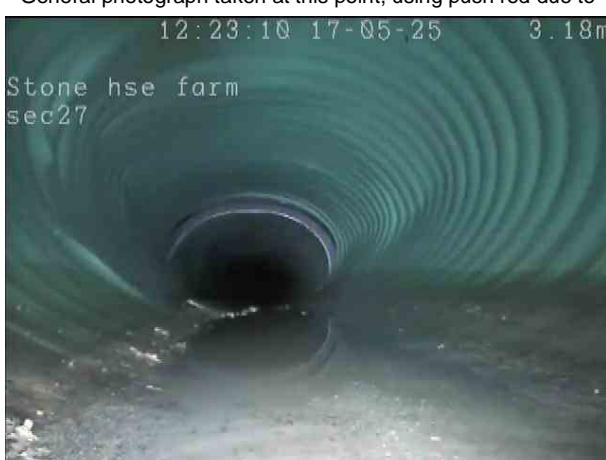
dac68b0f-372b-41bb-8d63-348e5d606ae2.png, 00:00:30, 3.40
m

Deformed sewer or drain, 40%

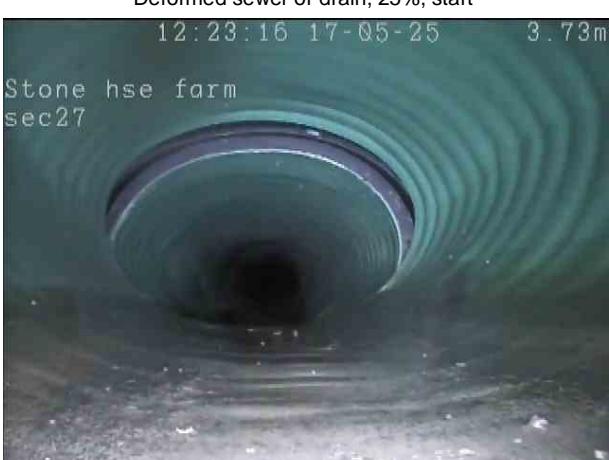
2c299aab-02dc-4b73-bbe7-51f12b5068d1.png, 00:00:36, 4.00m

III
Deformed sewer or drain, 45%

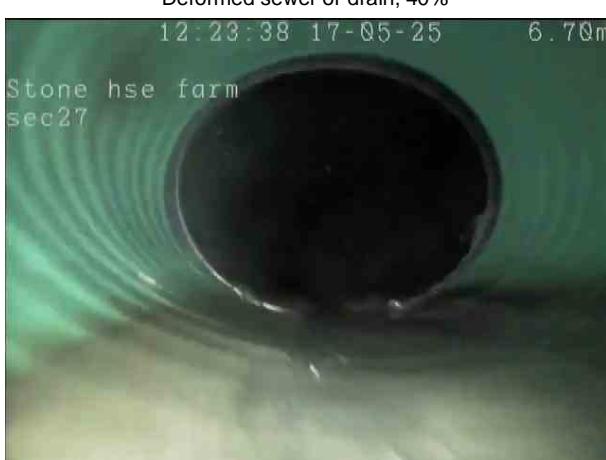
17d22757-c3fd-4c33-910e-5e52593eb4bc.png, 00:00:58, 6.80m

III Deformed sewer or drain, 20%

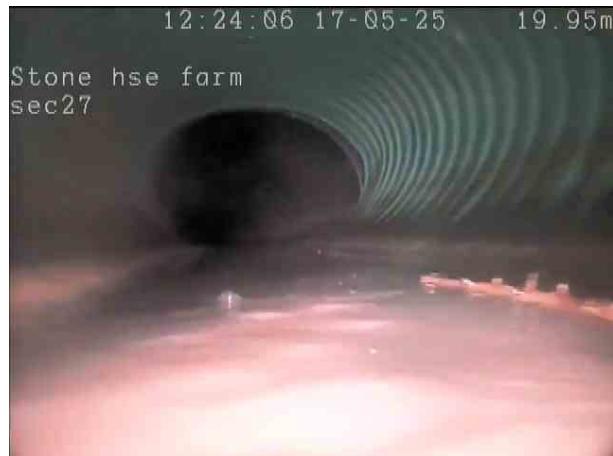
e2b9d399-1e2f-4a49-b648-9a6732af8ef8.png, 00:01:26, 20.00
m

Deformed sewer or drain, 35%

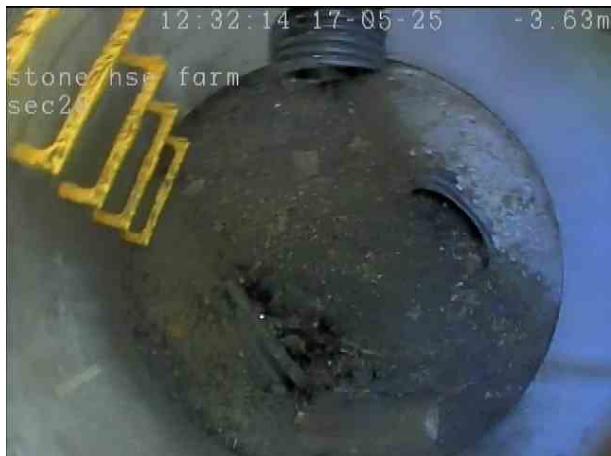
e2f2952c-1d6c-4e41-9694-f4658410fb5a.png, 00:00:12, 0.00 m

General photograph taken at this point, view inside SW7

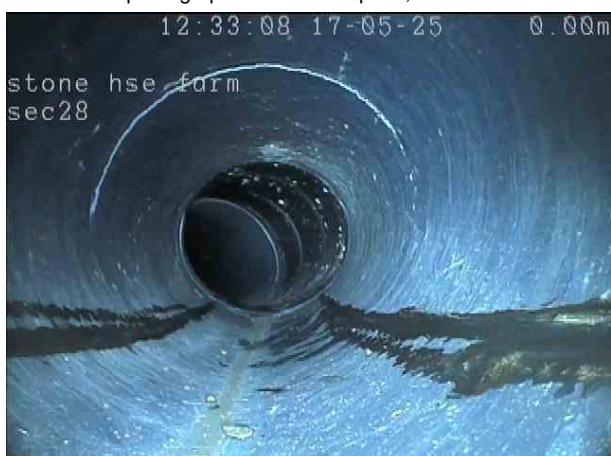
ee54a156-4197-4273-8e9c-2931be63c129.png, 00:00:25, 0.00 m

Water level, 0% of the vertical dimension
