1.0 Introduction

- 1.1 This technical note has been prepared in response to West Sussex County Council's (WSCC's) comments on DC/25/0403 as the Lead Local Flood Authority (LLFA). Following WSCC's review of Motion's Flood Risk Assessment (FRA) and Drainage Strategy, WSCC have provided a holding objection until further information is provided.

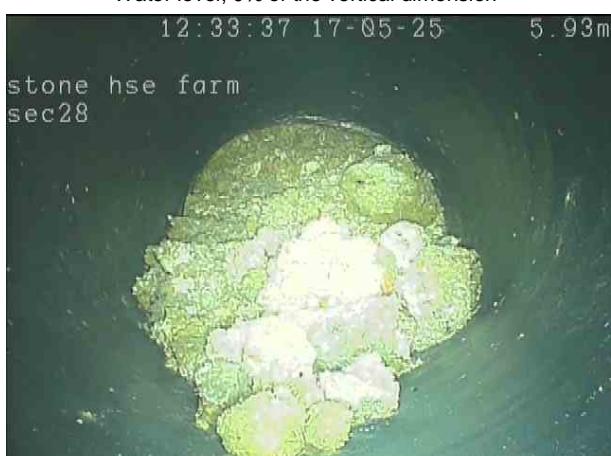
a9871681-a505-441e-9f82-48d595ada09c.png, 00:00:54, 6.00 m

General photograph taken at this point, redundant section

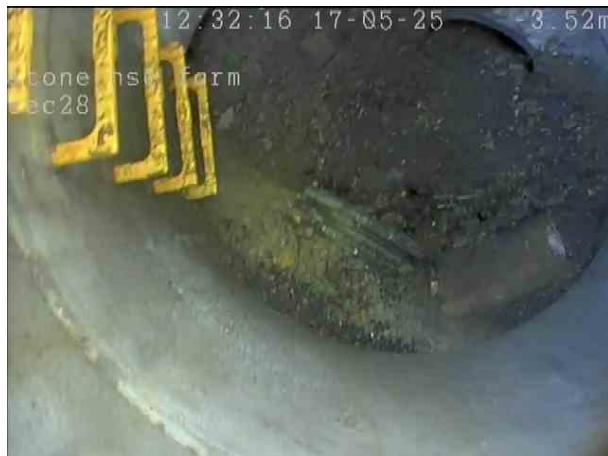
12b92024-3105-4cd7-b0af-d429f9d94cdd.png, 00:00:15, 0.00 m

General photograph taken at this point, base faulty

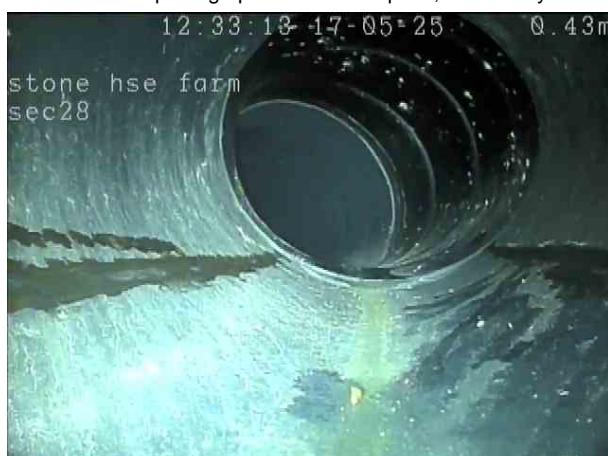
a5385689-2731-41f7-b623-ba8a58f72c92.png, 00:00:31, 0.50 m

Line deviates left, sharp bend

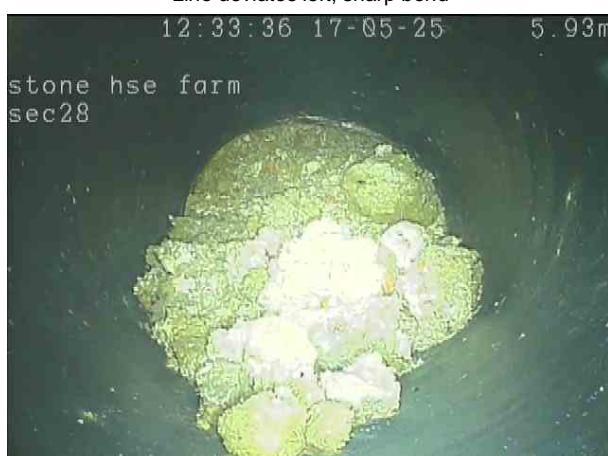
f75e597f-4d31-415e-b0f7-5ecd2f5fb5cb.png, 00:00:54, 6.00 m

Settled deposits, hard or compacted, 95% cross-sectional area loss
