| Project Name: | Old Clayton Kennels, Storrington |
| Document Reference: | 024.5063/SVR 2 |
| Document Name: | SuDS Verification Report |

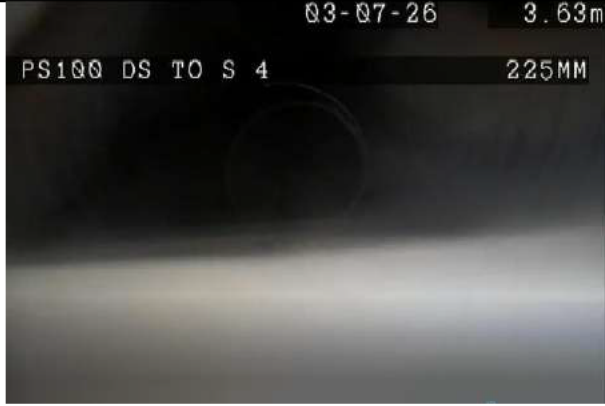
| | | <p>Standing water was observed within pipe PS100 to S4, with the CCTV camera appearing to become partially submerged during the survey.</p> |
| | | <p>It appears that the pipe rises towards manhole S4, whereas it should fall to the manhole invert. The Inspection report recommends simply cutting back the pipe; however, the connection will need to be reconstructed correctly to the manhole invert with appropriate benching. This may require a section of the pipework to be re-laid to achieve an adequate gradient and ensure the flow discharges correctly into the manhole.</p> <p>See below remedial works undertaken in Section 6 of this report.</p> |

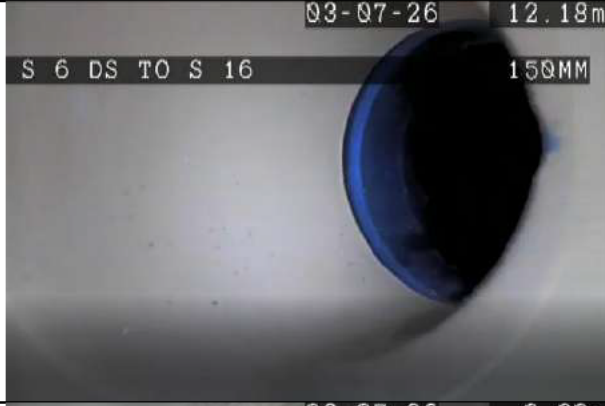
| 03Jul_003 | | The drainage network appears to be in generally good condition, with no visible evidence of defects. |

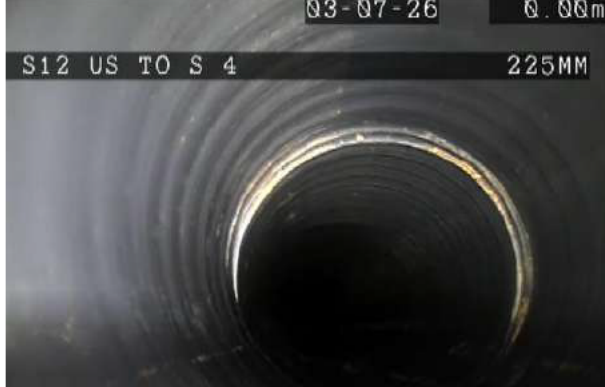
| 03Jul_005 | | No visible major defects. |

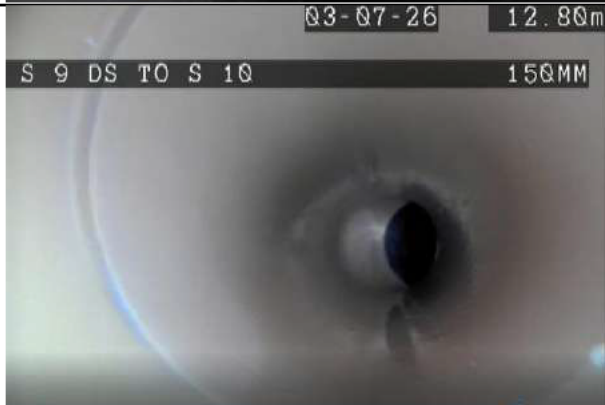
| 03Jul_006 | | No visible major defects. |

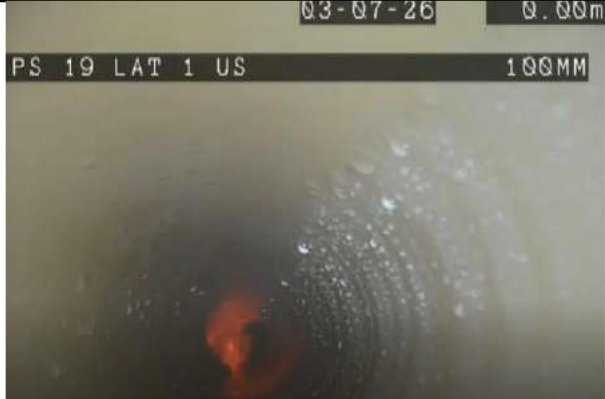
| 24Aug_001 | | No visible major defects. |

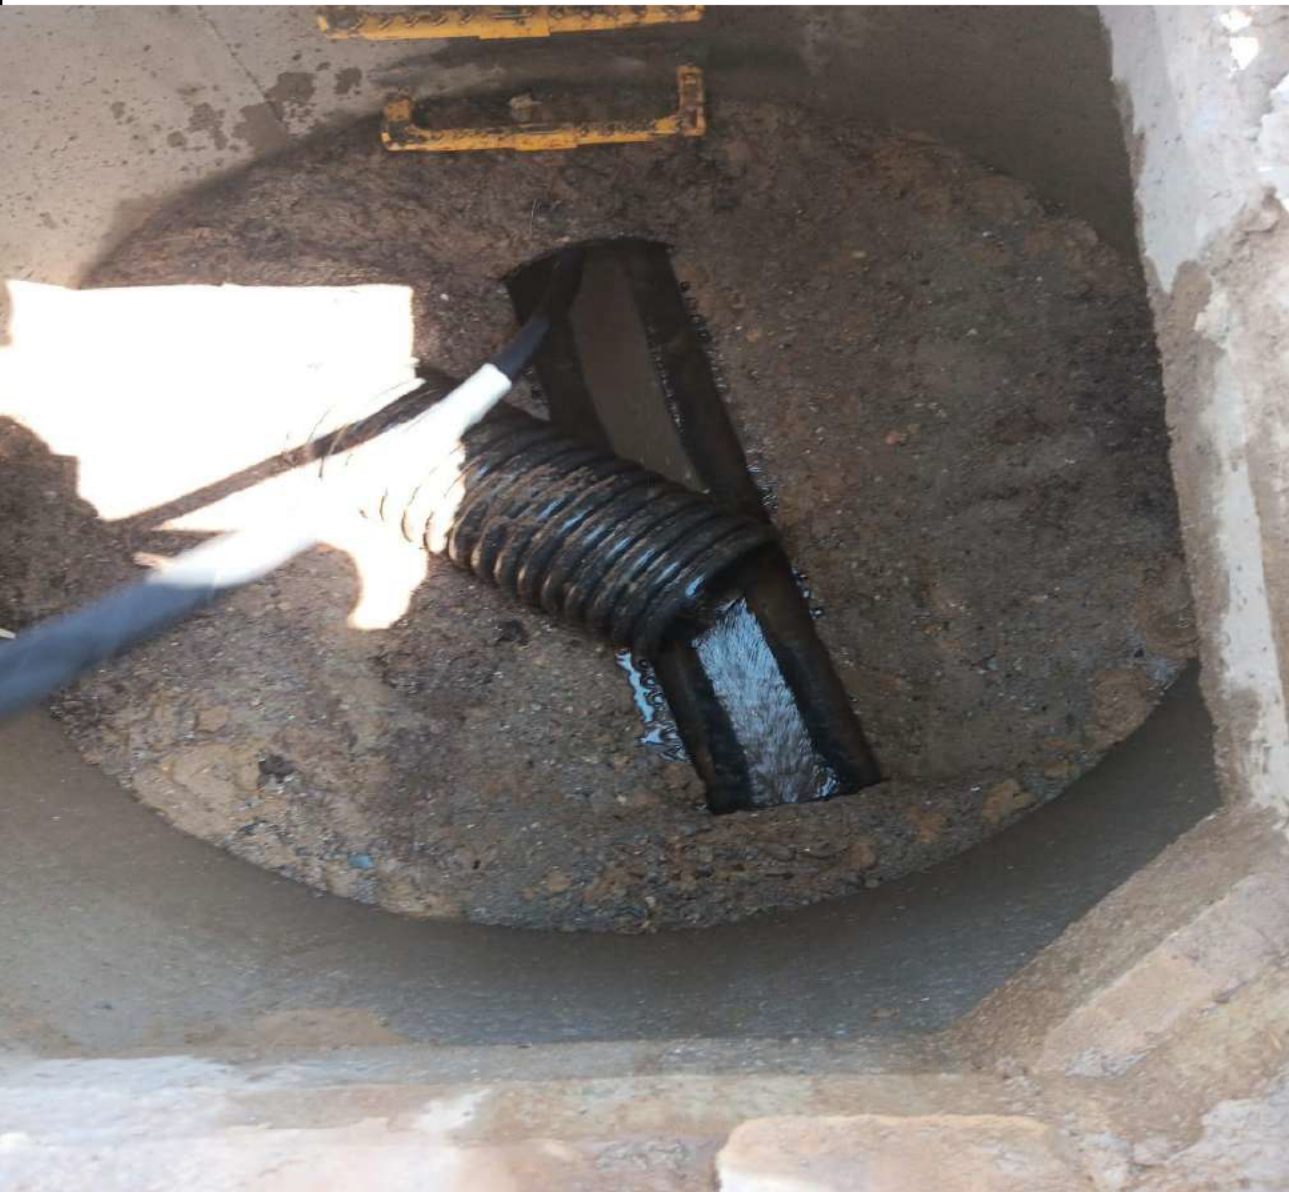
| Place:<br>476 STORRINGTON | Road: | Date:<br>03/07/2026 | Section Number:<br>37A | PLR: |

PIPE NEEDS CUTTING BACK IN MANHOLE AS  
POINTING UP CAUSING WATER TO LAY IN  
PIPE

- As noted above in comments within Table 2 above, remedial works are required within manhole S4 to ensure that the connection from PS100 falls towards S4.
- The system will need to be jetted, with all debris captured and removed from the drainage network, including the infiltration crates, once all works have been completed, as the evidence above indicates signs of sediment build-up. This is to ensure that the pipe network can adequately drain runoff and that the infiltration crates can function as intended. Following this, the system will need to be re-CCTV surveyed or verified during a suitably qualified third-party Civil Consultant's site inspection.

- The defect identified about between PS100 and S4 has been corrected by modifying the inlet level of this pipe run into S4. Evidence of the completed remedial works has been provided by the contractor in the photographs below, taken on site.

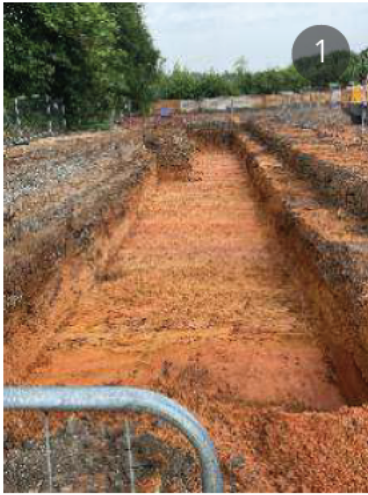
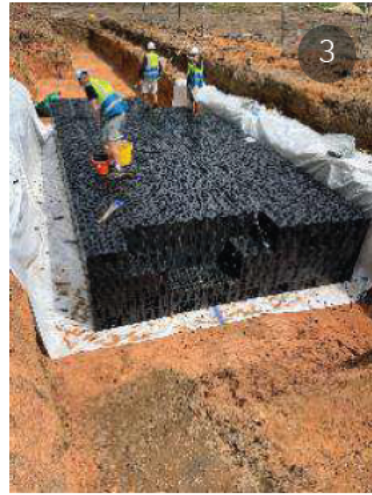
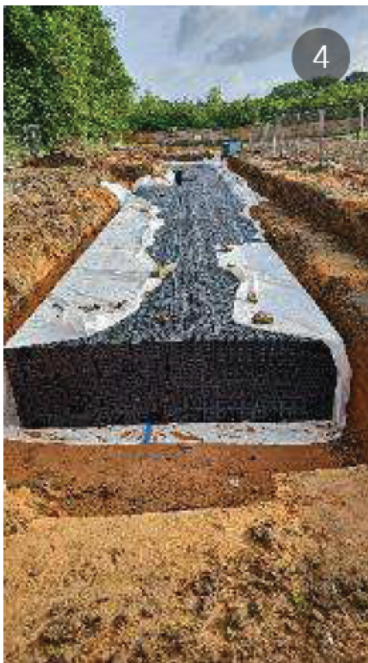
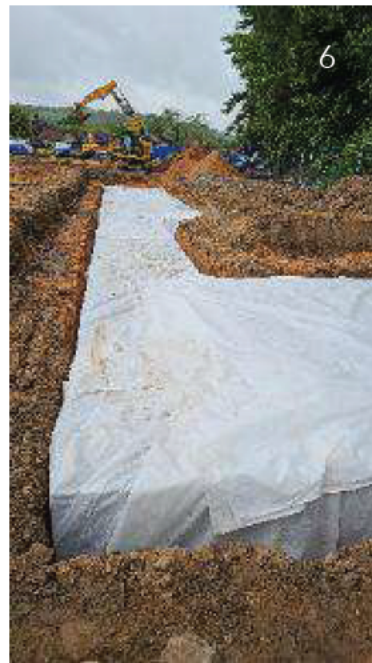
## INFILTRATION TANK - 01

Corners checked by Engineer - yes

Top levels checked by Engineer yes

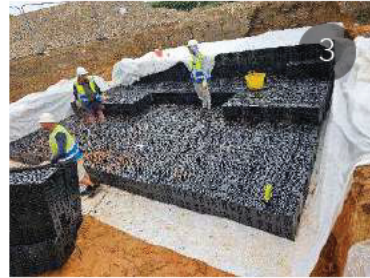
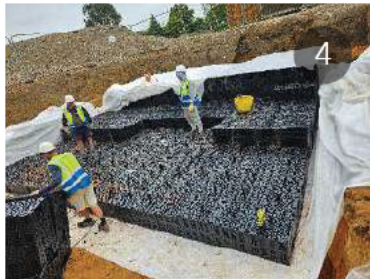
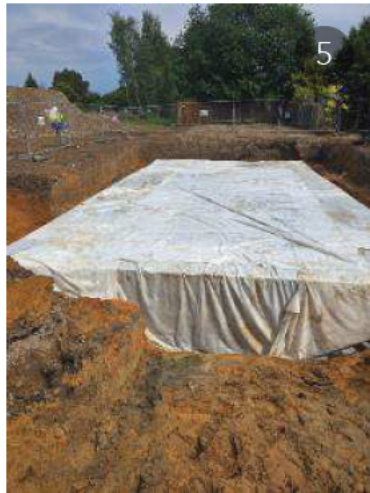
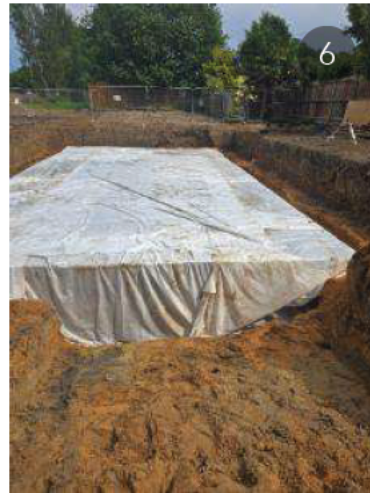
## INFILTRATION TANK - 02

Corners checked by Engineer - yes

Top levels checked by Engineer - yes
