## Verification Report

Former Sony Facility  
Southwater  
Horsham  
RH13 9YT

June 2026

000440032.0002.0001

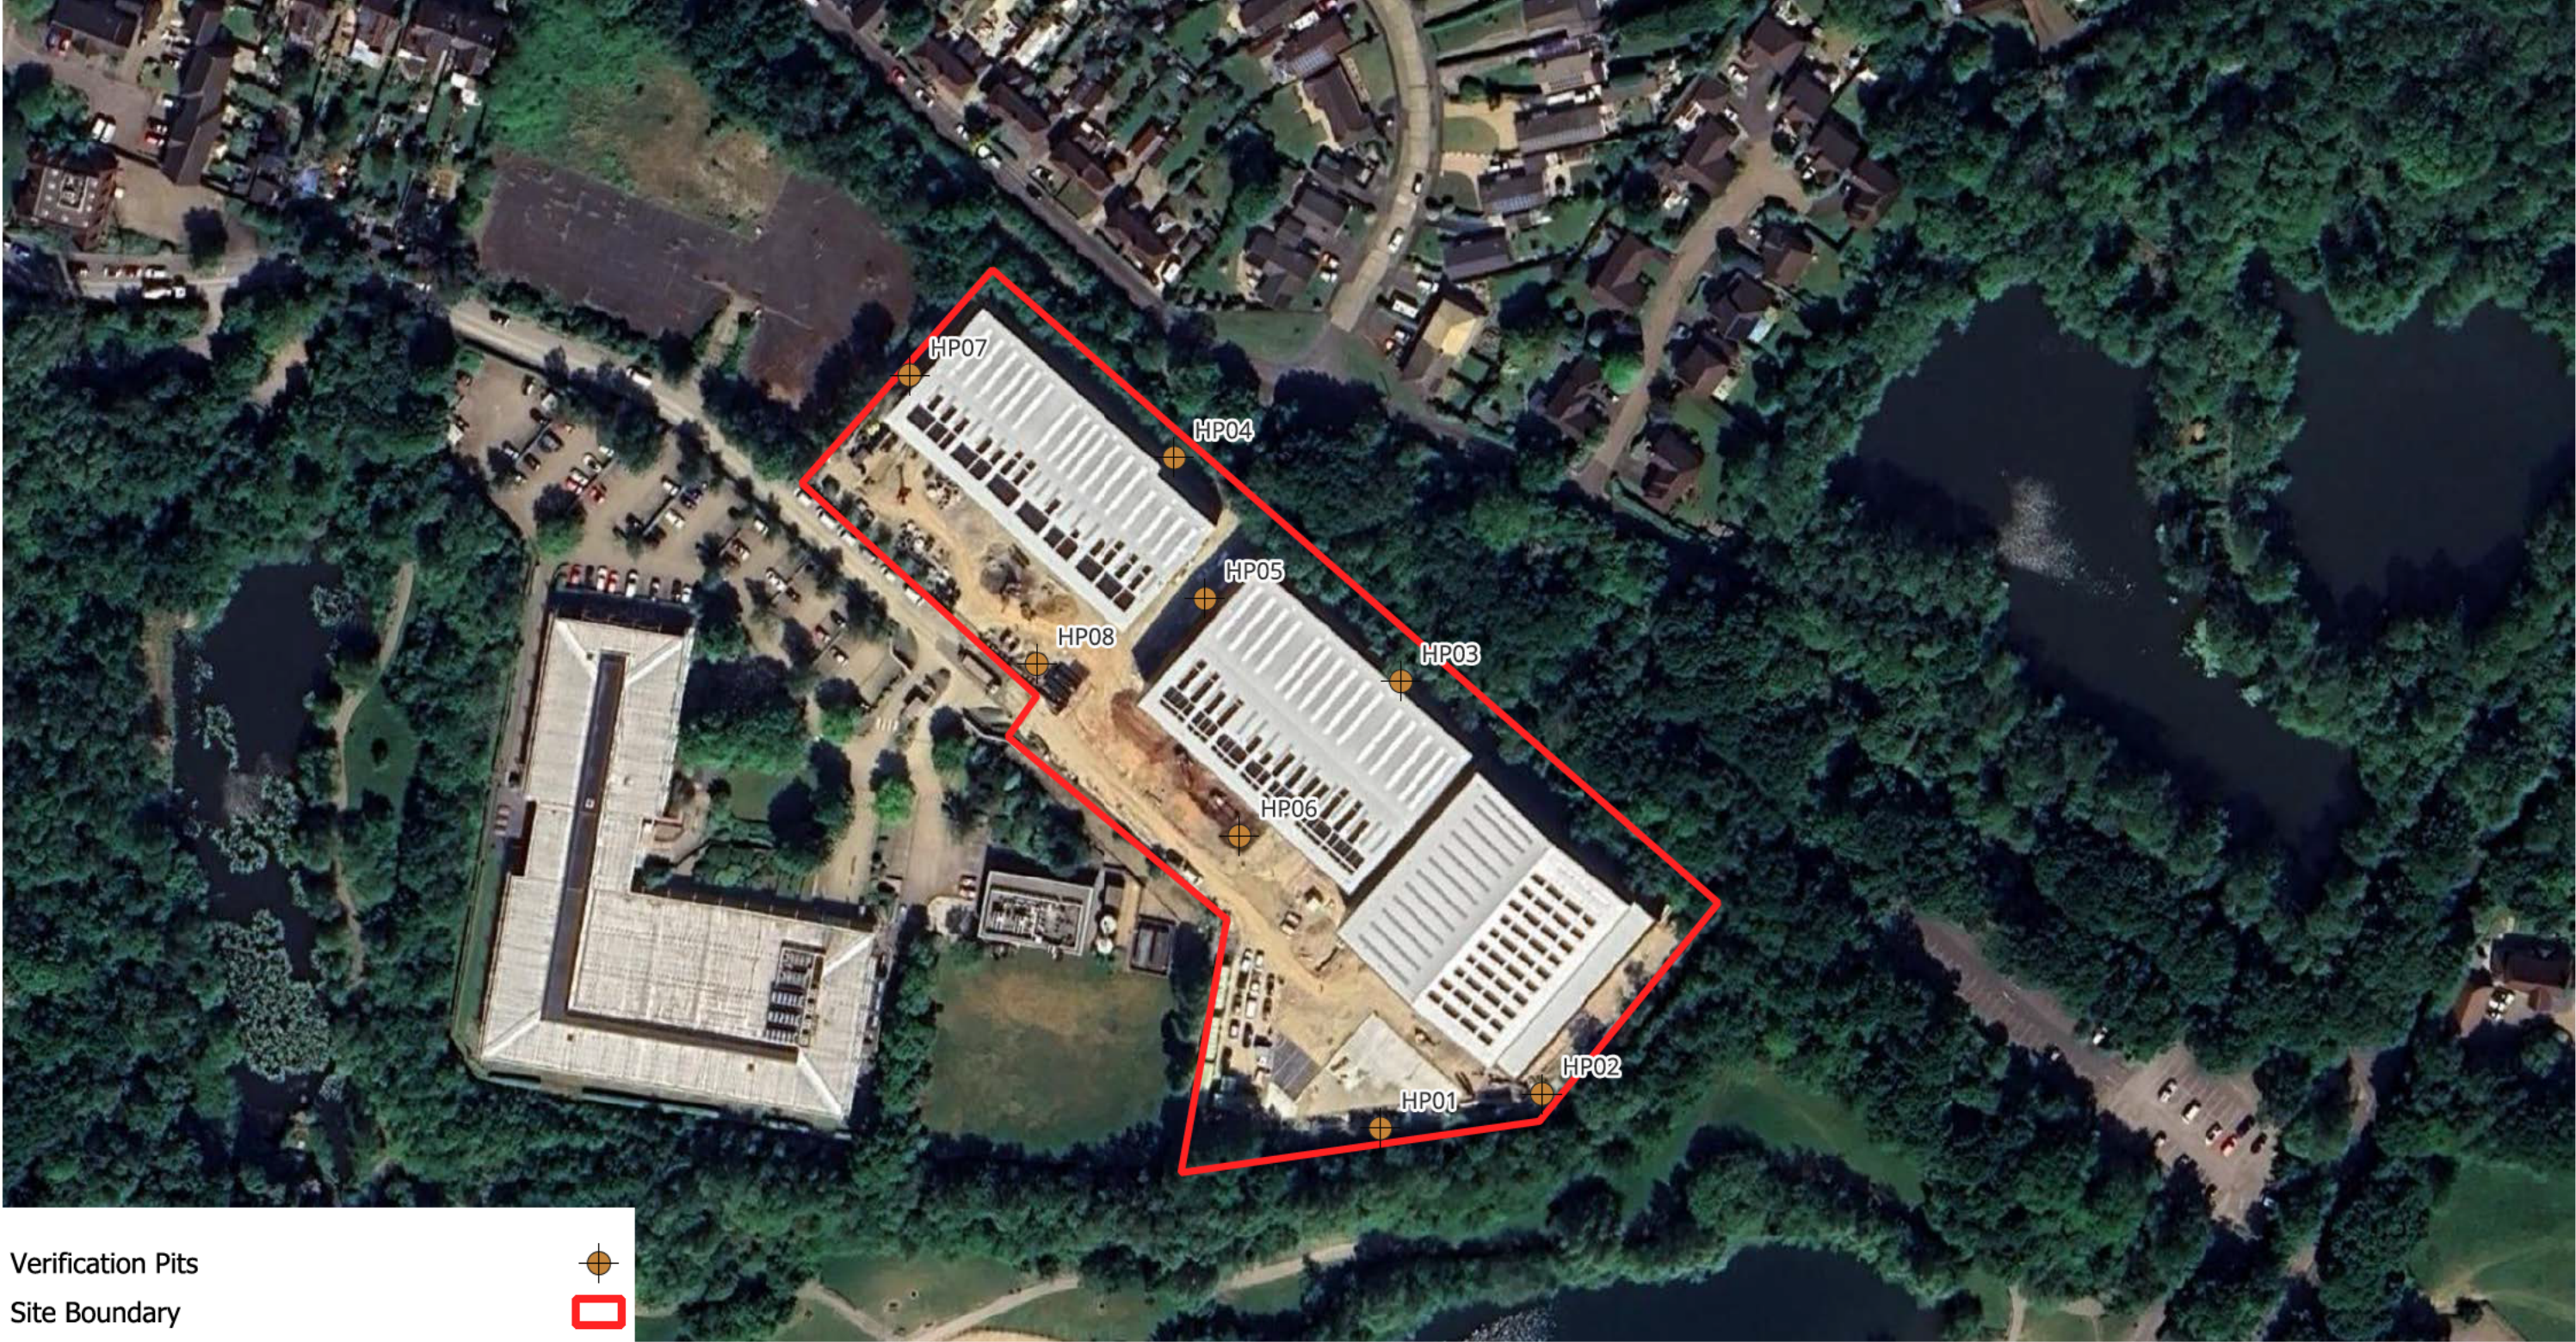
Verification Pits  
Site Boundary

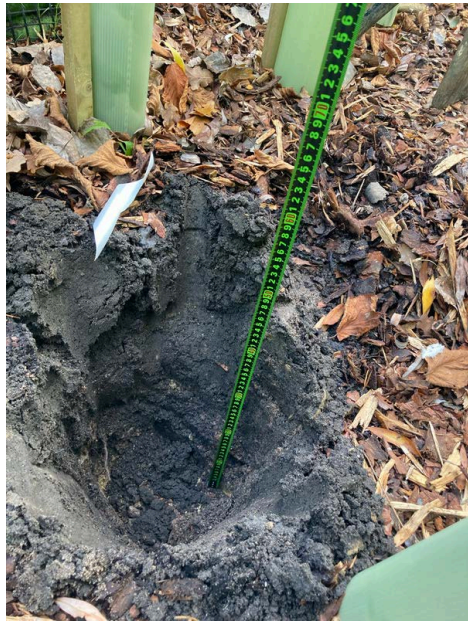
| 1 | 30/09/25 | |

| Description<br>HP01 pit | | |

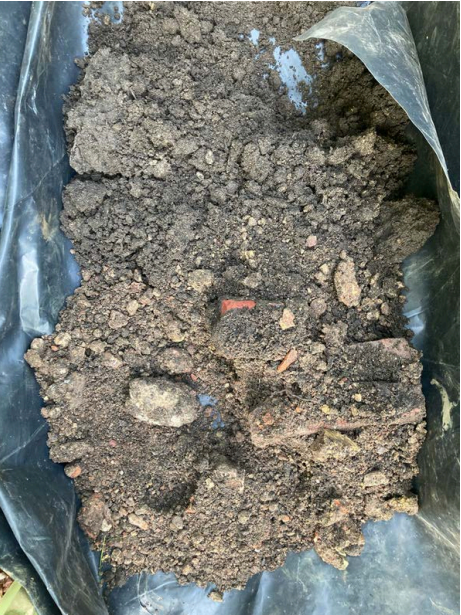
| 2 | 30/09/25 | |

| Description<br>HP01 arisings | | |

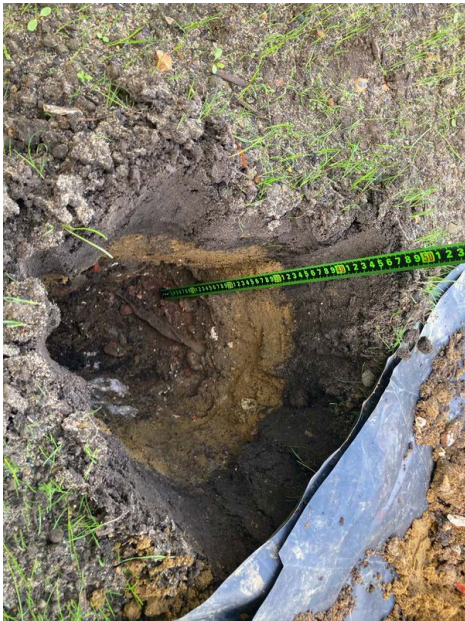
| 3 | 30/09/25 | |

| Description<br>HP02 pit | | |

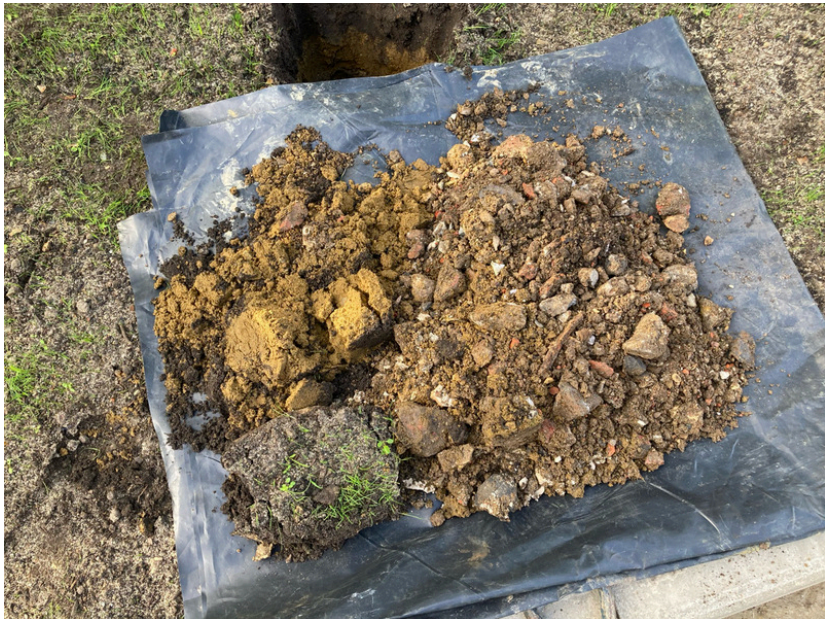
| 4 | 30/09/25 | |

| Description<br>HP02 arisings | | |

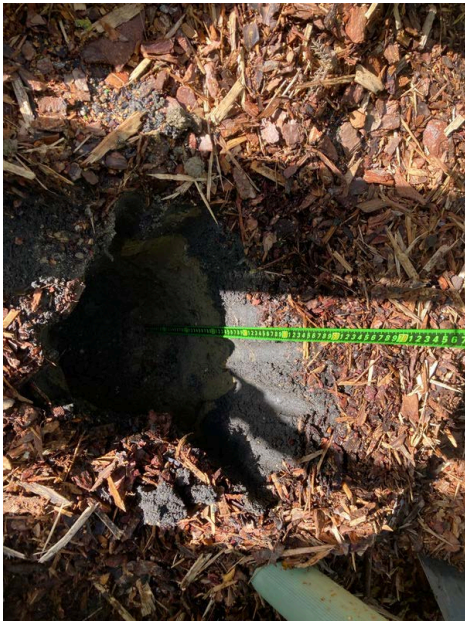
| Photo No.<br>5 | Date<br>30/09/25 | |

| Description<br>HP03 pit | | |

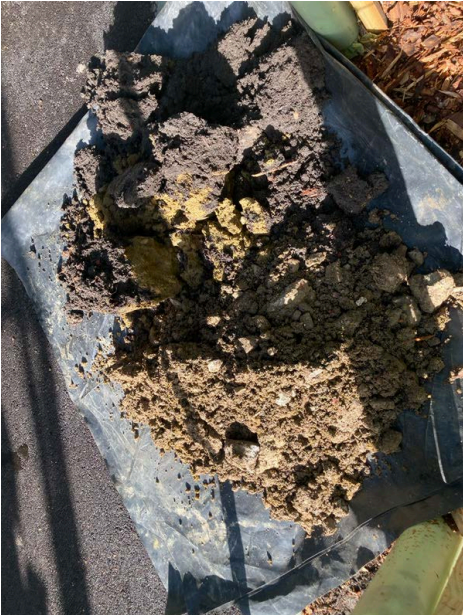
| Photo No.<br>6 | Date<br>30/09/25 | |

| Description<br>HP03 arisings | | |

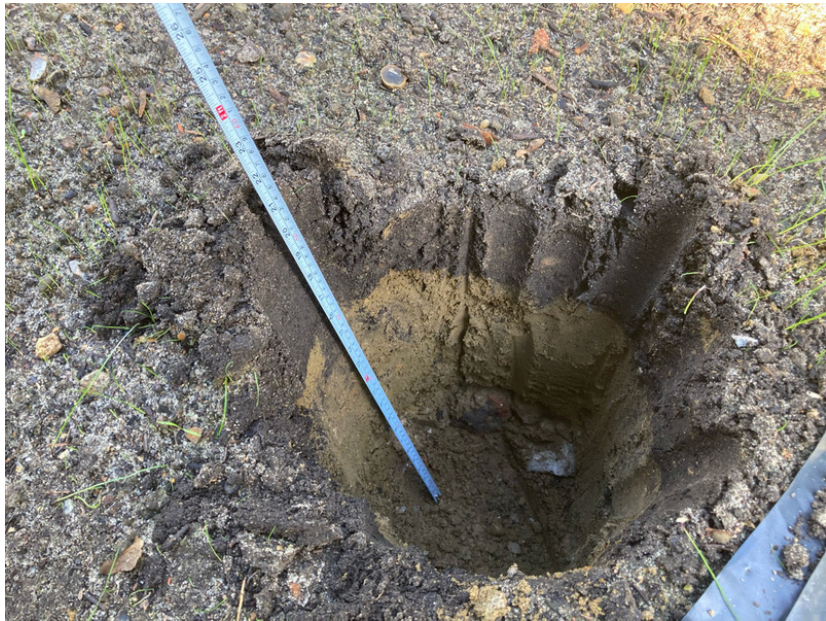
| Photo No.<br>7 | Date<br>30/09/25 | |

| Description<br>HP04 pit | | |

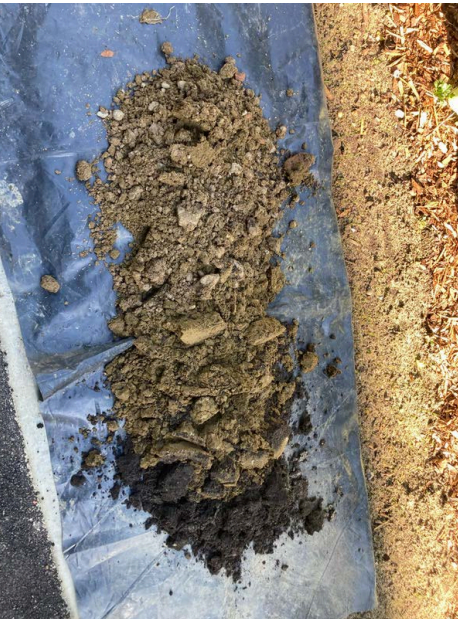
| Photo No.<br>8 | Date<br>30/09/25 | |

| Description<br>HP04 arisings | | |

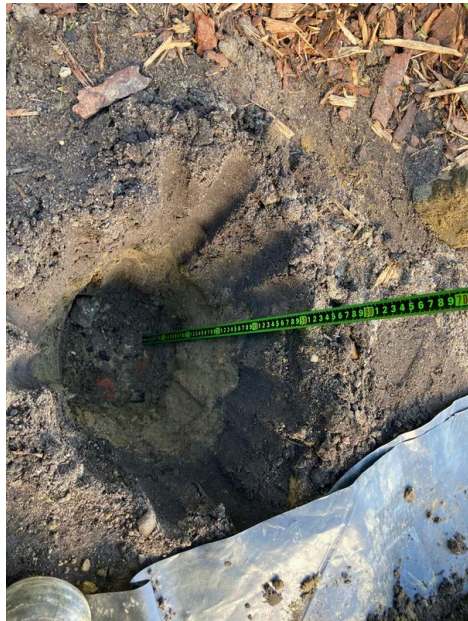
| 9 | 30/09/25 | |

| Description<br>HP05 pit | | |

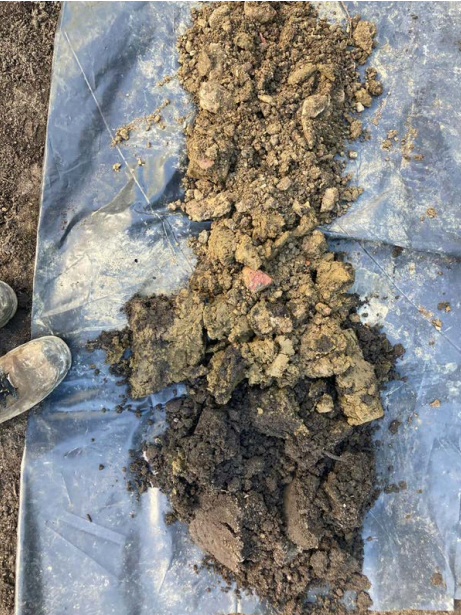
| 10 | 30/09/25 | |

| Description<br>HP05 arisings | | |

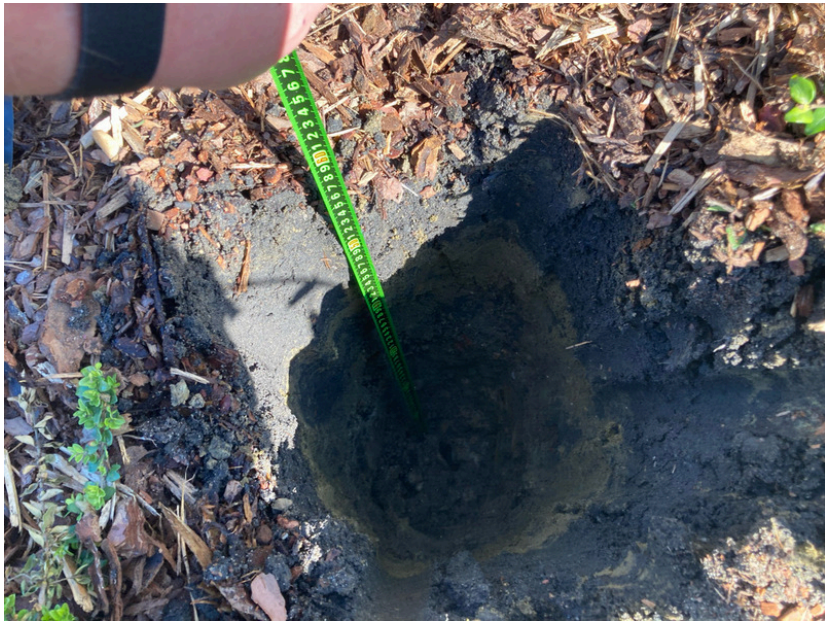
| Photo No.<br>11 | Date<br>30/09/25 | |

Made Ground was encountered in six of eight locations underlying the imported material, the other two locations were underlain by the Weald Clay Formation (HP06 and HP08). The underlying soils were observed to be visually clean and free from contamination.

| Description<br>HP06 pit | | |

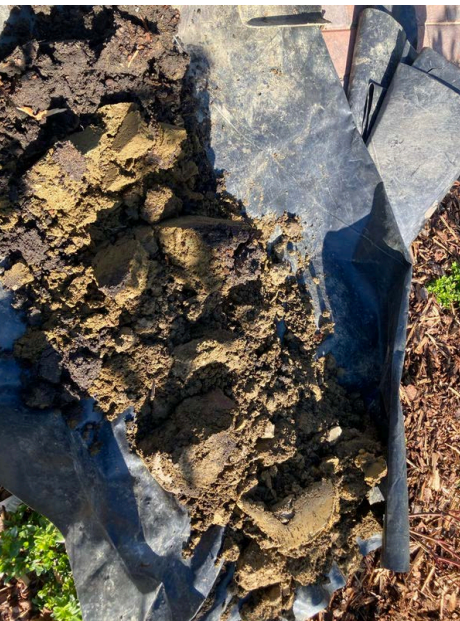
| Photo No.<br>12 | Date<br>30/09/25 | |

| Description<br>HP06 arisings | | |

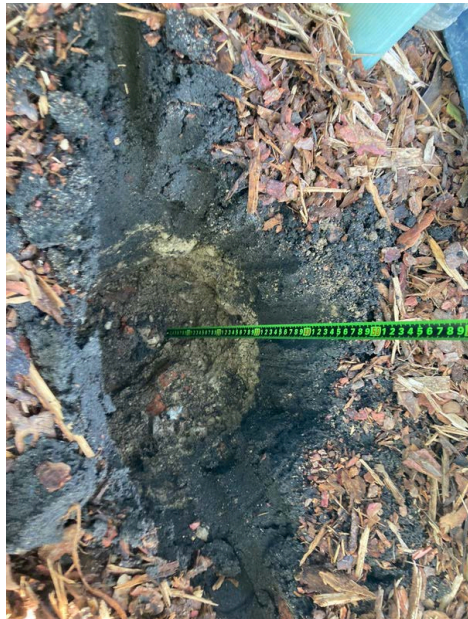
| Photo No.<br>13 | Date<br>30/09/25 | |

| Description<br>HP07 pit | | |

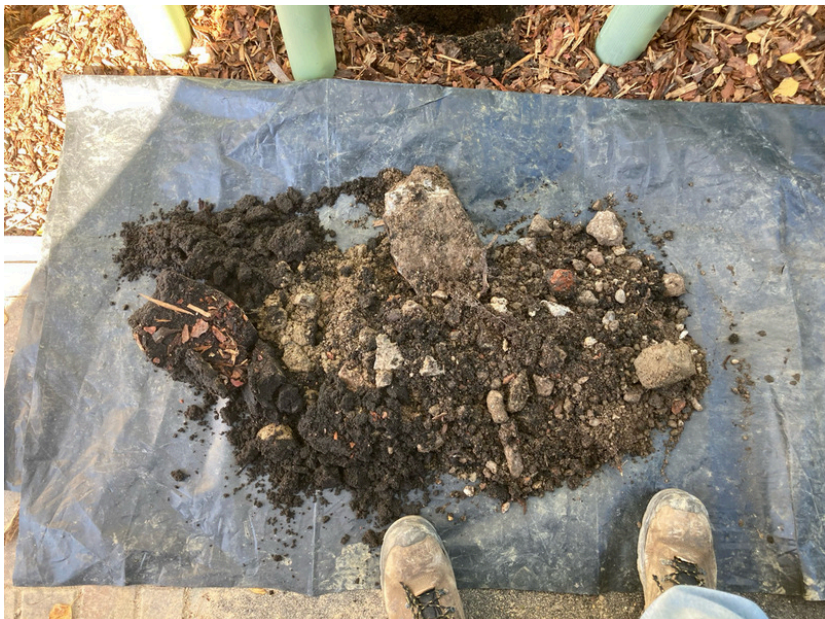
| Photo No.<br>14 | Date<br>30/09/25 | |

| Description<br>HP07 arisings | | |

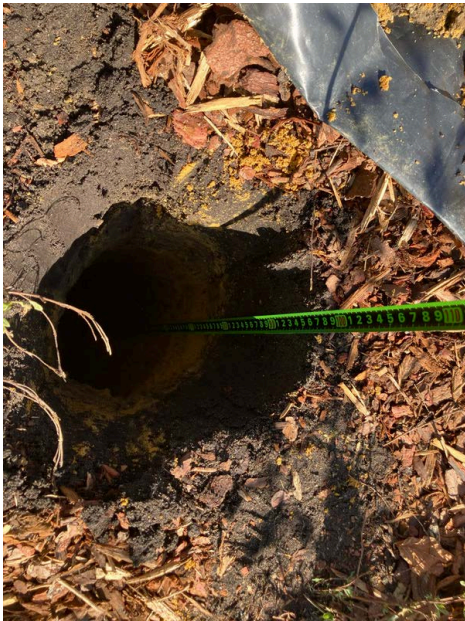
| Photo No.<br>15 | Date<br>30/09/25 | |

| Description<br>HP08 arisings | | |

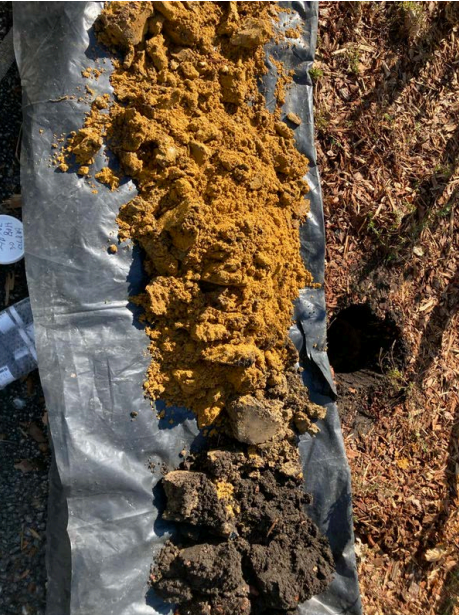
| Photo No.<br>16 | Date<br>30/09/25 | |

| Description<br>HP08 arisings | | |

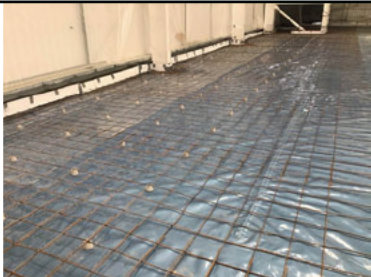
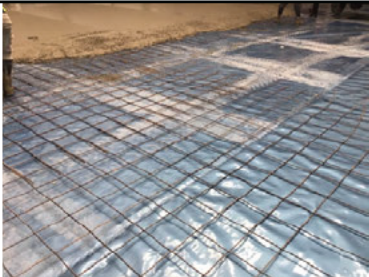
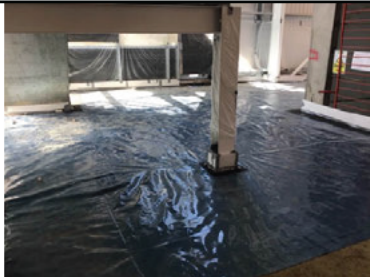
| Overview of the installed membrane prior to the laser pour progressing. | Overview of the Juta GP5 being installed prior to the pour progressing. | Overview of the office area installation. |

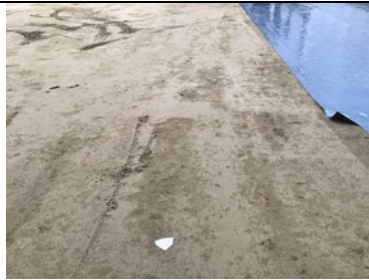
Evidence of the well rolled substrate prior to the membrane being installed.

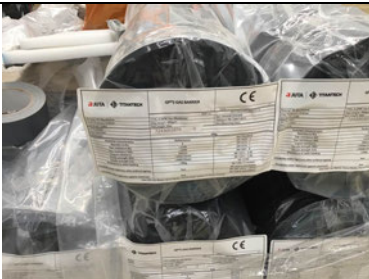
Evidence of the Juta GP5 gas membrane that has been installed on this project.

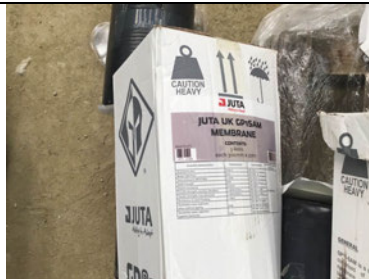
Evidence of the Juta GP1 SAM a that has been used for the detailing works on this project.

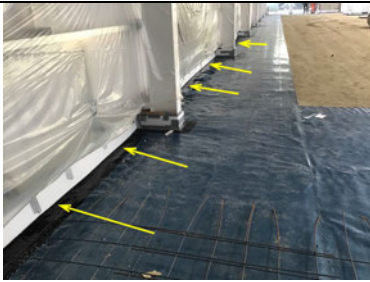
The perimeter retro fit detailing has been covered with miothene at the time of our inspection.

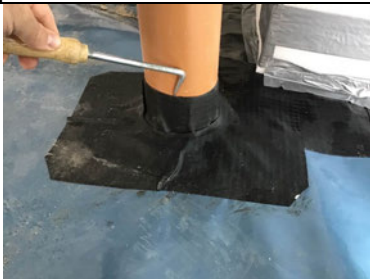
Probe testing a pipe penetration detail.

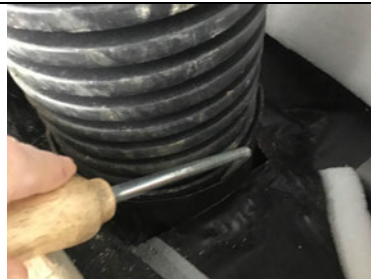
Probe testing a pipe penetration detail.

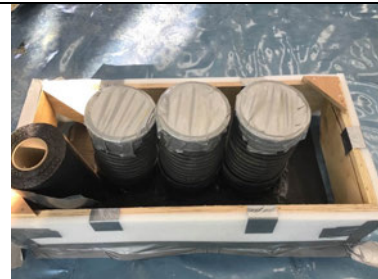
Pipe penetration detailing that has been boxed off.

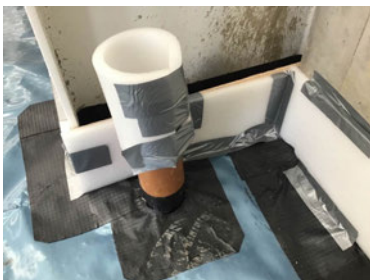
Pipe penetration detailing.

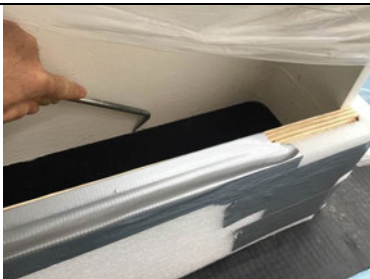
Probe testing the the detailing work to the inner web of the steel stanchion.

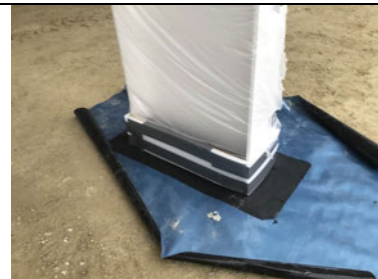
Steel stanchion covered with miothene at the time of our inspection.

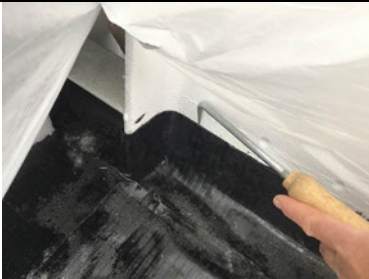
Probe testing the inner web of the steel stanchion detailing.

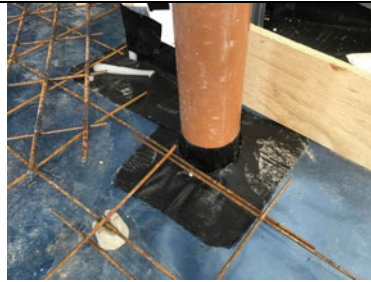
Typical pipe penetration detailing.

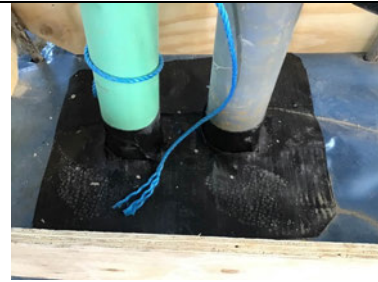
Typical double pipe penetration detailing.

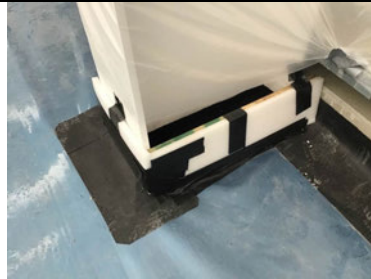
A restricted inspection took place of the steel stanchions due to miothene being in place at the time of our inspection.

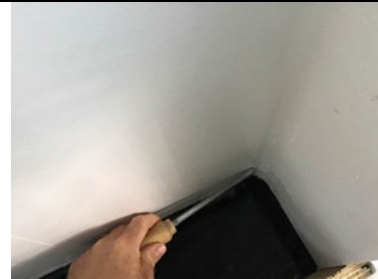
Probe testing the inner web of the steel stanchion.

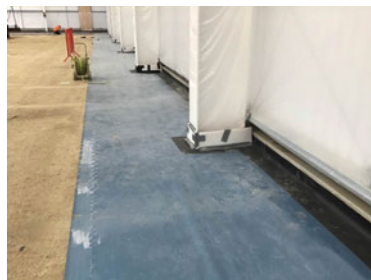
All steel stanchions were covered with miothene at the time of our visit therefore a restricted inspection took place.

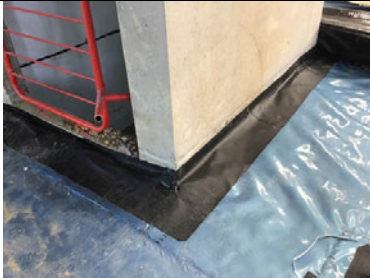
Retro fit detailing to the base of the concrete lift pit.

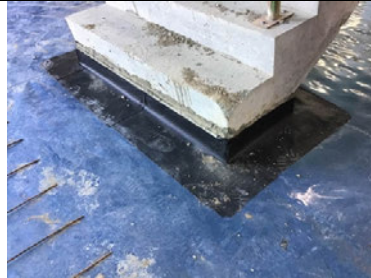
Overview of the detailing to the base of the concrete stair core.

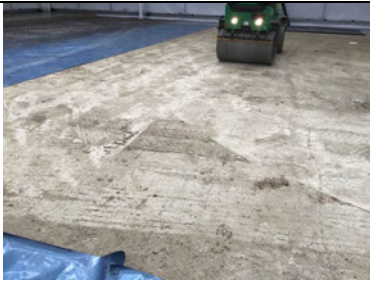
Evidence of the rolling machine used on the sand blinded substrate prior to the install of the gas membrane.

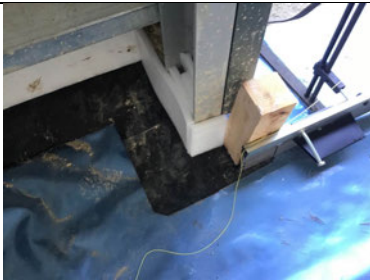
A restricted inspection took place of the steel stanchions due to miothene being in place at the time of our inspection.

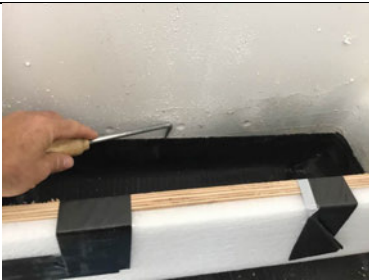
Probe testing the inner web of the steel stanchion.

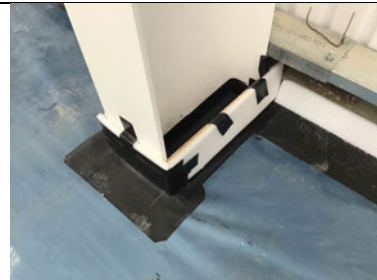
A restricted inspection took place of the steel stanchions due to miothene being in place at the time of our inspection.

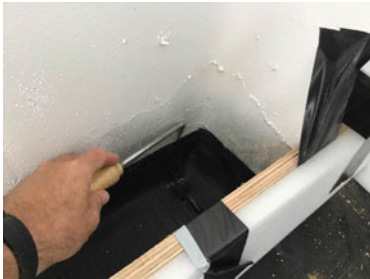
Probe testing the inner web of the steel stanchion.

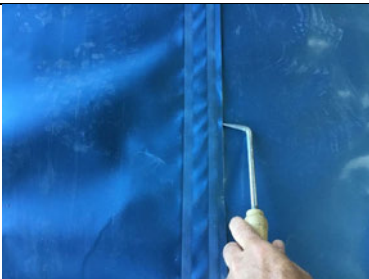
Probe testing the auto welded membrane lap.

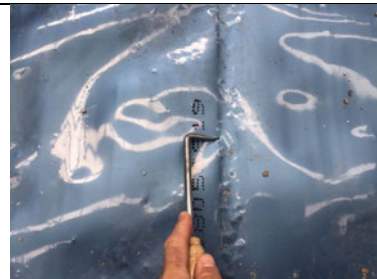
Probe testing a typical hand welded membrane lap.

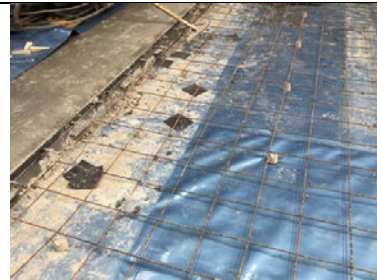
UK Membranes carried out their own CQA repairs as the pour progressed.

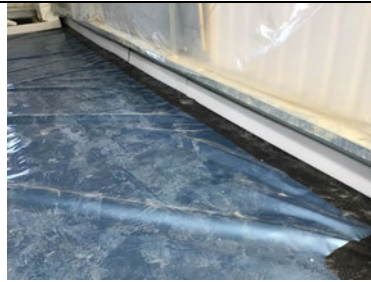
Miothene in place prior to our inspection.

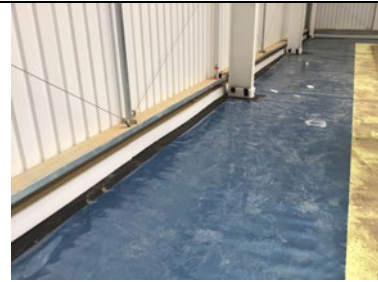
A restricted inspection took place to the detailing around the perimeter of units 1-3 due to the miothene being in place at the time of our visit.

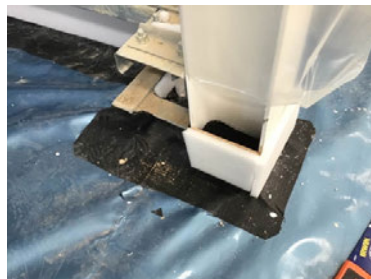
A restricted inspection took place of the steel stanchions due to miothene being in place at the time of our inspection.

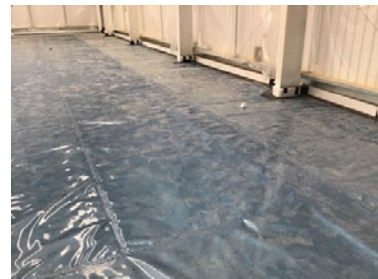
A restricted inspection took place of the steel stanchions due to miothene being in place at the time of our inspection.

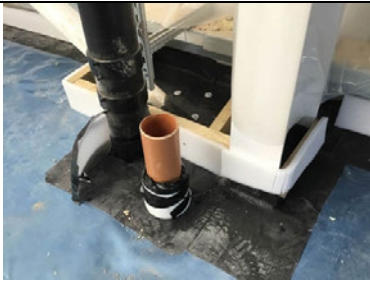
A restricted inspection took place of the steel stanchions due to miothene being in place at the time of our inspection.

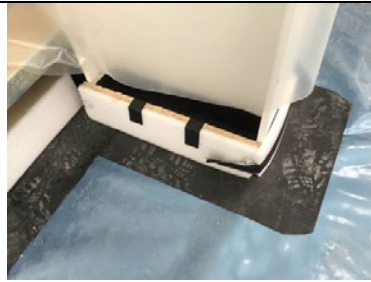
A restricted inspection took place of the steel stanchions due to miothene being in place at the time of our inspection.

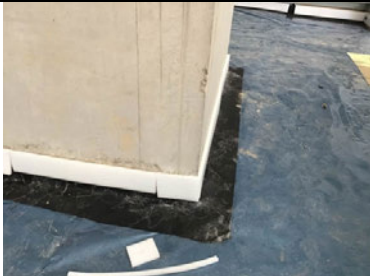
The lift pit detailing had been covered with miothene at the time of our inspection in unit 1.

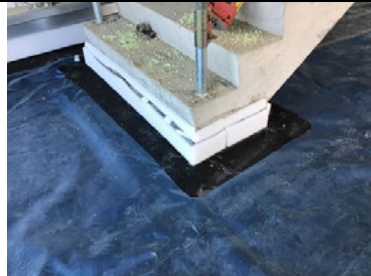
Miothene was in place around the bases of the concrete stairs in units 1-3.

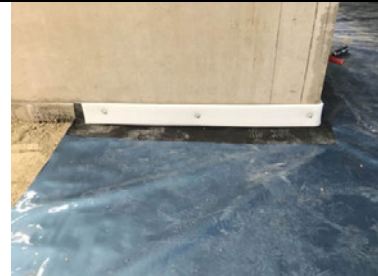
The lift pit detailing had been covered with miothene at the time of our inspection in unit 2.

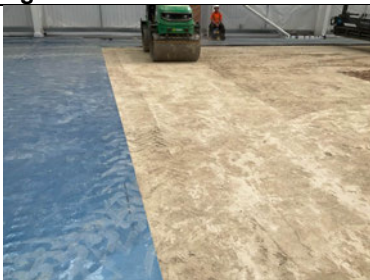
Substrate base being continuously rolled prior to gas barrier installation.

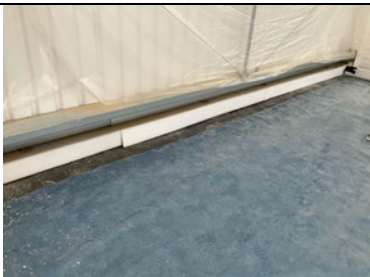
Restricted inspection of the termination detailing along the perimeter cladding rail.

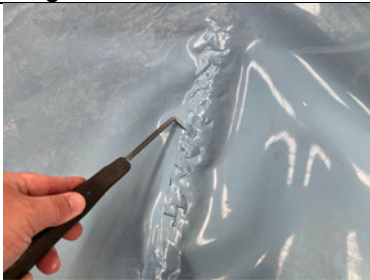
Probe testing along hand welded membrane lap joints.

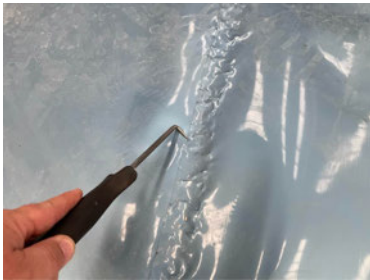
Probe testing along hand welded membrane lap joints.

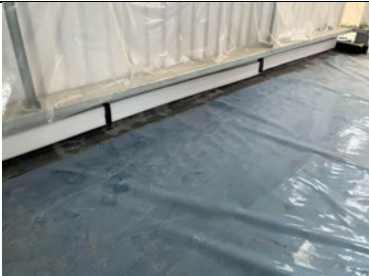
Restricted inspection of the retrofit termination detailing to the perimeter cladding rail.

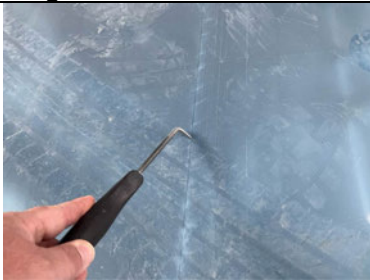
Probe testing along hand welded  
membrane lap joints.

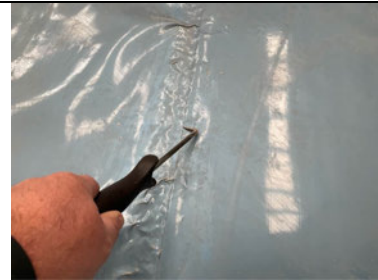
Probe testing along hand welded  
membrane lap joints.

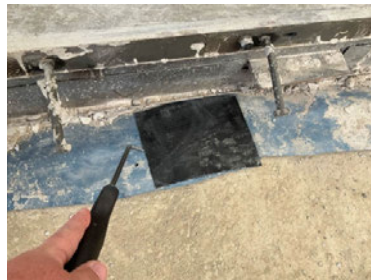
Probe testing to patched repaired armoured joint pin holes.

Armoured joint pin holes were patched repaired by installer using Juta GP1 SAM.

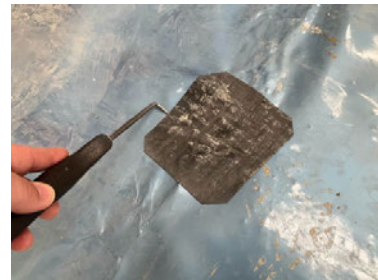
Probe testing to installers own CQA patch repair.

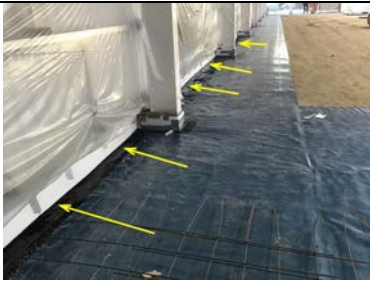
The perimeter retro fit detailing has been covered with miothene at the time of our inspection.

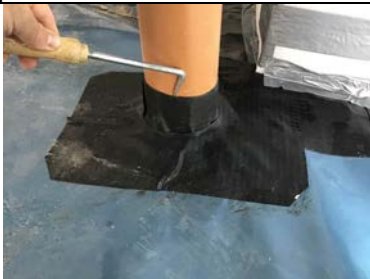
Probe testing a pipe penetration detail.

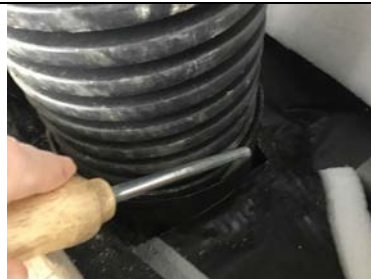
Probe testing a pipe penetration detail.

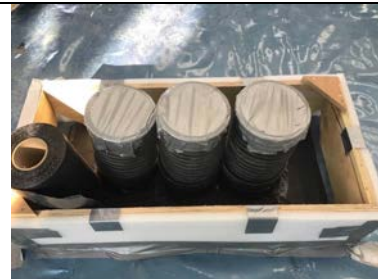
Pipe penetration detailing that has been boxed off.

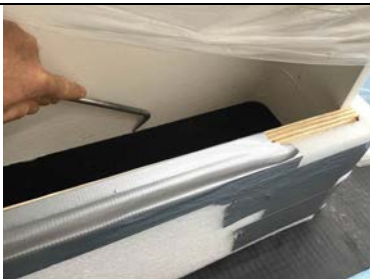
Probe testing the the detailing work to the inner web of the steel stanchion.

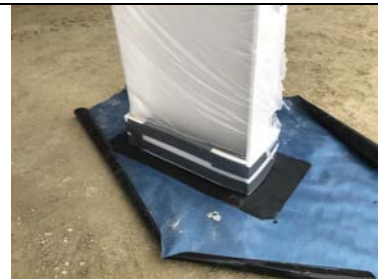
Steel stanchion covered with miothene at the time of our inspection.

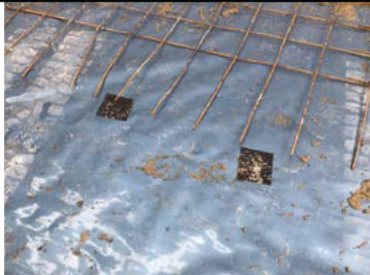
| A general overview of unit 7 pour 2 of 2. | Overview of the membrane installation as the pour progresses. | CQA repairs using Juta GP1 SAM, completed by UK Membranes as the pour progresses. |

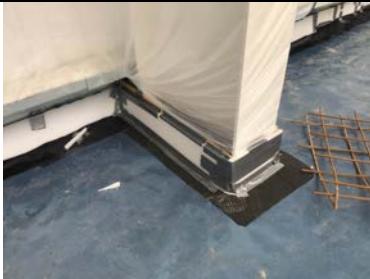
Steel stanchion covered with miothene at the time of our inspection.

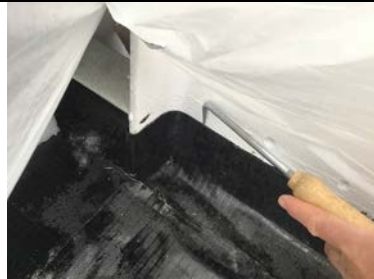
Probe testing the inner web of the steel stanchion detailing.

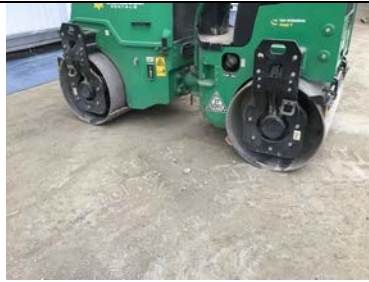
Evidence of the rolling machine used on the sand blinded substrate prior to the install of the gas membrane.

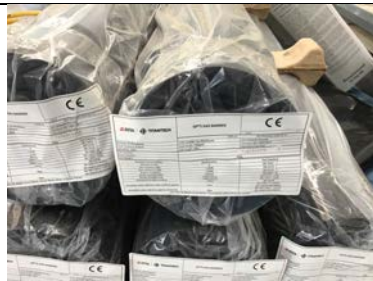
Evidence of the Juta GP5 Gas Membrane that has been used on this project.

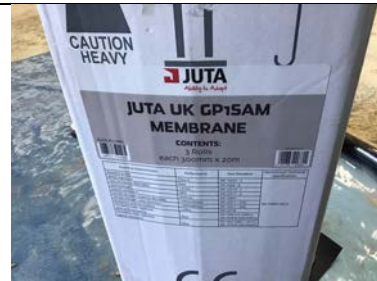
Evidence of the Juta GP1 SAM that has been used for the detailing work on this project.

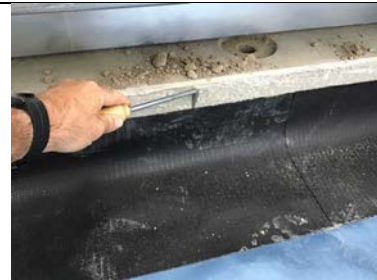
Probe testing the heat sealed perimeter curb stone detailing.

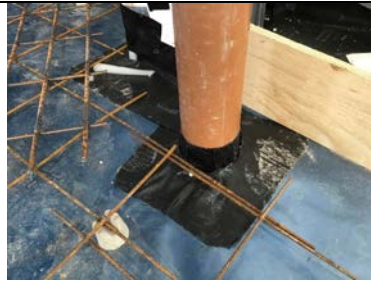
Typical pipe penetration detailing.

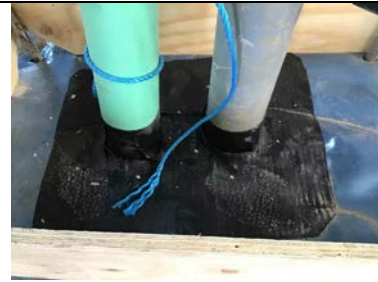
Typical double pipe penetration detailing.

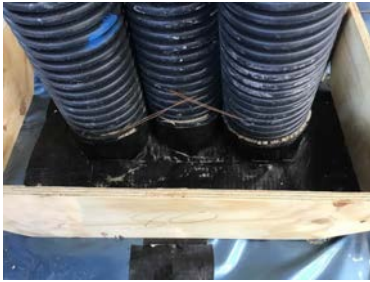
Pipe penetration detailing.

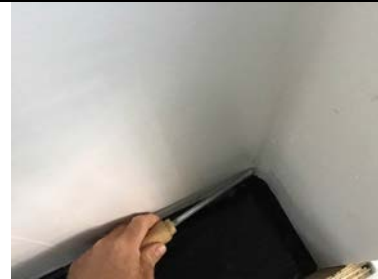
Probe testing the inner web of the steel stanchion.

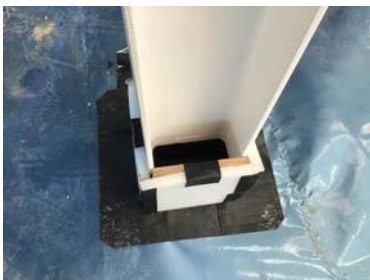
A restricted inspection took place of the steel stanchions due to miothene being in place at the time of our inspection.

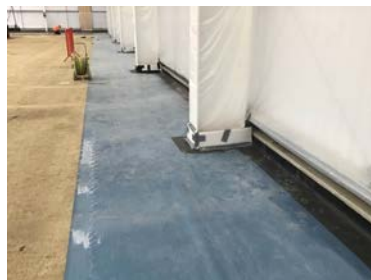
All steel stanchions were covered with miothene at the time of our visit therefore a restricted inspection took place.

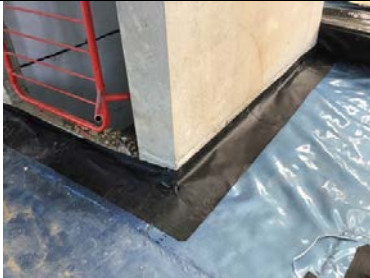
Retro fit detailing to the base of the concrete lift pit.

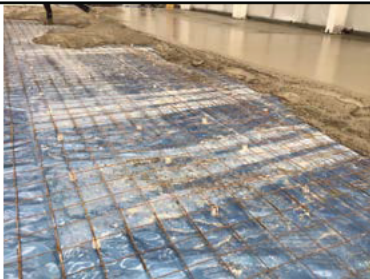
| <p>Overview of the Juta GP5 gas membrane installed prior to the pour processing.</p> | <p>Installation of the Juta GP5 Gas Membrane as the pour is progressing.</p> |

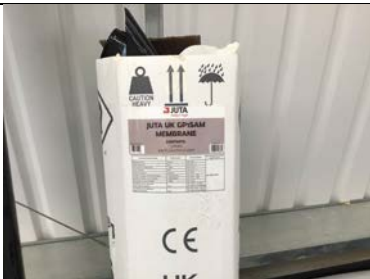
Evidence of the Juta GP1 SAM that has been used for the detailing work on this project.

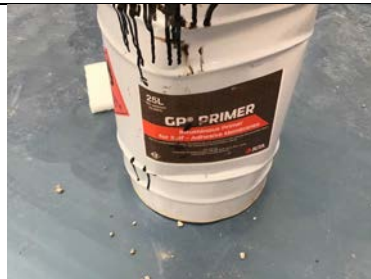
Evidence of the Juta GP Bitumen Primer that has been applied to the concrete prior to the detailing.

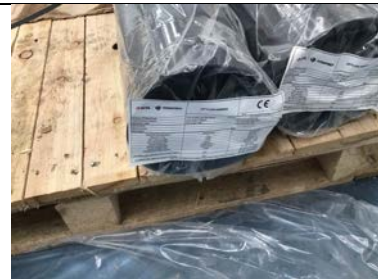
Evidence of the Juta GP5 Gas Membrane that has been used on this project.

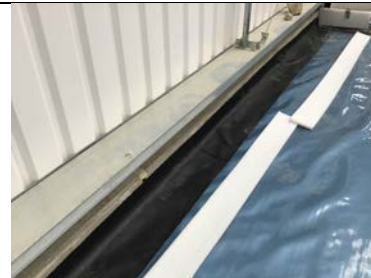
Overview of the perimeter termination detailing to the concrete curb stone.

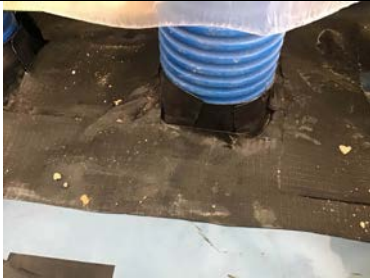
Typical pipe penetration detailing.

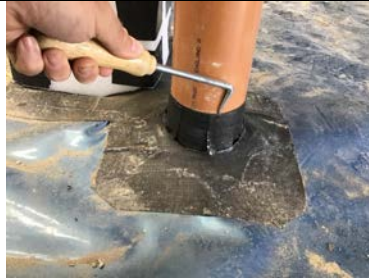
Probe testing a typical pipe penetration detail.

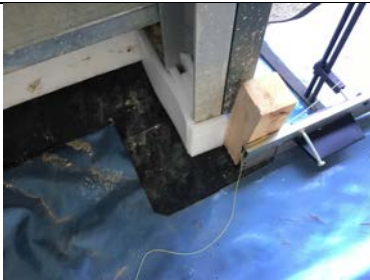
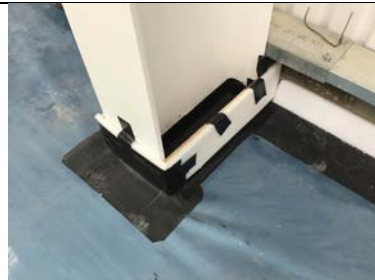
A restricted inspection took place of the steel stanchions due to miothene being in place at the time of our inspection.

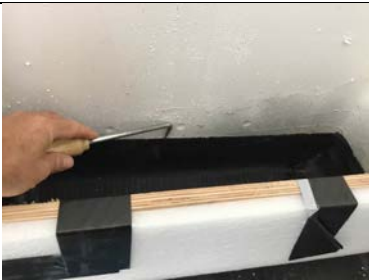
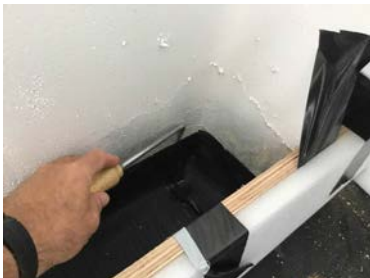
Probe testing the inner web of the steel stanchion.

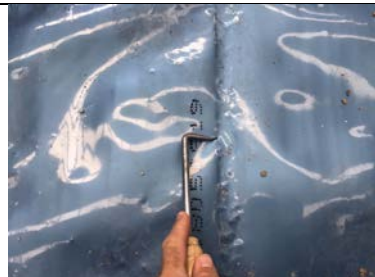
Probe testing a typical hand welded membrane lap.

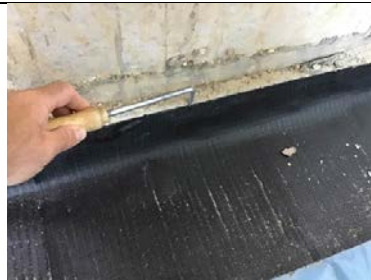
Probe testing the retro fit detailing to the base of the concrete stairs.

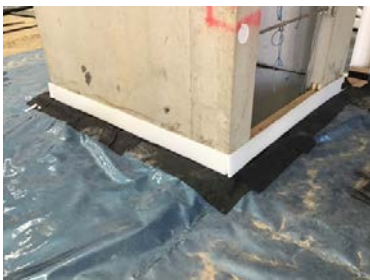
The lift pit detailing had been covered with miothene at the time of our inspection.

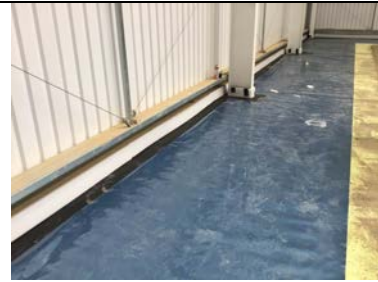
A restricted inspection took place to the detailing around the perimeter of units 1-3 due to the miothene being in place at the time of our visit.

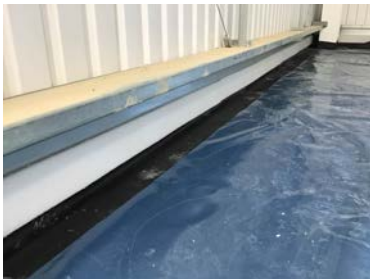
A restricted inspection took place to the detailing around the perimeter of units 1-3 due to the miothene being in place at the time of our visit.

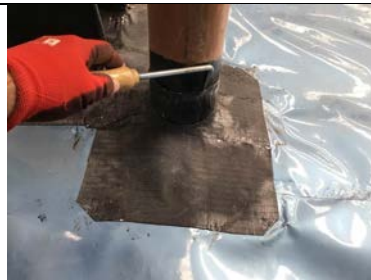
Probe testing a typical pipe penetration in unit 1.

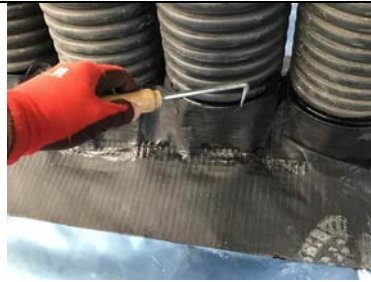
Probe testing all pipe penetration detailing in unit 2.

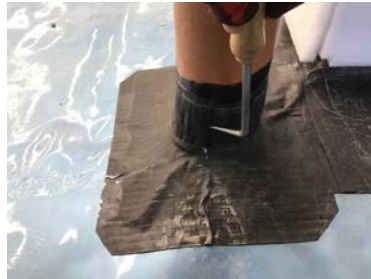
Probe testing a typical pipe penetration detail in unit 3.

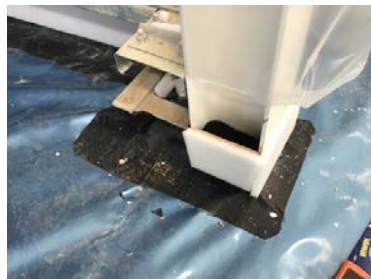
A restricted inspection took place of the steel stanchions due to miothene being in place at the time of our inspection.

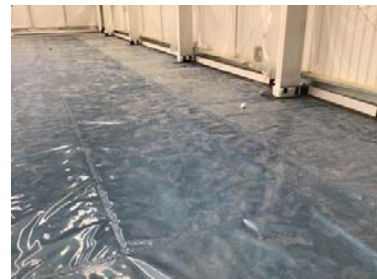
A restricted inspection took place of the steel stanchions due to miothene being in place at the time of our inspection.

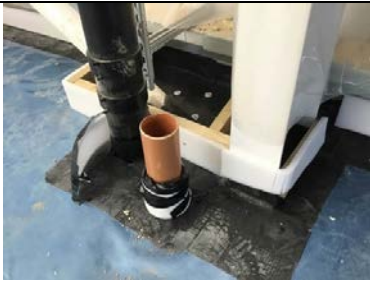
A restricted inspection took place of the steel stanchions due to miothene being in place at the time of our inspection.

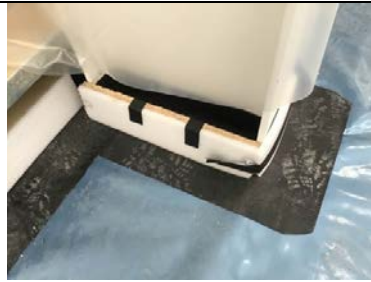
A restricted inspection took place of the steel stanchions due to miothene being in place at the time of our inspection.

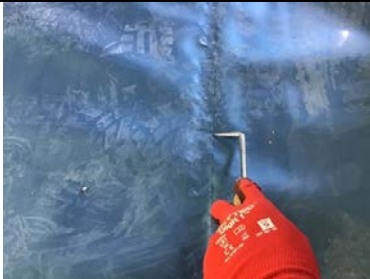
Prob testing all hand welded membrane lap's across units 1-3.

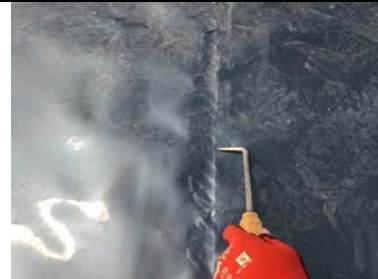
Probe testing a typical hand welded membrane lap.

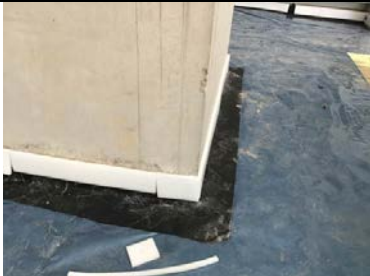
The lift pit detailing had been covered with miothene at the time of our inspection in unit 1.

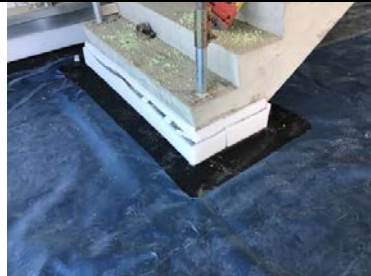
Miothene was in place around the bases of the concrete stairs in units 1-3.

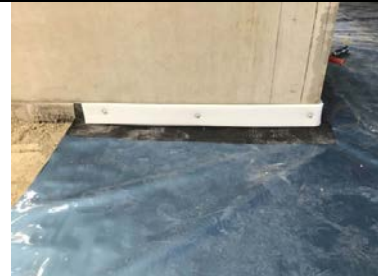
The lift pit detailing had been covered with miothene at the time of our inspection in unit 2.

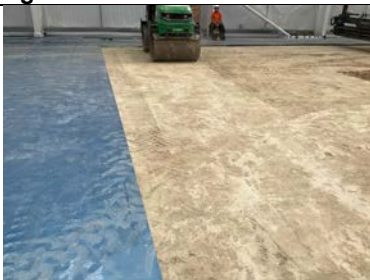
Substrate base being continuously rolled prior to gas barrier installation.

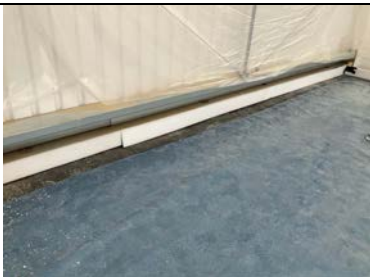
Restricted inspection of the termination detailing along the perimeter cladding rail.

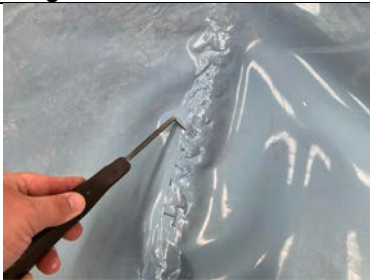
Probe testing along hand welded membrane lap joints.

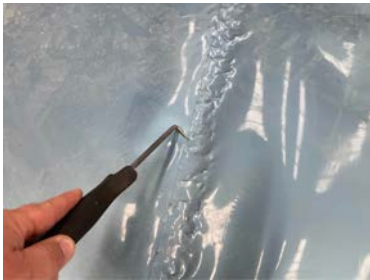
Probe testing along hand welded membrane lap joints.

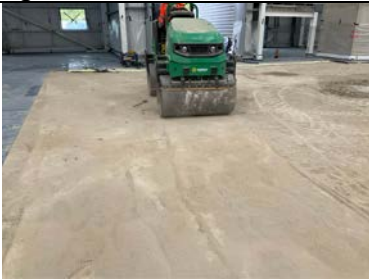
Substrate base being continuously rolled prior to gas barrier installation.

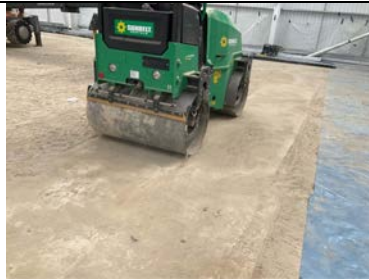
Substrate being rolled in preparation of gas barrier.

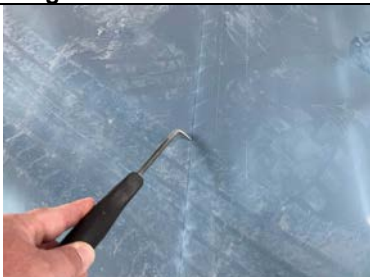
Probe testing along hand welded  
membrane lap joints.

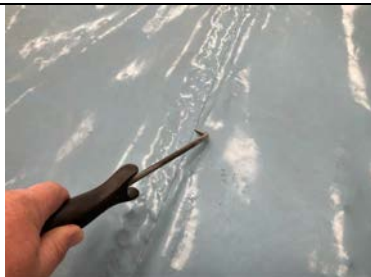
Probe testing along hand welded  
membrane lap joints.

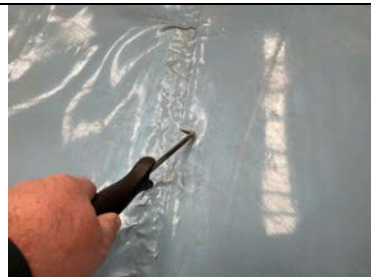
Probe testing along hand welded  
membrane lap joints.
